High Street Example Commercial Building Survey

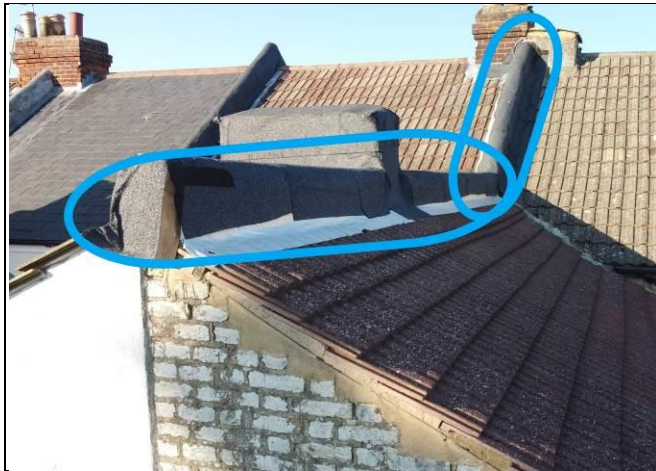
The parapet walls are small walls at roof level. They are covered with mineral felt, indicating to us that there have been leaks, as covering them with mineral felt is not normal practice.

There has also been a product known as Flashband used which is a stick on flashing. Again we would term this as temporary/DIY quality work. We can see it has had poor quality repairs.

Felt over rear parapet wall with Flashband repairs to base
~ Aerial View - 360 Photo ~

Flashband is a sticky backed felt, which is best used for temporary repairs only.

ACTION REQUIRED: We recommend the entirety of the felt capping is stripped back and if possible a coping stone is added and repairs are carried out to the parapet walls.

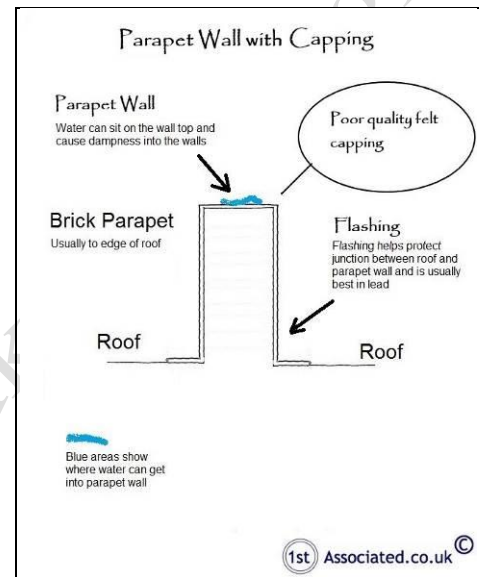
Parapet wall with felt capping

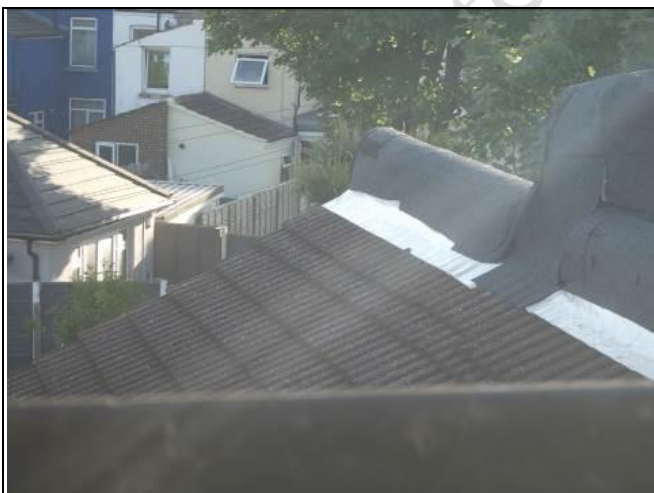
Felt over parapet with Flashband flashing repairs
~ Aerial View - 360 Photo ~

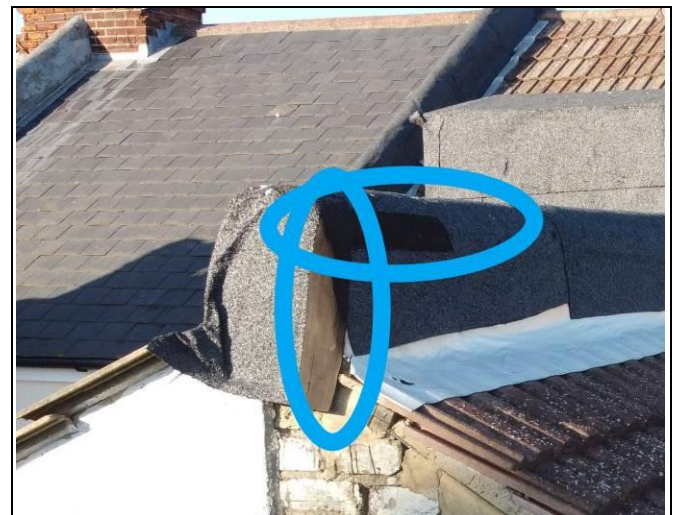
Poor quality repairs on a poor quality felt capping
~ Aerial View - 360 Photo ~

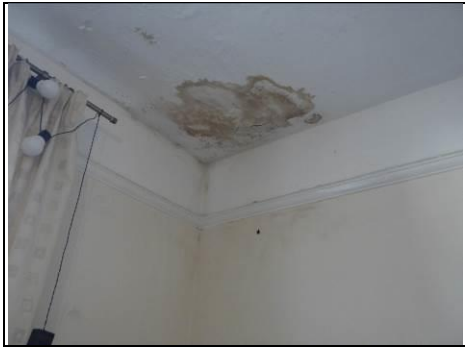
We can see there is damp staining in the front bedroom. Unfortunately we have not been able to have a good look at this roof internally but externally we can comment that at the very least there looks to be problems with the parapet wall roof detail, we noticed a tree growing out of the front left parapet.

Damp staining to front bedroom to left hand side

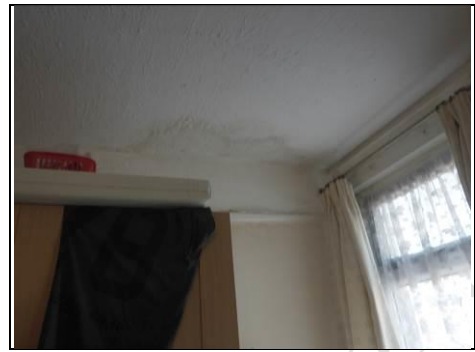
Damp staining in front bedroom to right hand side

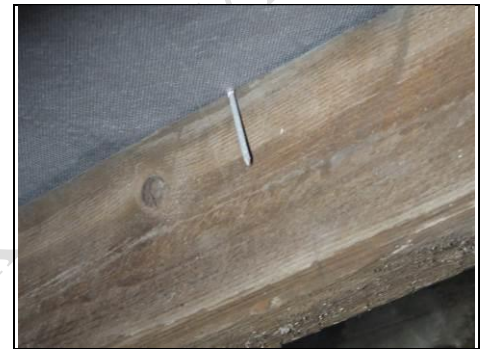
We noted a nail in the roof. First of all we rarely see nails through the roof like this. This is where the roofer has miss hit the nail that fixes the batten on (the timber that holds the tile in place). This gives us an indication of the general standard of work/speed at which it was carried out.

Nail in the rear of the roof

ACTION REQUIRED: The existing owner should be contacted to see if there is any form of insurance backed guarantee in relation to the roofing work.

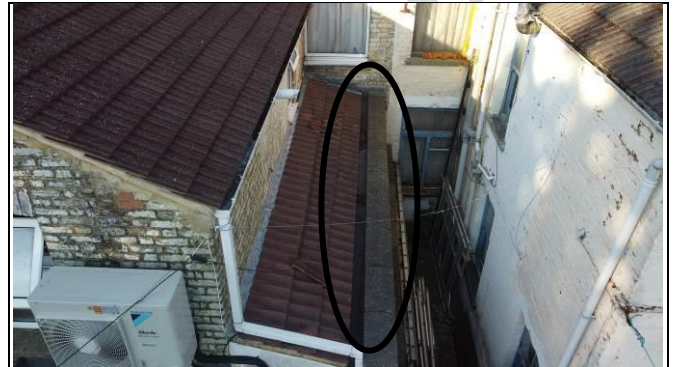
It has an internal gutter, we are not keen on these as they tend to leak sooner or later, either because the roof is so shallow or because of the internal gutter.

We can see there looks to have been water damage and deterioration already from the condition of the left hand wall and the coping stones look like water is leaking through. We think in the long term this will cause damage, deterioration and dampness.

Left side single pitched roof next to boundary wall
~ Aerial View - 360 Photo ~

ACTION REQUIRED: The internal gutter needs to be checked and cleared to ensure it is watertight and you need to re-bed/repair the boundary wall and associated coping stones.

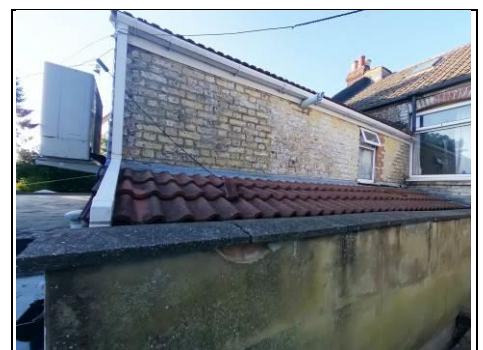
Capping stone needs bedding in

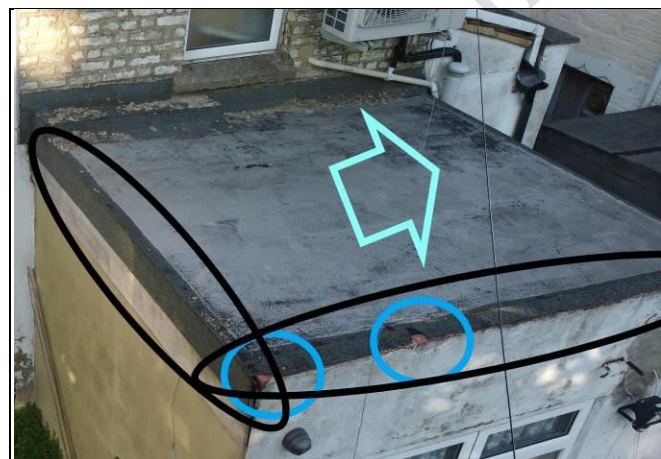
We would start by commenting that this is a flat, flat roof, meaning that there is no good fall on it. There is also no gutter. We think that water will be sitting on it, which causes accelerated deterioration.

1. First of all it is a flat, flat roof, meaning there is no good fall on it. However, even if it did have a fall there is no gutter to catch the water, so presently because there are no upstands around the flat roof (marked with black ovals on sketch) we think that water will be discharging down the external walls.
2. We also noticed that the felt work has not been carried out very well and bricks are visible to the front of the wall.
3. Also, we would add that we think the flashing is poorly carried out and we would prefer it to be replaced with lead.

Arrow shows the direction we believe the fall should go in

ACTION REQUIRED: We recommend a new roof, with insulation cut to falls, and the adding of guttering and downpipe. The downpipe needs to discharge into a soak-away.

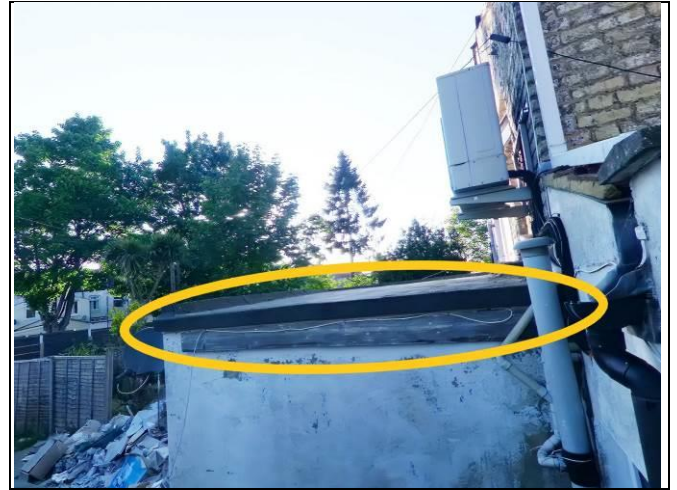
No gutter on rear flat roof
~ Aerial View - 360 Photo ~

ANTICIPATED COST:
Expect costs in the region of £7,500 to £12,000, depending upon whether the decking and ceiling below need work. Please obtain quotations before you legally commit to purchase.

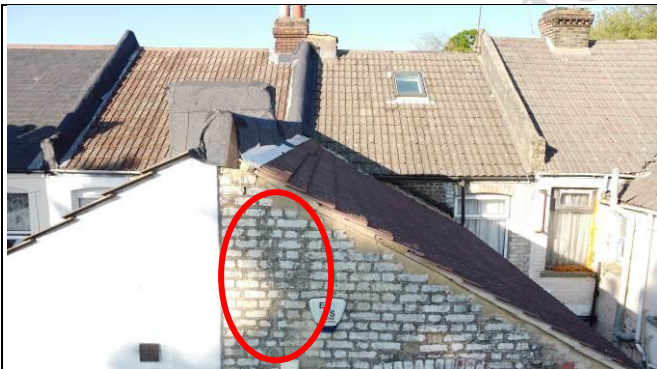
We noted cracking to the brickwork to the rear of the property. It looks to have been patch repaired.

Crack running down rear wall
~ Aerial View - 360 Photo ~

ACTION REQUIRED: As this is a one-off inspection we believe that caution is the best way forward. We would recommend the existing owners take out an insurance claim, advising that the cracking has been noted by a structural surveyor (this should cost them nothing other than time to write the letter/email). This usually means that the insurance company will carry out a monitoring exercise (the Building Research Establishment recommend monitoring any cracks for a minimum of one year) to establish if there is any progressive movement. Your future liability should be limited to the cost of the excess on the insurance providing the insurance company is happy for you to take over the insurance claim.

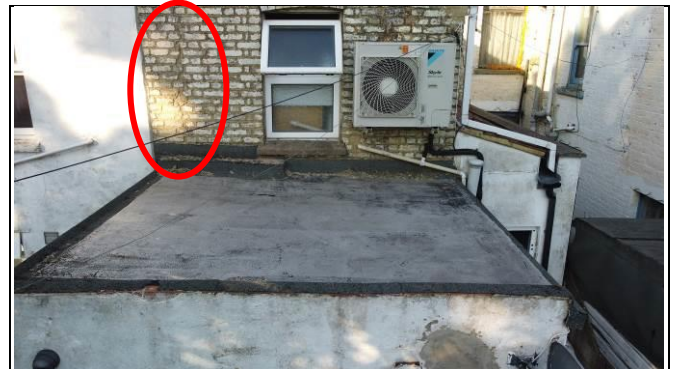
Crack running up left side
~ Aerial View - 360 Photo ~

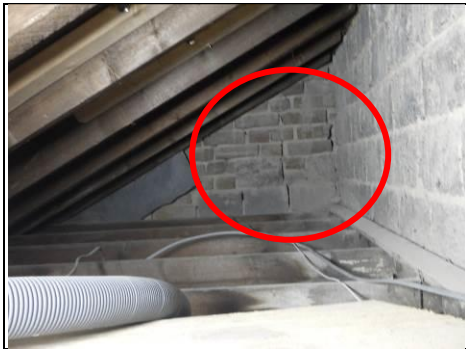
Within the roof we could also see straight joints which we believe are cracks. We would also say something unusual has happened to this wall due to the way it is bedded into the roof.

We also noted this wall is the external wall which has had the opening formed in it to gain access into the rear office. It should have had a structural support added and it may also be contributing to the movement.

Movement in roof space to rear wall

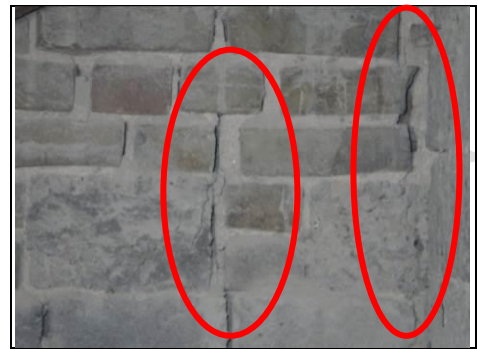
Close of cracks in roof space to rear wall

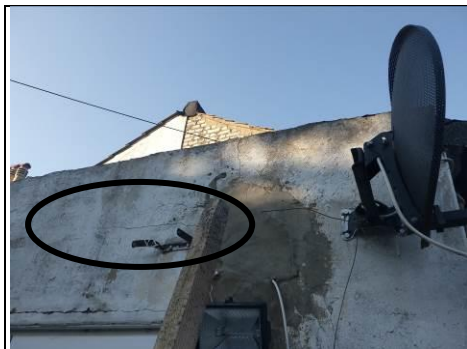
We noted generally there is cracking to the rear rendered walls. This could relate to the movement in the property, it could also relate to the general dampness getting into the building. It is very difficult to be certain as there was a lot of stored items against the property, as you are aware.

Crack to rear render

ACTION REQUIRED: If the render cracks relate to the rear flat roof discharging water on it. Once the rear roof work has been carried out then we would look to re-render.

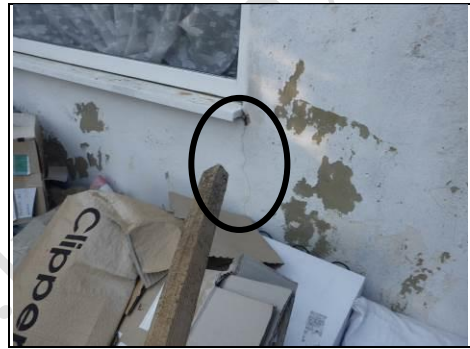
Crack below window to rear

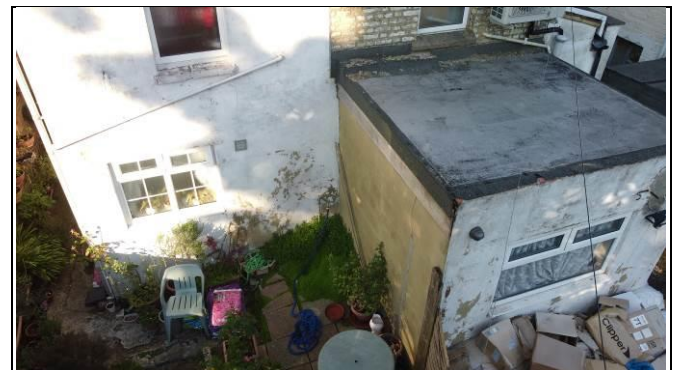
There is a cable on the neighbour's side of the render.

Deteriorating render and area of unpainted render, plus electric cable running up wall on neighbour's side
~ Aerial View - 360 Photo ~

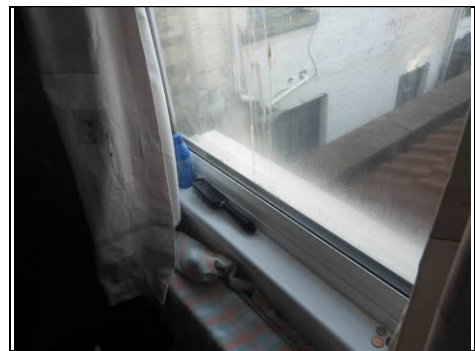
Misting over window in middle bedroom

ACTION REQUIRED: We would recommend replacing all the windows with double glazed windows with trickle vents.

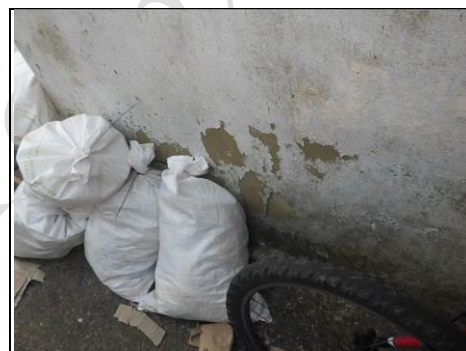
We were unable to check this for dampness in the usual way due to the shelving and stored items etc. However, we think the deterioration seen to the rear render probably relates to dampness travelling towards the rear of the property.

Dampness to rear render

ACTION REQUIRED: We recommend you add a French drain to the rear of the property, with a perforated pipe to the base, running into the nearby drain, subject to getting approval from the local authority/drainage authority.

ANTICIPATED COST: In the region of £2,000 to £4,000; please obtain quotations before you legally commit to purchase the property.

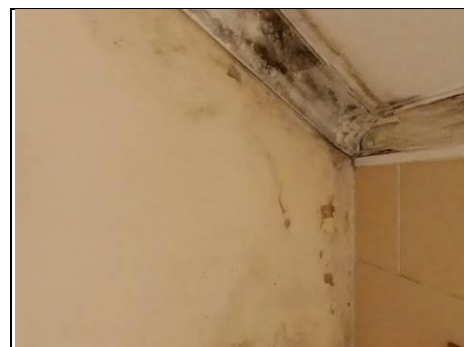
We noted black mould in the bathroom. There is no extract fan in either the bathroom or the kitchen. These areas are likely to have condensation, which in turn cause black mould.

Black mould in bathroom

ACTION REQUIRED: We would recommend large good quality humidity controlled extract fans be added to kitchens and toilets.

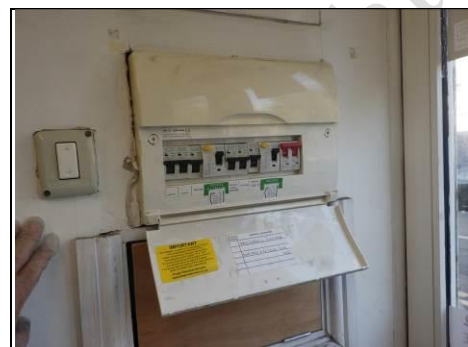
Dated fuse board

We recommend a new fuse board in a metal fire resistant casing.

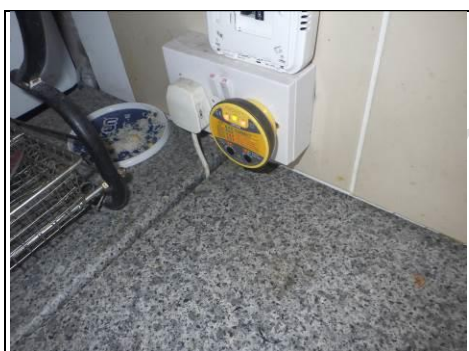
The electrics failed our earth test twice during the course of the survey. There should be three green lights, we had two red lights the first time, which indicate the live neutral has been wrongly installed. The second time we carried out the test is failed with one red light, which means an unknown fault.

First earth test failed, with two red lights showing

ACTION REQUIRED: We recommend immediate work is carried out to make the kitchen safe and also a general upgrade of all the electrics. We reiterate, this work needs to be carried out immediately.

We also recommend an Institution of Engineering and Technology (IET) test and report to be carried out by an NICEIC registered and approved electrical contractor or equivalent.

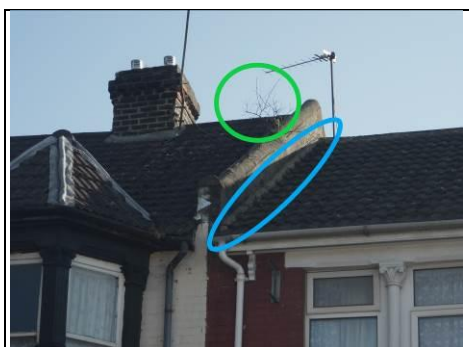
These are in poor condition, with cement flashings. There is a tree growing from the front left parapet.

Tree growing out of front left parapet wall and cement flashing

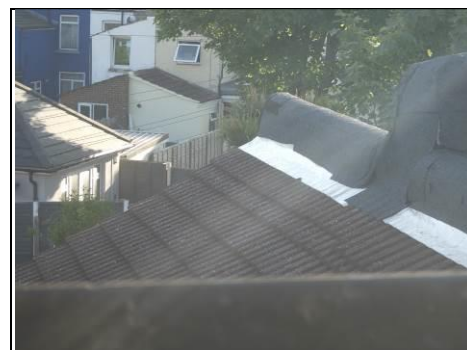
Felt flashing over parapet with
Flashband repairs

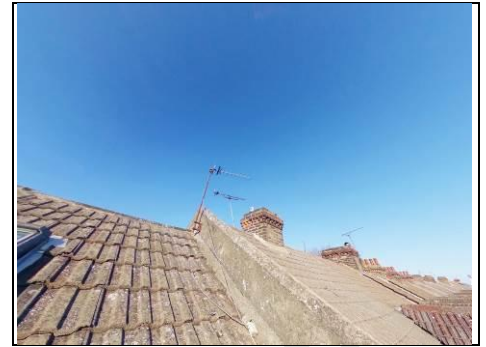
There are also cement flashings which can be problematic.

Close up of left rendered parapet with cement flashing

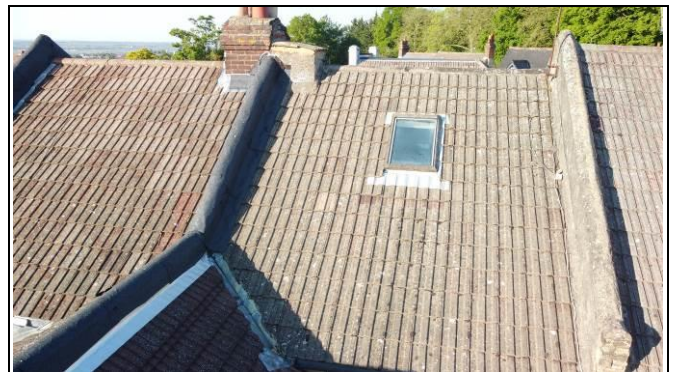
There are signs it has been repaired, as we can see Flashband around it. When we tried to open it internally it would not stay open.

Rear roof window
~ Aerial View - 360 Photo ~

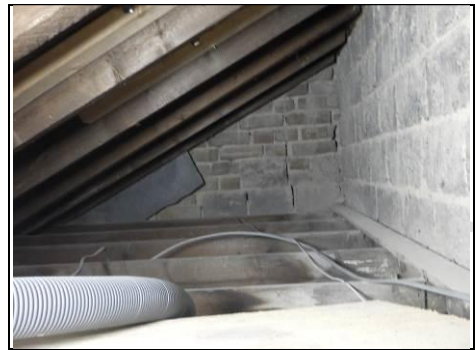
Movement in roof space to rear wall

ACTION REQUIRED: The only way to be one hundred percent certain is to have the roof cleared and checked

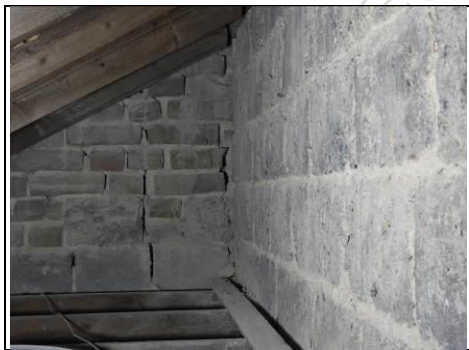
Movement in rear gable end

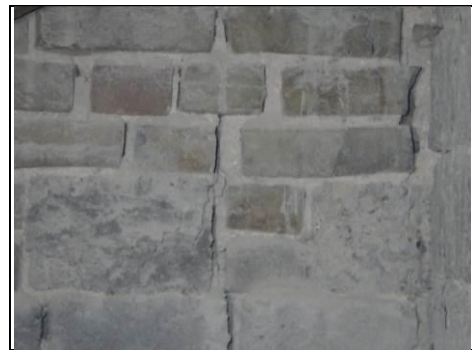
Close of cracks in roof space to rear wall

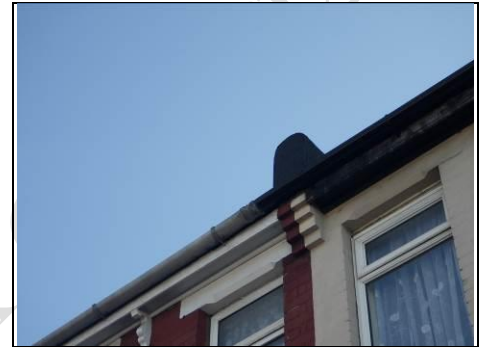
Joist to right gutter looks to be a different size, looks to have had a mastic repair – likely to be leaking

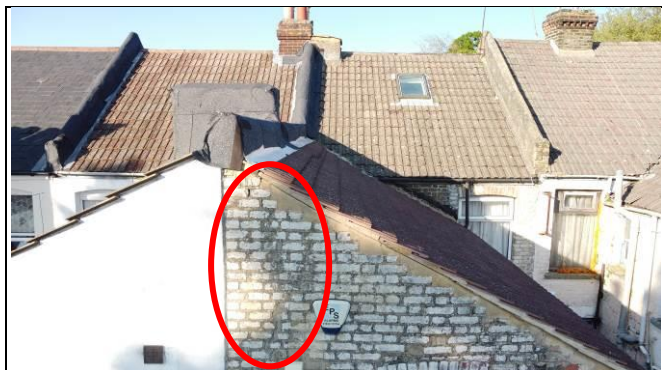
We noted cracking to the brickwork to the rear.

Crack running down rear wall
~ Aerial View - 360 Photo ~

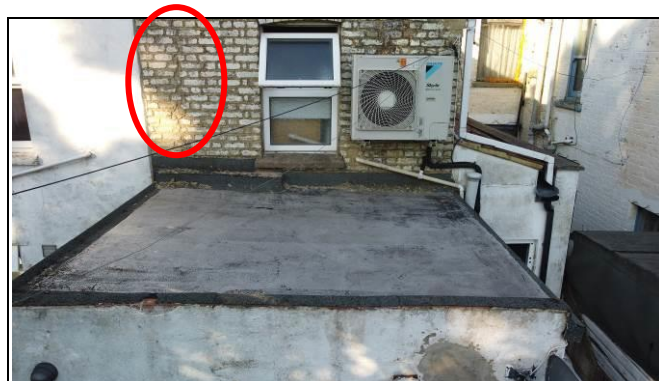
Crack running up left side
~ Aerial View - 360 Photo ~

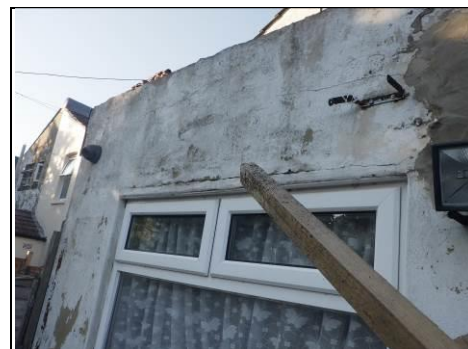
Also we think rainwater discharging off the flat roof may be affecting it. We cannot be certain as we were not there on a rainy day, however it does look this way.

Deteriorating render to rear with
timber lintel over window

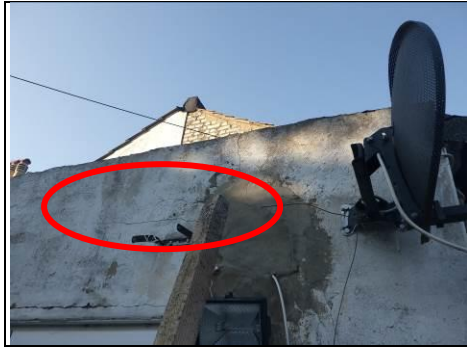
Crack to rear render

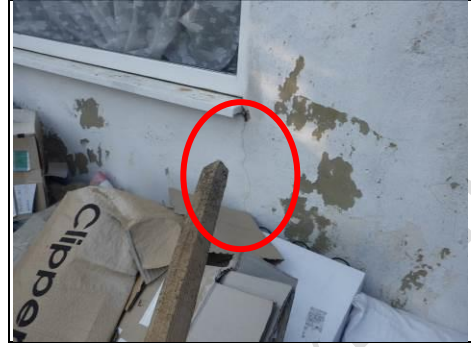
Crack below window to rear

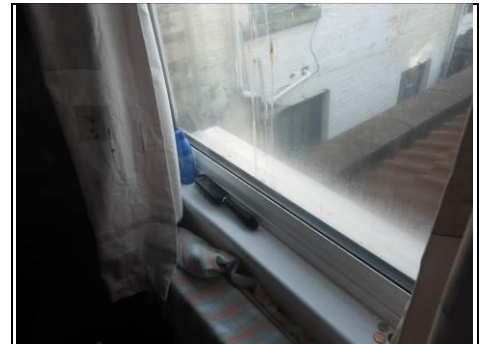
In this case many of them were mastic sealed or taped up and generally look to have problems. In addition to this some of the windows are misting over and unopenable/unclosable.

Misting over window in middle bedroom

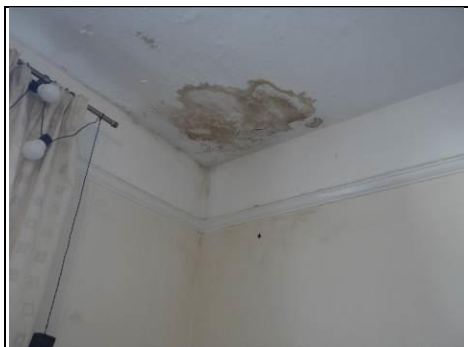
We noted leaks to the front bedroom ceiling.

Damp staining to front bedroom to left side

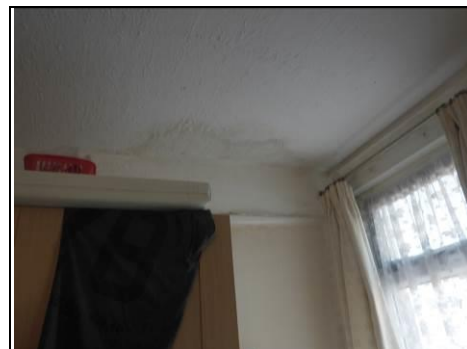
Damp staining in front bedroom to right side

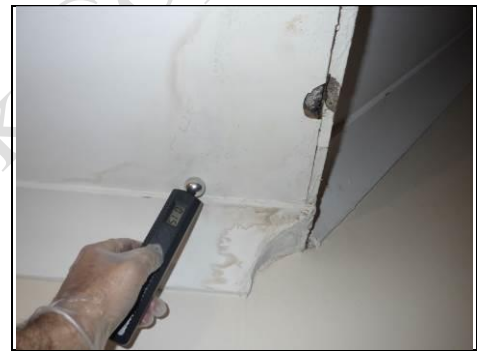
Testing for lateral damp by staining by stairs to room in roof

ACTION REQUIRED: Please see our comments in the Executive Summary and elsewhere within this report.

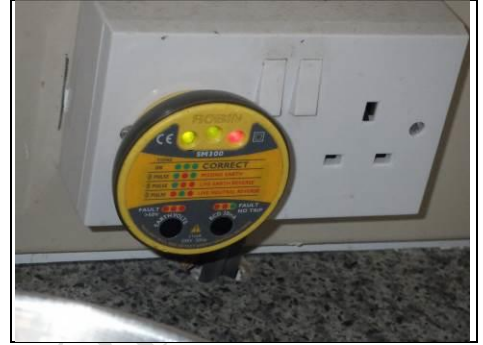
Second earth test failed

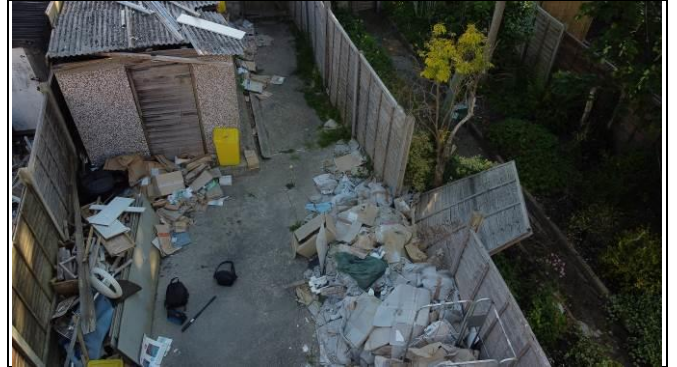
A timber fence panel is down to the right side.

Rear garden, full of rubbish and stored items and broken fence panel to right side
~ Aerial View - 360 Photo ~

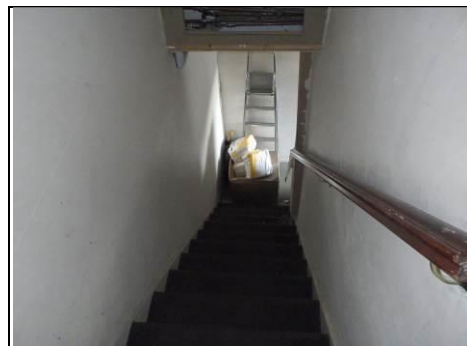
Stored items at bottom of stairs a trip hazard
