Victorian Example Residential Building Survey

GENERAL INTRODUCTION

Firstly, may we thank you for your instructions of XXX we have now undertaken an independent Building Survey (formerly known as a Structural Survey) of the aforementioned property. This Survey was carried out on XXX.

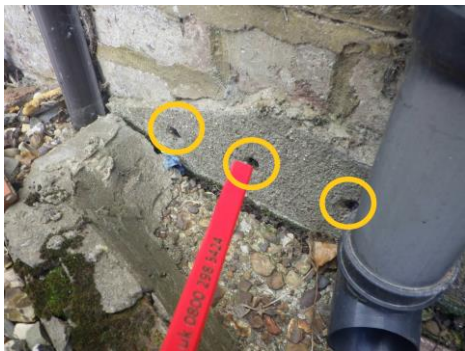
We could also see that there are old drill holes where a chemical damp proof course which has typically been inserted in years gone by indicating that there is a known about dampness problem in this property. We also obtained high damp meter readings internally when we checked the walls with a damp meter.

Chemical DPC

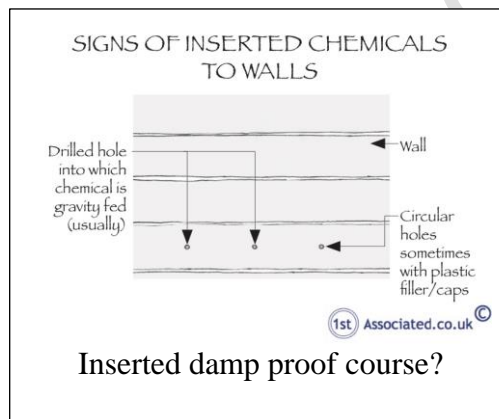
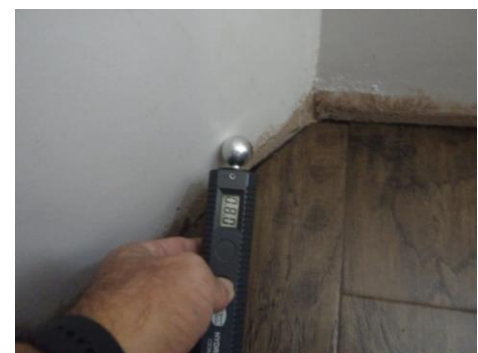
High damp meter reading

We would not recommend damp proof courses are inserted in older properties like this but once they have been inserted it is difficult/impossible to un-do them. These older walls are meant to breathe acting like an overcoat or gortex by letting some dampness in and then allowing it out again/dissipating. A damp proof course tends to waterproof the walls which is what is used in a modern property which are different to older properties like this.

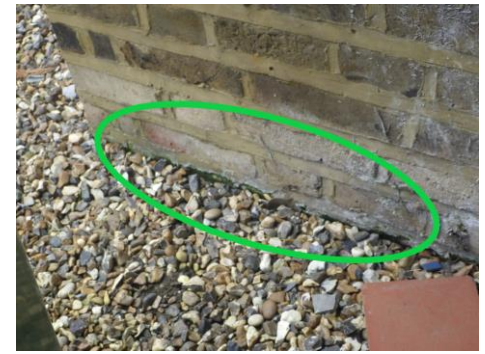
Dampness due to sloping site

Moss

ACTION REQUIRED: We recommend a French drain and/or land drain is added to the front and side of the property to divert the water all the way around the property and is discharged into a soakaway which the owner advised is located to the rear of the property.

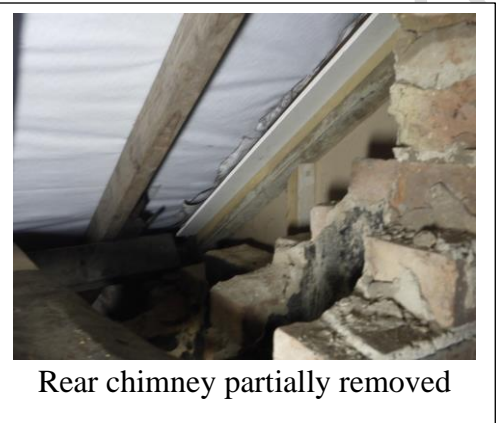
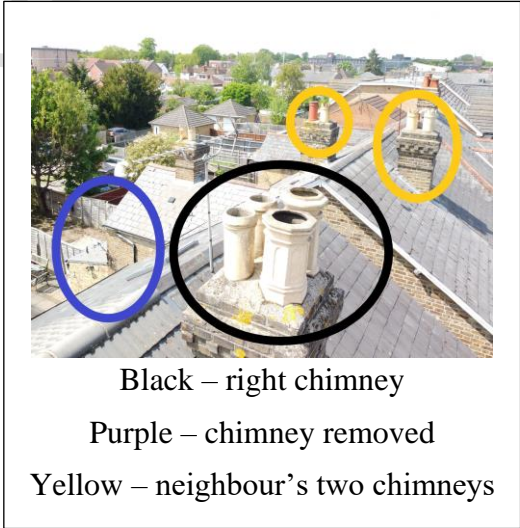
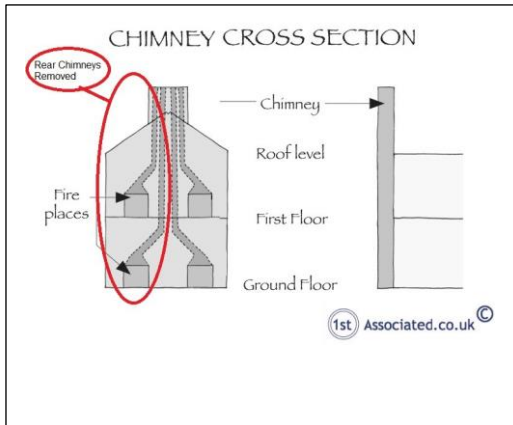
There is a chimney to the right. To the rear we noted that the chimney has been partially removed at roof level and within the roof space.

ACTION REQUIRED: Periodic inspection of the area as sometimes the roof tiles that are used to cover up the opening where the chimney was can leak.

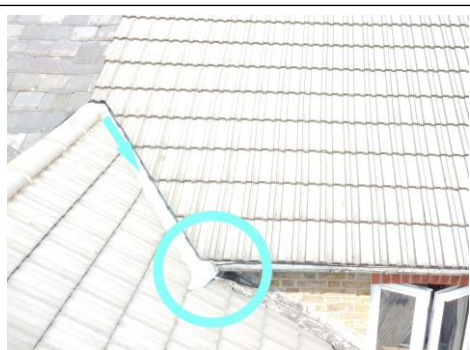
This property has awkward valley gutters which are generally a problematic area. We could see that there looks to have been a long term leak to the rear right valley gutter and wet rot is visible internally from within the roof space. We are not sure whether there has been a repair or not on the valley gutter. We can see the lead flashing beneath it has been tarred indicating that dampness has got through.

Rear valley gutter

ACTION REQUIRED: Ask the owner if they have carried out repairs to the valley gutter and if so when and also can they provide any information with regard to receipts, etc of the work carried out. We think it is likely there will be a repair needed. It is a fairly difficult to access area and it may need repairs to the flashing as well.

ANTICIPATED COST: Assuming access can be gained relatively easily without the need for expensive scaffolding we would expect costs in the region of £1,000 – £2,000. This will involve making good the valley area and lead flashing and any brickwork, checking the guttering is not leaking in this area and then ultimately once you know it is watertight repairing the timber. Please obtain quotations before you legally commit to purchase the property.

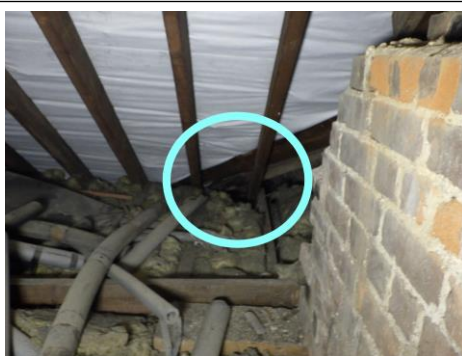
Wet rot visible within roof space

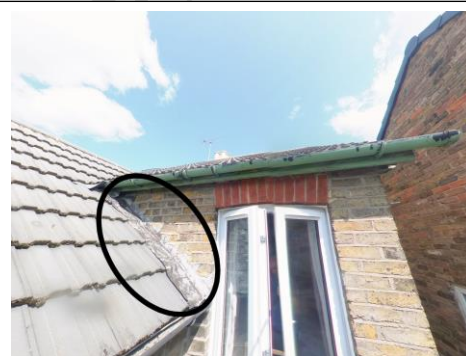
Tarred lead flashing to rear

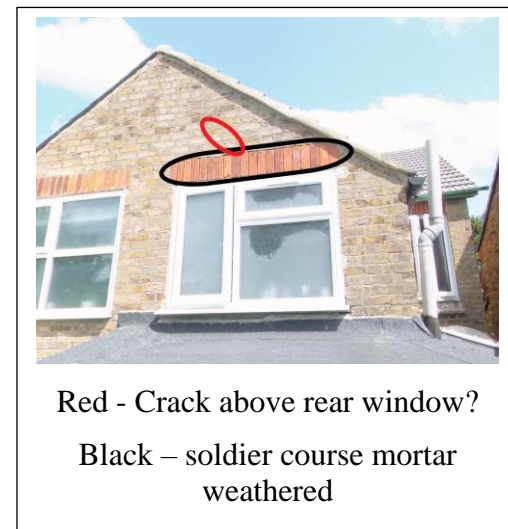
We noted what looked to be some movement over the rear bathroom window. This could relate to the windows that we understand were installed relatively recently in XXX. It may be that the timber lintel behind the soldier course of bricks (the red bricks) has failed and deteriorated, it certainly looks in poor condition with the soldier brickwork needing repointing to stop dampness getting in and also to strengthen the area.

Close up of crack above rear window?

ACTION REQUIRED: If you wish to be one hundred percent certain that there isn't any risk we would recommend the existing owners take out an insurance claim, advising that the cracking has been noted by a structural surveyor (this should cost them nothing other than time to write the letter/email). This usually means that the insurance company will carry out a monitoring exercise (the Building Research Establishment recommend monitoring any cracks for a minimum of one year) to establish if there is any progressive movement. Your future liability should be limited to the cost of the excess on the insurance providing the insurance company is happy for you to take over the insurance claim.

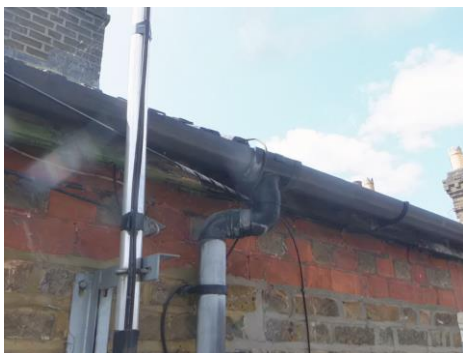
The property has plastic hopperheads, gutters and downpipes. They are in below average condition for their age, type and style and we could see a leaking and sun damaged downpipe and the gutters need clearing. We could also see that some of the black gutters have been painted green which never seems to work for that long.

Leaking and sun damaged downpipe

We also recommend that the gutters and downpipes are cleaned out, the joints are checked and the alignment checked to ensure that the gutters fall towards the downpipes.

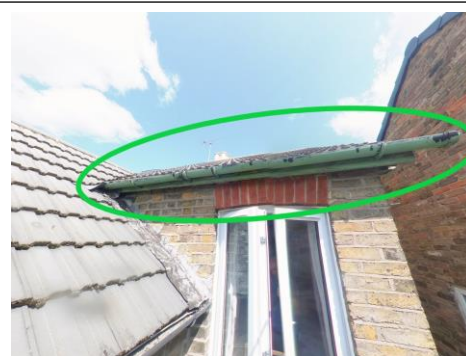
Rear gutters painted green

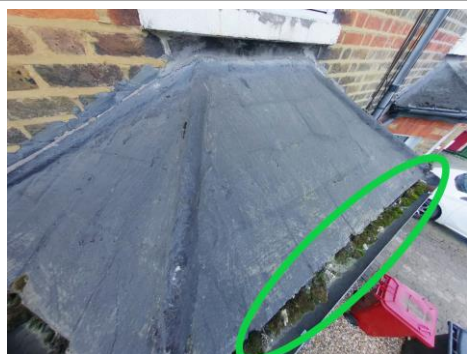
Moss/vegetation in front gutter and repaired bay roof

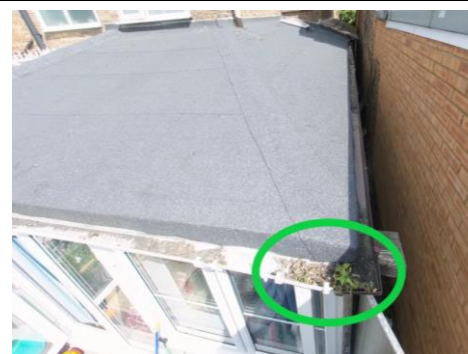
Gutter blocked to rear left with vegetation growing within it

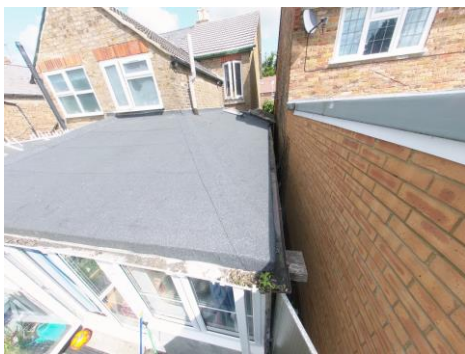
There is a gap to the left side of the property (all directions given as you face the front of the property). This is an awkward gap and we think it is where dampness could be being held. It is so small in some areas that it is not possible to get down. We noted there is a lot of rubbish and stored items to the rear left.

No view of left side

ACTION REQUIRED: We would recommend you finish the work in these areas. As mentioned elsewhere within this report clear the gap and lower the ground level and add a drain and ideally add a guttering to the roof if it hasn't got a guttering.

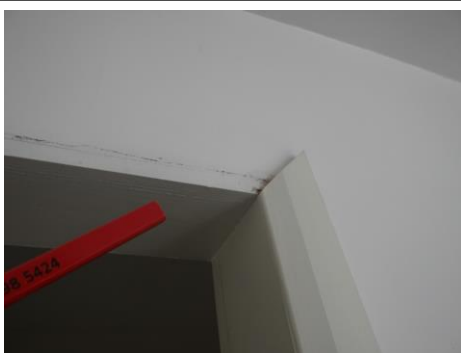
Architrave missing

ACTION REQUIRED: Fix architrave and skirtings and check the exposed elephant trunk is working and conceal it and then repair, prepare and redecorate.

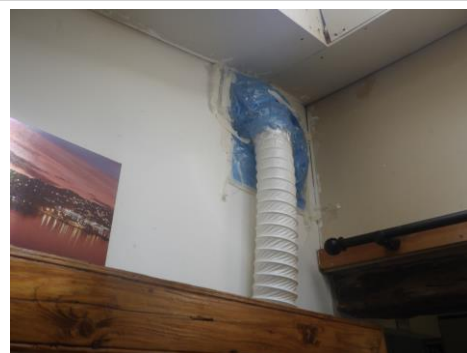
Exposed elephant trunk

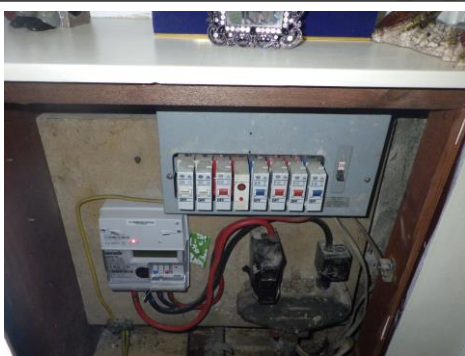
The electric fuse board is dated and better are now available. We can see some other indicators that this is an older style electric system such as the single socket points; we would recommend these are upgraded to double socket points (there are now some socket points with USB ports). We also noted a light in the bathroom has dropped out of position.

Dated fuse board

ACTION REQUIRED: We recommend a new fuse board with a metal casing; modern standards require half hour to one hour fire resistant casing around a fuse board.

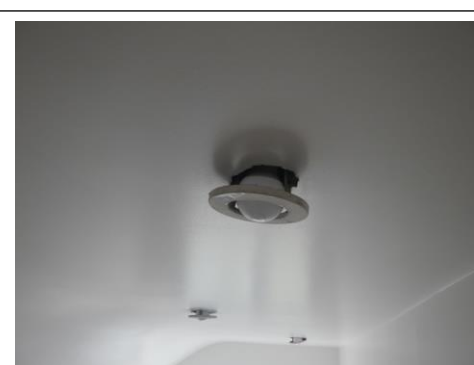
Light out in rear bathroom

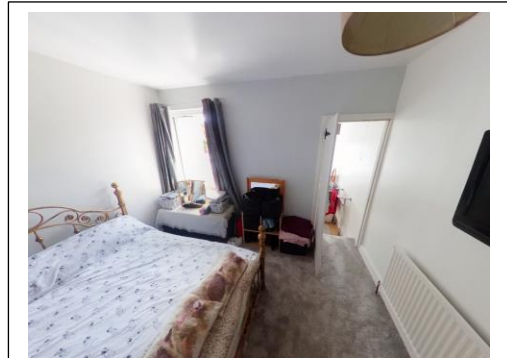
This is often carried out on cheaper central heating systems to save the labour and piping costs of positioning the radiators underneath the windows. However, it then reduces the air movement in the room which can lead to black mould.

Internal radiator in rear bedroom

ACTION REQUIRED: We suggest you live in the property and then if there are problems we recommend you move the radiators underneath the windows as this gives a better circulation of air and reduces the chance of condensation.

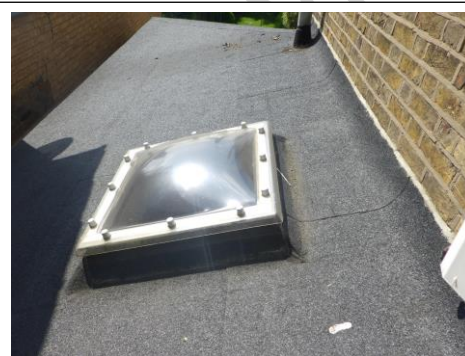
Roof Window to rear

The property has one fixed domed roof window, which looked in average condition. The important factor with roof windows is the flashing around them, in this instance we would comment the flashing is felt; we would prefer lead.

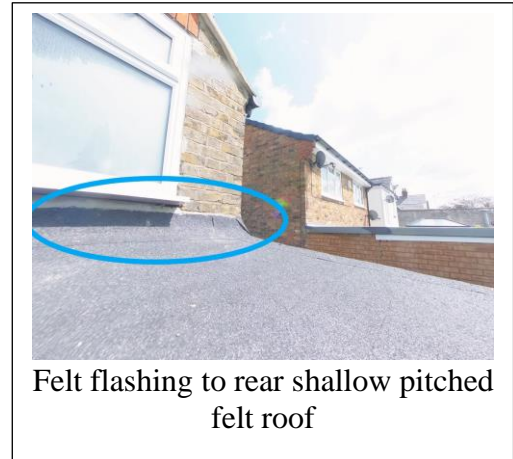
Felt flashing to rear shallow pitched felt roof

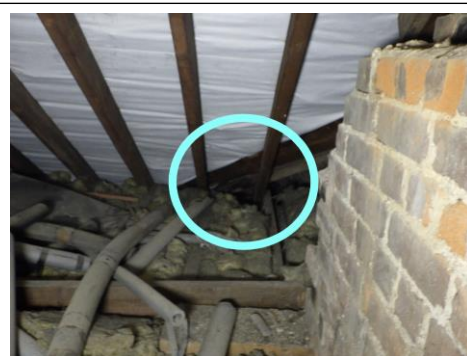
Wet rot to valley gutter

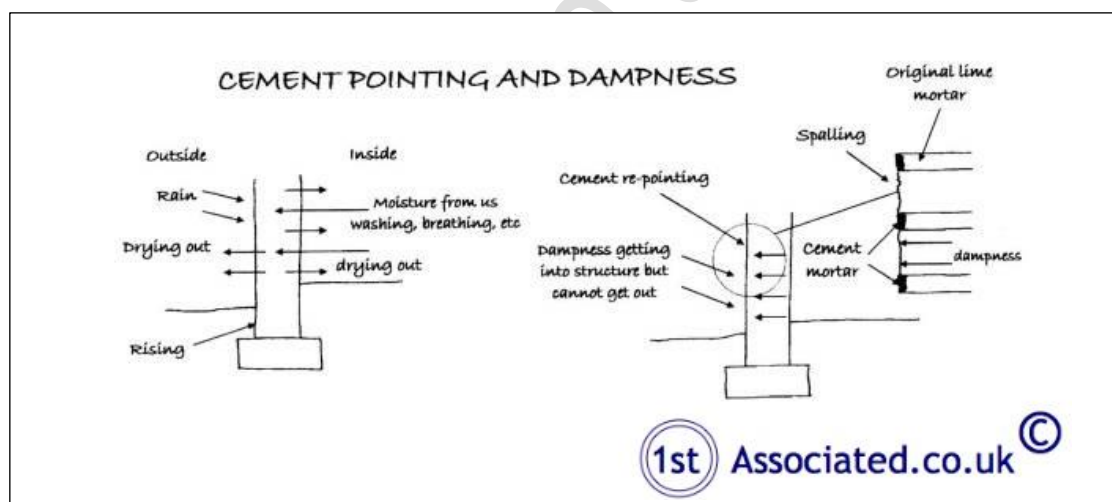
We would draw your attention to the cement mortar re-pointing that has been carried out on the exterior of the property that we feel is not appropriate to this building. Originally it will have been built with a lime-based mortar and this is what should be used for any re-pointing in the future.

The original lime mortar is a softer material which allows dampness to dissipate, whereas cement mortar is a harder material that does not allow the walls to 'breathe' and in turn causes dampness to come into the walls. The use of cement mortar causes deterioration to brickwork and does lead to the face of the bricks deteriorating, which in turn leads to dampness. This is a very important point.

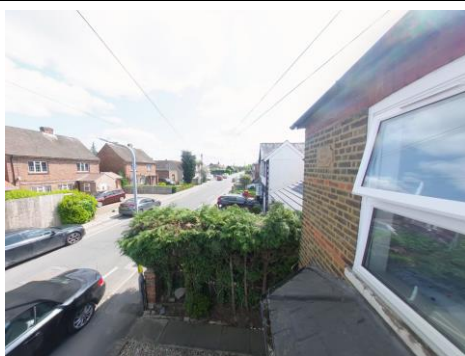
Conifers front left

There are trees and bushes and the conifers to the front left looks to have been cut back fairly recently. You need to check and confirm whose land this is on; it looks to be on your land.

ACTION REQUIRED: We would recommend that all of the trees and bushes are regularly maintained.

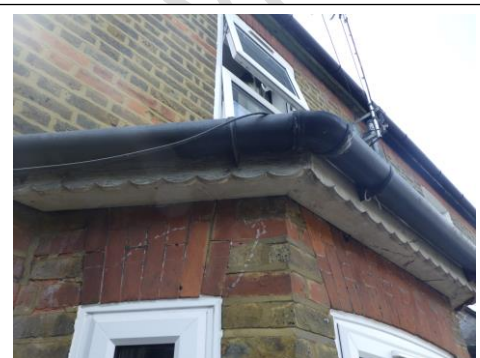
For example, to the front bay where we can see the paint is flaking and some bare timber is visible.

Fascias and soffits need redecoration

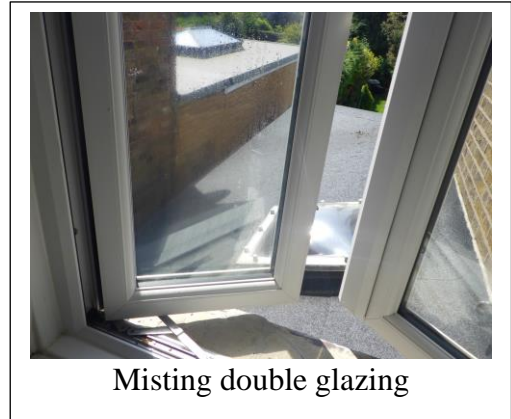
We would draw your attention to the fact that sealed double glazed units can fail, particularly as a result of poor workmanship during installation. Failure of the seal leads to condensation between the two panes of glass and simply replacing the affected units may not provide a satisfactory long-term solution. In this case, we noted a misted window which is very poor if this is a new window.

Misting double glazing

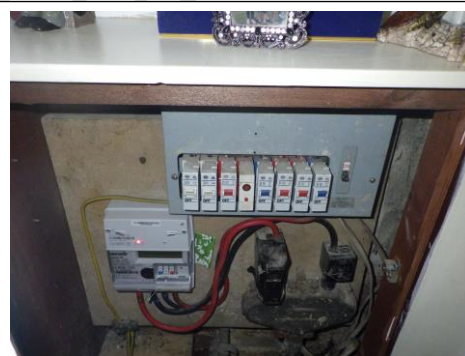
Dated fuse board

ACTION REQUIRED: Replace.

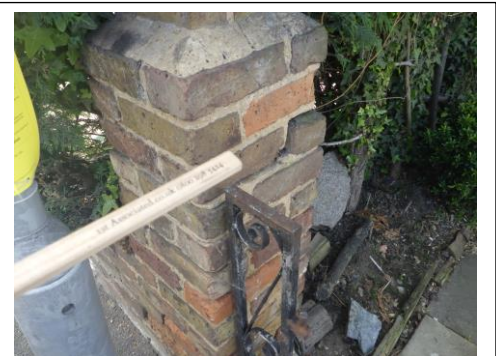
Front left garden wall damaged
