COMMERCIAL BUILDING SURVEY

Three Storey Converted Cheese Factory

Mr Businessman

GEM Associates Limited

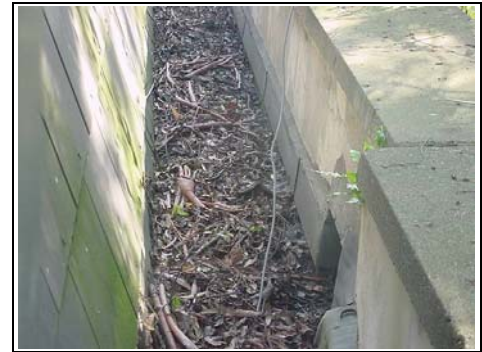
There is a mansard roof with box gutters to either side. Box gutters are renowned for problems, particularly where they back up and block with leaves. We can see this as being a problem to the rear of the property in this case and even with regular maintenance we still feel there is bound to be some blockages and issues.

Put a leaf guard over the box gutter and also regularly maintain it, probably monthly in the case of the rear box gutter.

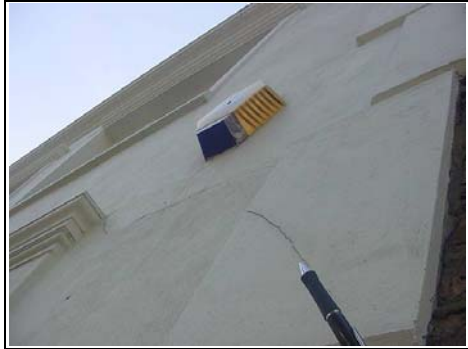
We can see from adjacent properties that there has been cracking and movement in the area. We feel this is likely to occur to this property and may have occurred in the past. The render is newly painted and unfortunately hides any such defects. We would expect there to be latent defects to this property.

Cracking to property

ACTION REQUIRED: You need to ensure that your insurance company is happy to insure for such risk and specifically identify the trees and the distance they are from your property.

Your solicitor/legal adviser needs to specifically ask about whether there have been any problems to the property. We would recommend the existing owners make an insurance claim, as most insurance companies would wish to monitor the property for one year prior to advising on the problem. This of course is the difficulty with our one off inspection, as it is limited in the amount of information we can obtain compared with a year long supervision inspection.

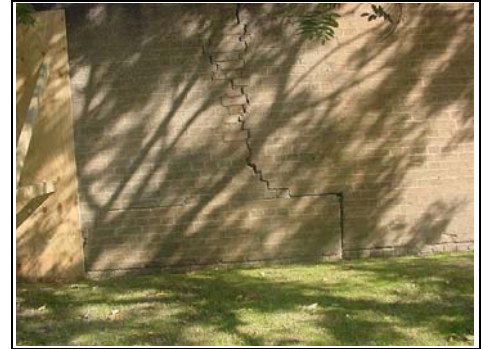
Cracking to adjacent property

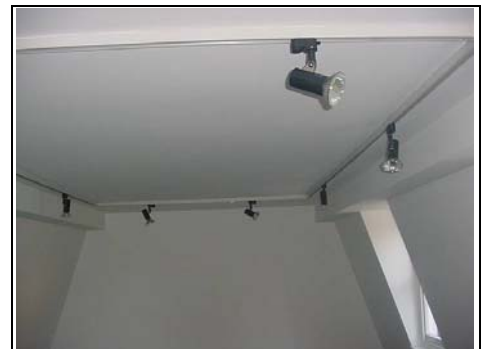
Lights not to office standard level

ANTICIPATED COST: This depends upon the work and we would recommend quotes, but we would costs to be in the thousands of pounds as it is always difficult to re-wire.

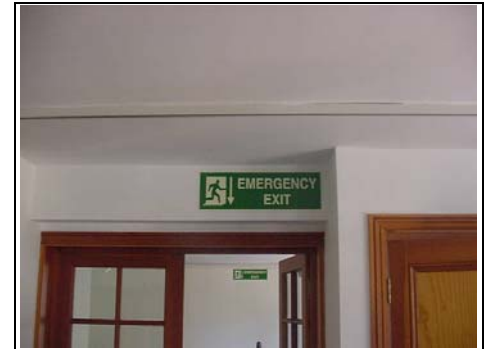
We believe this should be an illuminated emergency exit sign

ACTION REQUIRED: We do not believe that the property should be sold without a suitable Fire Certificate.

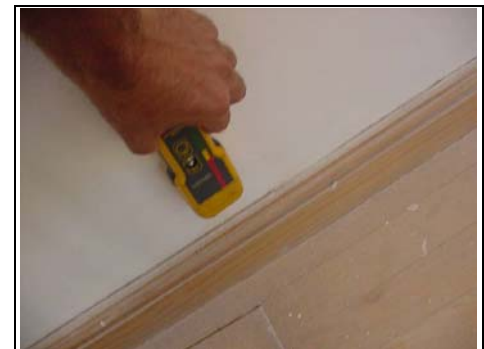
To the rear of the property there is rising damp. We have not seen this area, but we suspect the adding of a French gully will suffice. The property does sit on a slight slope and therefore allowance will have to be made for this. We would reiterate that we have not been able to see the rear of the property.

ACTION REQUIRED: We would recommend adding a French gully.

ANTICIPATED COST: In the region of £5,000 to £10,000. The most expensive part of this is joining into an existing drainage system.

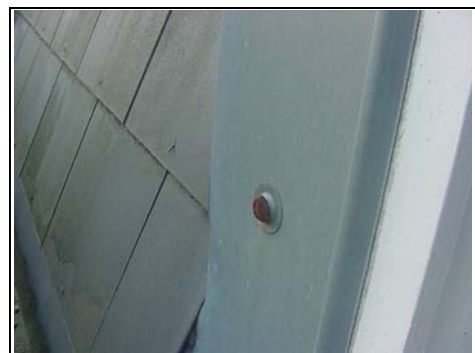
Rusting fixing bolt

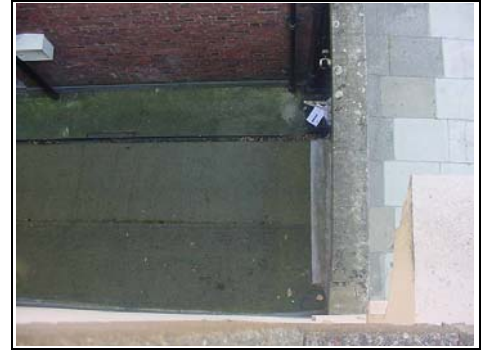
We did note that there was a roof to the right hand side that we believe belongs to the neighbouring property. This is a flat roof and there can sometimes be problems at the junction with a flat roof and your building. We have been unable to access this roof to comment further. However, it does look like the flashing has been repaired with Flashband, which is a temporary repair product.

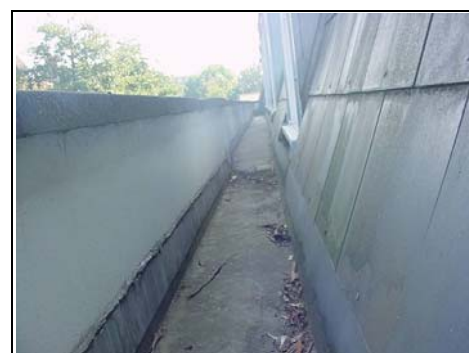
The property has box gutters. These can be a problem area, particularly to the rear of the property we would expect problems, as there are a lot of leaves and debris landing into the box gutter. This can very quickly build up and go over and above the flashings. We noted the flashing were relatively small, as can be seen in the adjoining photo.

Note relatively low flashing

ACTION REQUIRED: The only way forward is to regularly maintain these gutters. We would recommend a leaf guard; we would also recommend increasing the height of the flashing as we feel this will be a problem.

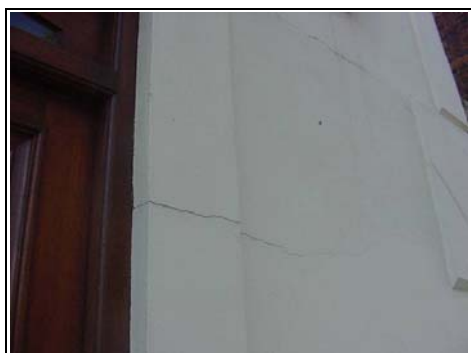
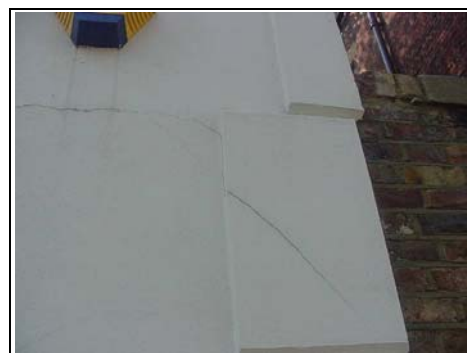
We did note cracking. Please see our comments in the Executive Summary.

Cracking to render to the front of property

ACTION REQUIRED: All cracks need to be sealed as soon as possible to stop dampness getting into the property and/or making the cracks worse.

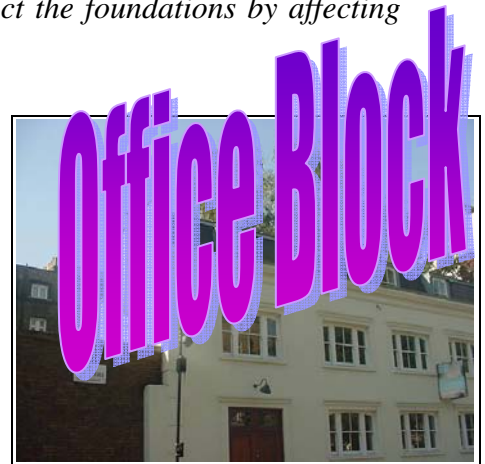
There are a number of trees very close to this property to the rear. They are difficult to see from the front of the property. However, as you can see in the adjoining photo, they are larger than the property itself, as well as bring in close proximity. This is why we believe there will be problems, as tree roots can cause damage to foundations and underground services. We would technically term these trees as being within what is called influencing distance. We believe that these trees may be affecting the property.

ACTION REQUIRED: You need to obtain advice from an arboriculturist (not a tree surgeon). Please see our comments within the Executive Summary.

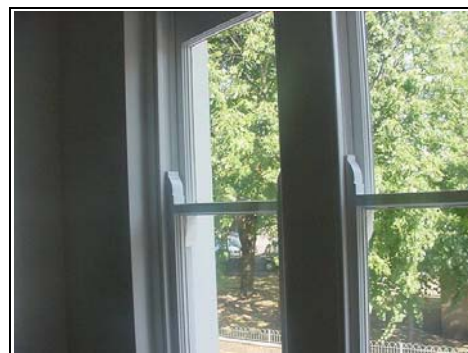
This property predominantly has sliding sash windows, which are single glazed and have a painted timber finish and are in reasonable condition considering their age, type and style.

ACTION REQUIRED: We would add that we were unable to open several of the windows. As is common they will need some easing and adjusting from a carpenter who is use to dealing with this type of work. We believe this work should be carried out by the existing developer.

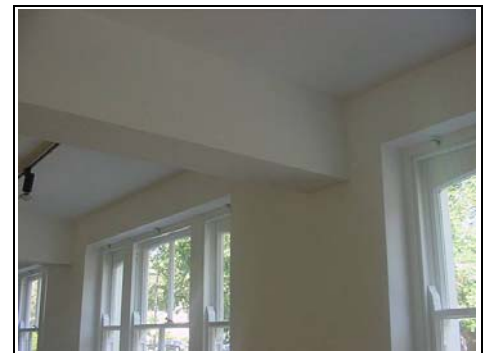
There are a number of large beams running from the front to the rear of the property. This indicates to us a considerable change in the configuration of the property from its original building design and does also explain why there is deflection, albeit minor, to the first and second floor levels. We can gauge from this deflection that the property has not been built to, what would be term, institutional investment standards. Therefore, if you are purchasing the property freehold and do at some time intend to lease it; it will limit the market to whom you can lease to.

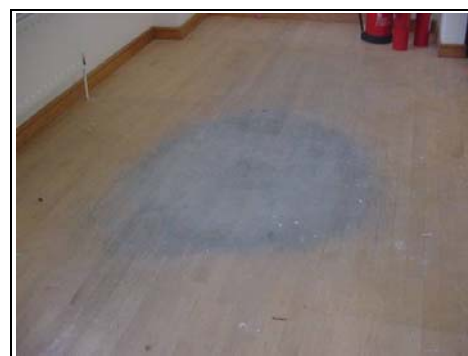
Wear to the floor

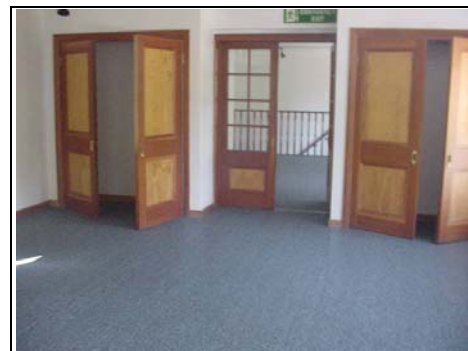
Staircase

The refurbishment had not been completed at the time of our inspection. All doors around staircase areas need to be fire doors (this means a half hour to hour fire resistance, depending upon location), door closers and any glazed areas should have Georgian wire polished plated glass, to name but a few requirements.

The property has two staircases. We noted that the underside of the right hand staircase was exposed. It is more normal today to have a half hour fire barrier to stop fire spreading from the ground floor to the first floor if this situation should occur. You may wish to take a view on whether you add this.
