COMMERCIAL BUILDING SURVEY
OF
Three Storey Office Block in the City of Westminster, London

Mr Businessman

GEM Associates Limited

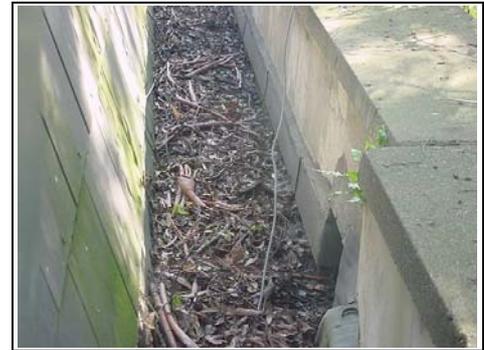
There is a mansard roof with box gutters to either side. Box gutters are renowned for problems, particularly where they back up and block with leaves. We can see this as being a problem to the rear of the property in this case and even with regular maintenance we still feel there is bound to be some blockages and issues.

Put a leaf guard over the box gutter and also regularly maintain it, probably monthly in the case of the rear box gutter.

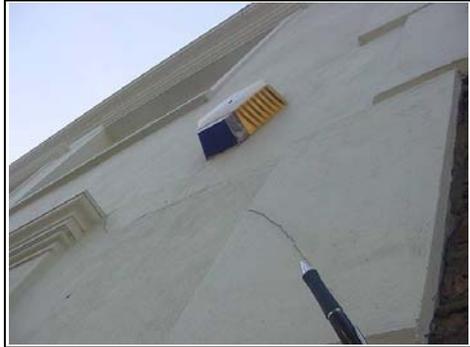
We can see from adjacent properties that there has been cracking and movement in the area. We feel this is likely to occur to this property and may have occurred in the past. The render is newly painted and unfortunately hides any such defects. We would expect there to be latent defects to this property.

Cracking to property

ACTION REQUIRED: You need to ensure that your insurance company is happy to insure for such risk and specifically identify the trees and the distance they are from your property.

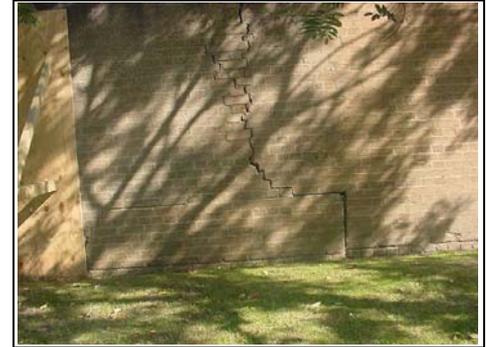
Cracking to adjacent property

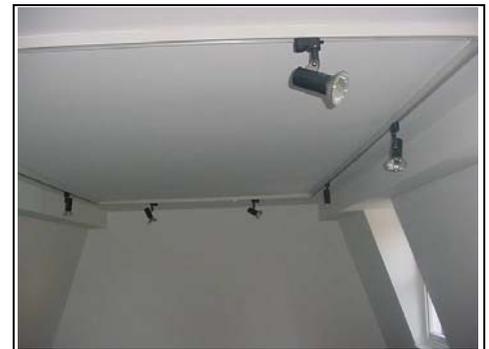
Lights not to office standard level

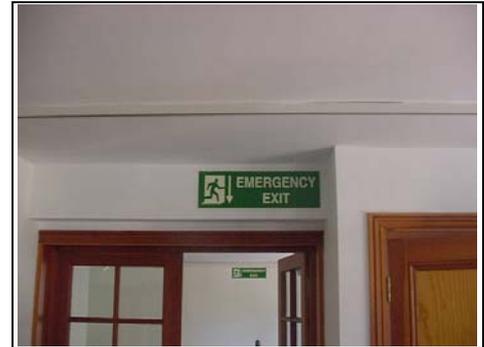
We believe this should be an illuminated emergency exit sign

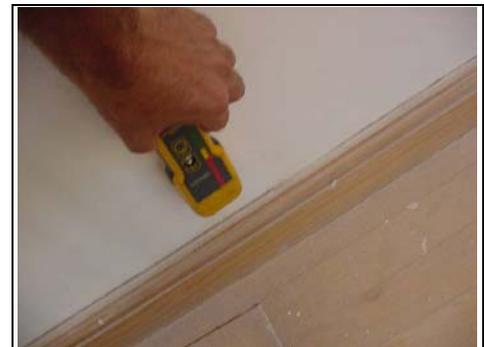
To the rear of the property there is rising damp. We have not seen this area, but we suspect the adding of a French gully will suffice. The property does sit on a slight slope and therefore allowance will have to be made for this. We would reiterate that we have not been able to see the rear of the property.

ACTION REQUIRED: We would recommend adding a French gully.

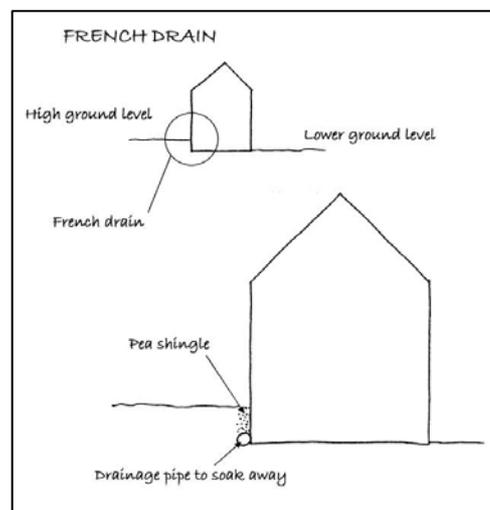
Suspended Timber Floor

It is a particular concern, as there is a suspended timber floor which could have started to rot due to the dampness.

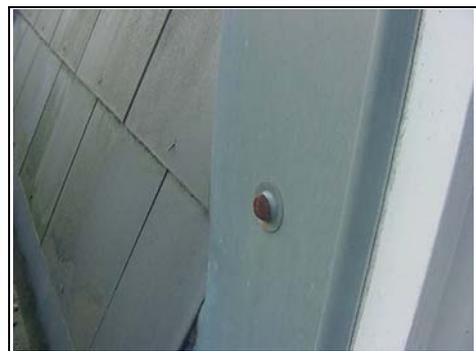
Rusting fixing bolt

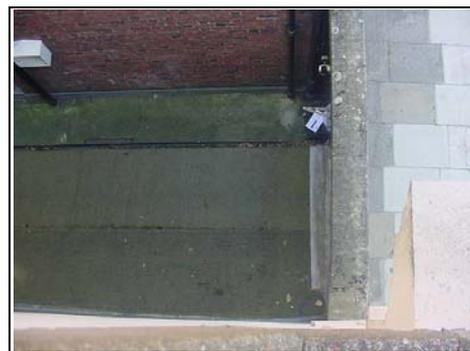
We did note that there was a roof to the right hand side that we believe belongs to the neighbouring property. This is a flat roof and there can sometimes be problems at the junction with a flat roof and your building. We have been unable to access this roof to comment further. However, it does look like the flashing has been repaired with Flashband, which is a temporary repair product.

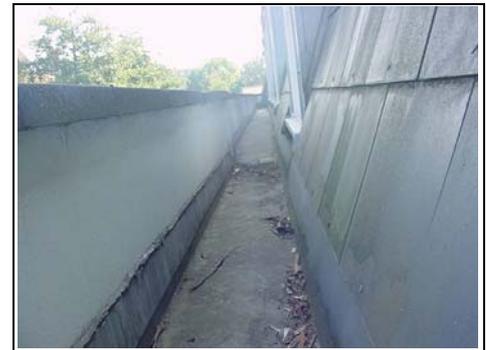
The property has box gutters. These can be a problem area, particularly to the rear of the property we would expect problems, as there are a lot of leaves and debris landing into the box gutter. This can very quickly build up and go over and above the flashings. We noted the flashing were relatively small, as can be seen in the adjoining photo.

Note relatively low flashing

ACTION REQUIRED: The only way forward is to regularly maintain these gutters. We would recommend a leaf guard; we would also recommend increasing the height of the flashing as we feel this will be a problem.

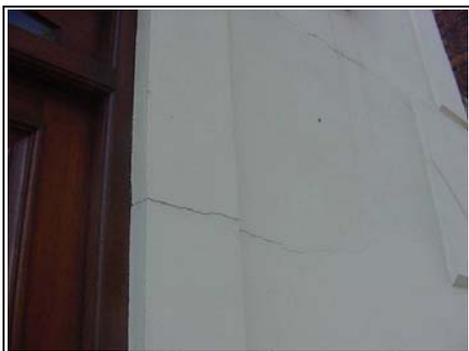
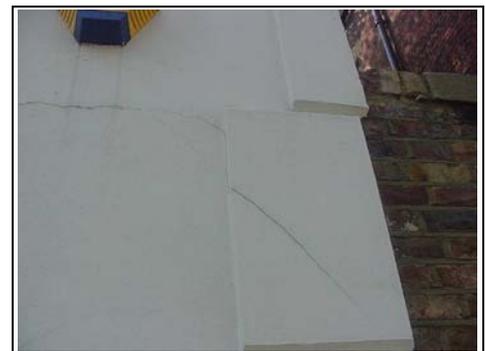
We did note cracking. Please see our comments in the Executive Summary.

Cracking to render to the front of property

ACTION REQUIRED: All cracks need to be sealed as soon as possible to stop dampness getting into the property and/or making the cracks worse.

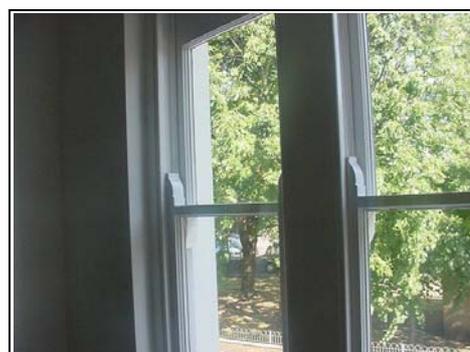
This property predominantly has sliding sash windows, which are single glazed and have a painted timber finish and are in reasonable condition considering their age, type and style.

ACTION REQUIRED: We would add that we were unable to open several of the windows. As is common they will need some easing and adjusting from a carpenter who is use to dealing with this type of work. We believe this work should be carried out by the existing developer.

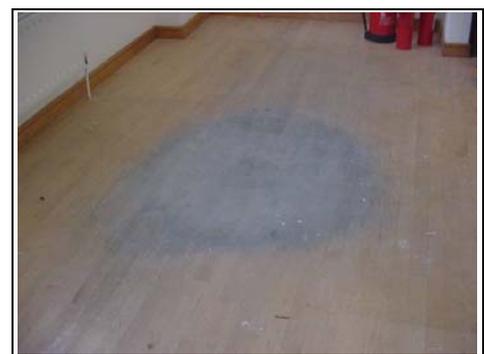
Wear to the floor

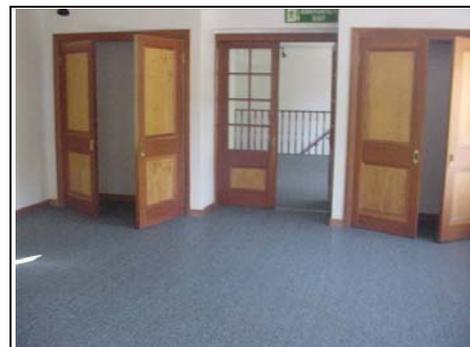
Staircase

The property has two staircases. We noted that the underside of the right hand staircase was exposed. It is more normal today to have a half hour fire barrier to stop fire spreading from the ground floor to the first floor if this situation should occur. You may wish to take a view on whether you add this.
