**COMMERCIAL BUILDING SURVEY
OF
A Retail Unit in Kent: Two Shops, Offices and Storage**

**FOR
Mr Retail**

GEM Associates Limited

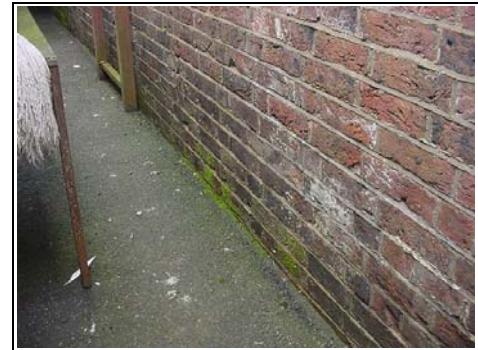
In addition to this, we have identified rising damp to the left hand rear of the property. This is due to the ground level variation of the adjoining properties.

High ground level to left hand side wall, which is damp with moss growing on it

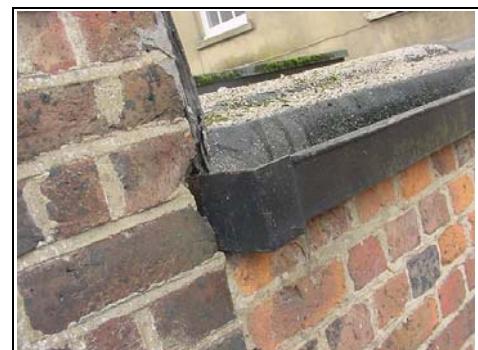
Gutter sitting on the wall

The amount of water discharging down the wall surface of the florist we feel has affected the lintel to the left hand side wall and repairs will be needed to be carried out to this.

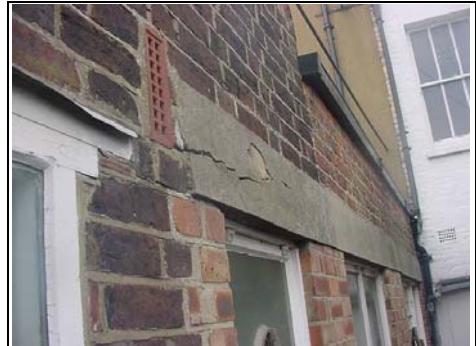
Lintel to the left hand side wall

ACTION REQUIRED: You need to get advice with regard to the Lease to establish whether you do have appropriate repair, redecoration or yield up clauses, which allows you to request the repair and removal of fixtures and fittings. There is also, typically, a reinstatement clause that would require the property to be put back in the configuration it was originally, assuming of course you have documentation (drawings?) to establish what its original configuration was.

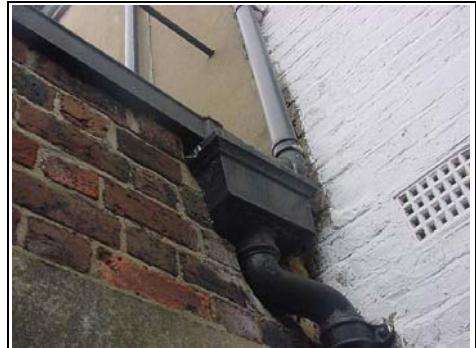
Gutter and hopper head sitting on the wall. These are prone to allowing dampness into the wall structure.

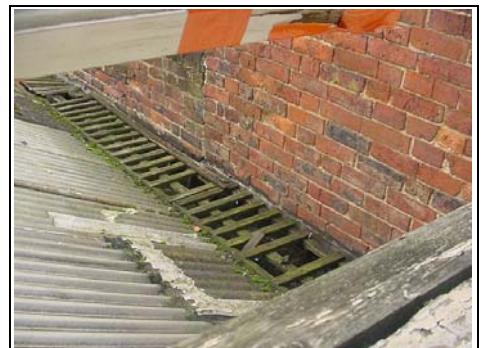
There is an awkward valley gutter detail to the right hand side of the property that we could see when we went in the CAB (Citizens Advice Bureau). We believe that damage and deterioration of this wall has been hidden by the wooden panelling.

This is a photo of the valley gutter.

ACTION REQUIRED: The lease needs to be inspected to establish your position and you need to take a business decision as to how you wish to proceed, as we are aware that you have had dealings with this company in the past, and indeed sold them a property recently.

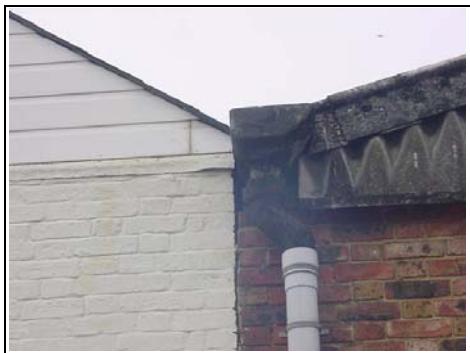
A considerable amount of water is getting into this storage facility and office area, particularly down the right hand back wall (all directions given as you face the property from the front). This is affecting both your property and the adjoining CAB (Citizens Advice Bureau).

The valley gutter and relatively small hopper head

The only long term solution is to redesign the valley gutter. We would recommend a wider valley gutter. The roof problems could in turn, we believe, have affected the roof structure. Please note we have not gained access to the high level areas within the store.

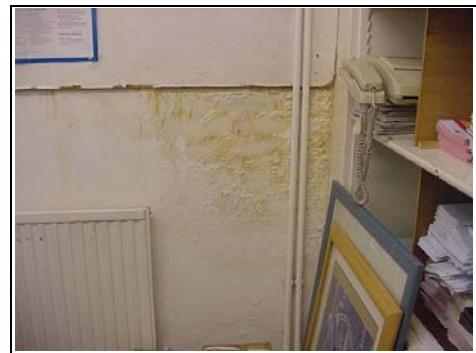
Water damage to the CAB office, which you will have liability for

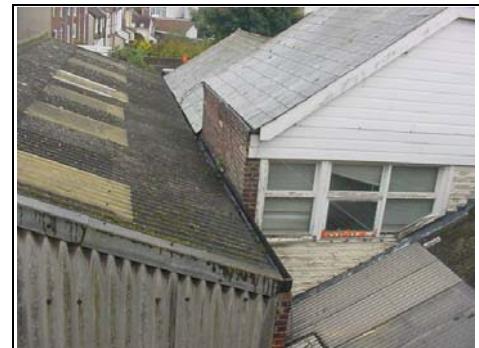
The view of the right hand side valley gutter detail and your asbestos roof

ACTION REQUIRED: We would recommend the only long term solution to the valley gutter problems that you have is to change the design of them. We would recommend a wider valley gutter, which allows access, i.e. to be a width of approximately half a metre to one metre. This, unfortunately, would involve reconfiguring part of the roof. Also, the question is do you replace the asbestos now, or encapsulate it, which of course depends how long a term your long term plans are!

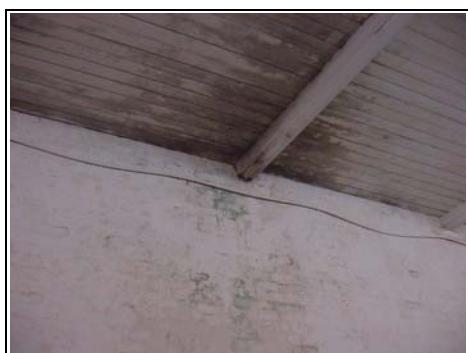
Leaking valley gutter within the store.
Note the moss to the wall indicating
this has been a long term issue

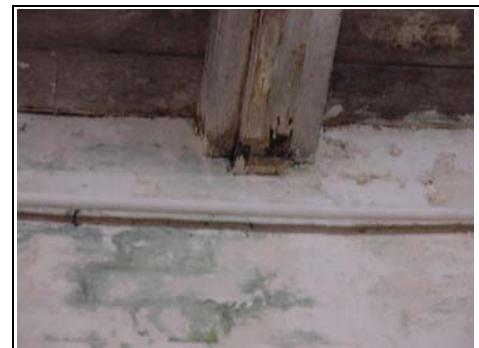
Rot to supporting beams

We would add that the timber beams need checking as there looks to be rot to some of them.

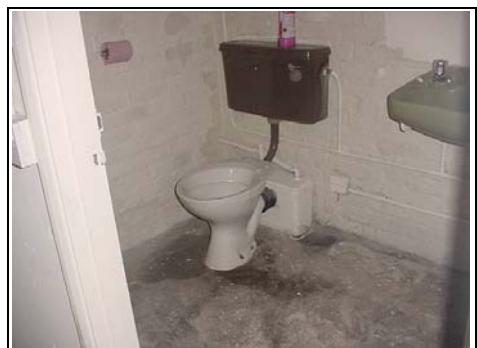
Finally, there is also a general upgrading requirement to the charity area/store if it is to be used.

Upgrading required!

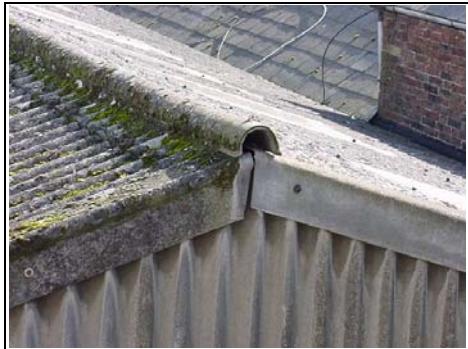
We would specifically draw your attention to the asbestos that has been used for the roofing, which in our opinion, the perception of asbestos problems do affect clients/future tenants.

Cracked asbestos on roof

ACTION REQUIRED: We believe that you should budget for repair/replacement of the asbestos roof, if you are looking at this as a long term investment, i.e. ten years plus.

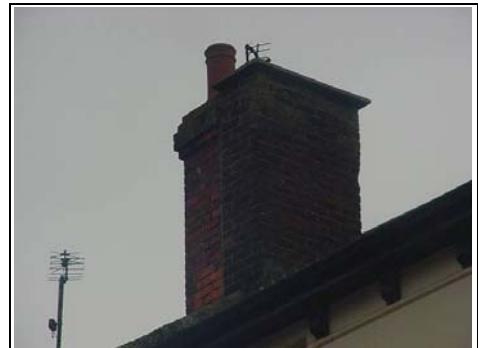
Chimney Two – front right hand side

This chimney has been removed but dampness is getting in, in this area. Sometimes the cover of the old chimney never bed correctly and leak.

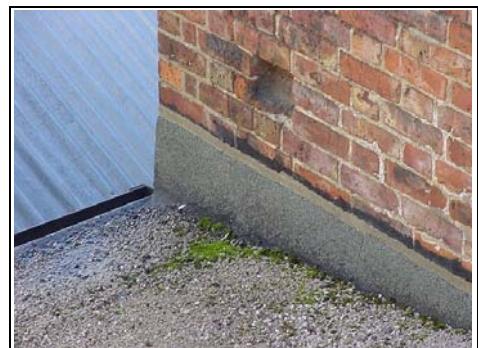
Repaired flashing

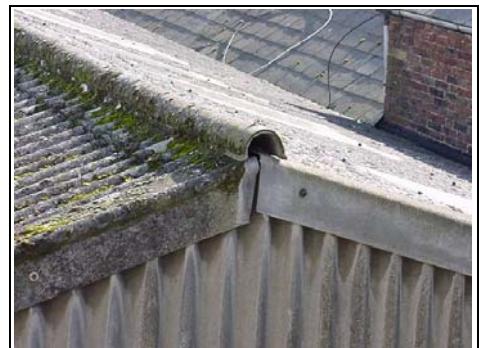
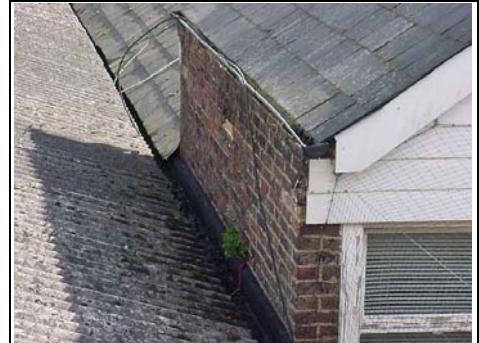
Plants growing out of valley gutter

The valley gutters are very problematic to this roof and are the cause of most of the dampness in the walls to the right hand side. To the left hand side there is also dampness, due to the difference in levels.

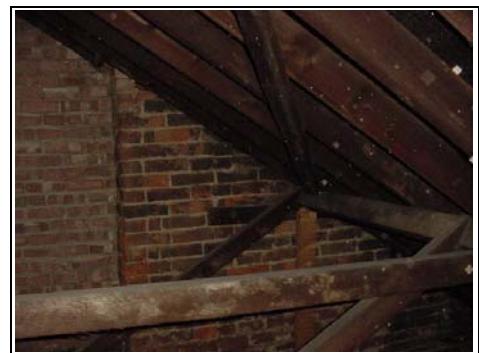
Note the new looking vertical timber to the right hand side of the photo.

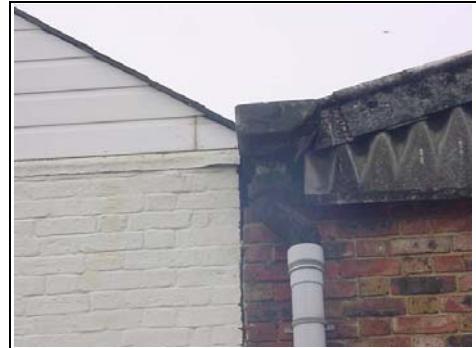
Leaking gutter

We would always recommend that the gutters and downpipes are cleaned out, the joints are checked and the alignment checked to ensure that the gutters fall towards the downpipes.

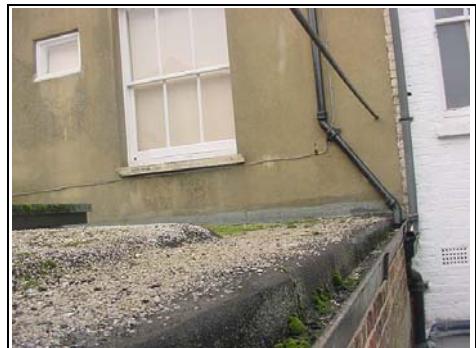
One of the main problems with the type of guttering this property has is that they sit on the wall. Therefore, any leaks, as inevitably there are, soak into the wall.

Gutter sitting on the wall

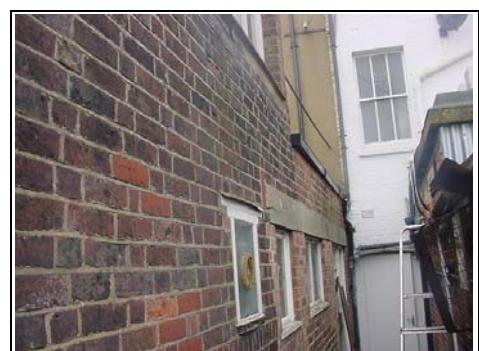
The brickwork to the left hand side of the property, likely to have water discharging down it in the flat roof area, which is why there is deterioration to the lintel

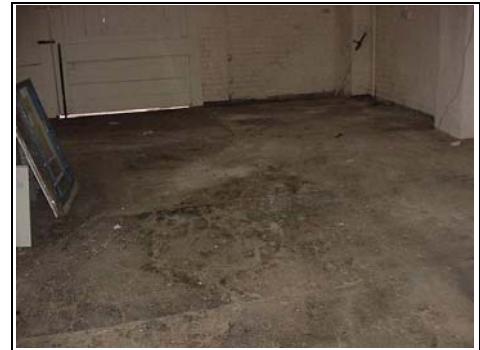
The ground floor to the charity shop store is very uneven and has been mentioned in the Schedule of Dilapidations as needing repair.

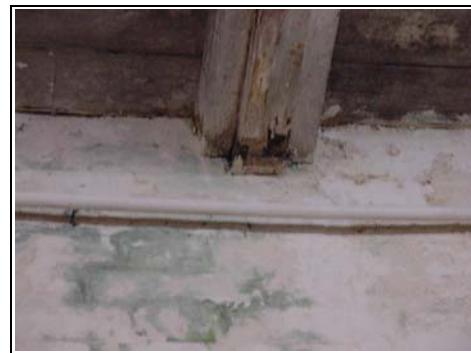
Tests were taken with a moisture meter at random points to external walls, floors and other surfaces. In the charity shop/store we get high readings of lateral dampness. The dampness is affecting next door in the CAB and also the timber ends, which we believe will need some work. Again, please see our comments in the Executive Summary.

Dampness to timber ends
