RESIDENTIAL BUILDING SURVEY
OF
A Post War 1960's Bungalow

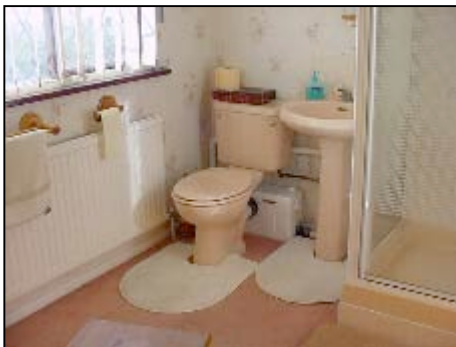
First floor shower room. If you look closely behind the WC you will see the shredder manufactured by Saniflow.

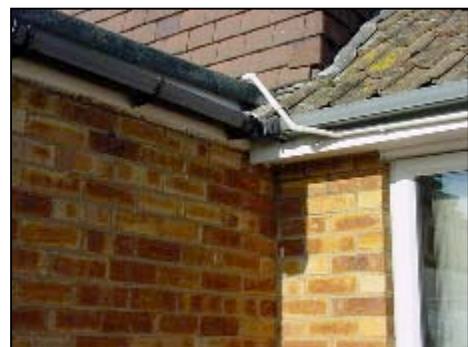
This is the drainage pipe from the WC – the white pipe.

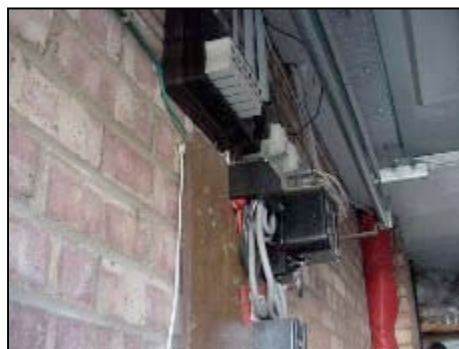
The electrics are dated; we particularly noticed the fuse board, which we recommend, is changed.

Fuse board.

ACTION REQUIRED: We would recommend a new fuse board and consumer unit. We would therefore always recommend that a test and inspection is carried out by a registered NICEIC electrician. We would suggest that the electrician also advises on any upgrading that is necessary

ANTICIPATED COST: New fuse board and test, £250 plus the tests and the cost of carry out any work.

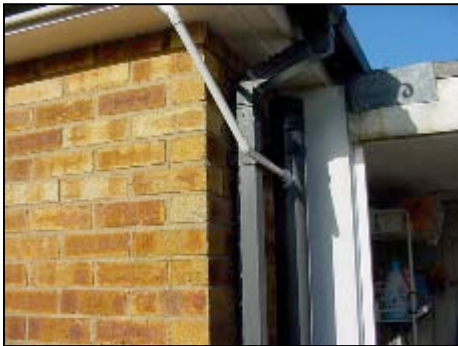
You have a Saniflow WC, which consists of an electrical shredding unit (to allow the waste to go down a small pipe). Which do make a bit of noise, this allows waste to be fed down almost any diameter of pipe.

In this instance the diameter used looks to be about 20 mm (half an inch) which is much thinner than we have seen previously; also it does go on quite a torturous route before it gets to the soil and vent pipe at the rear left hand corner (all directions given as you face the property). We suggest that this is liable to block if you are not very careful what you put down the WC.

The white pipe is a close up of the Saniflow waste pipe.

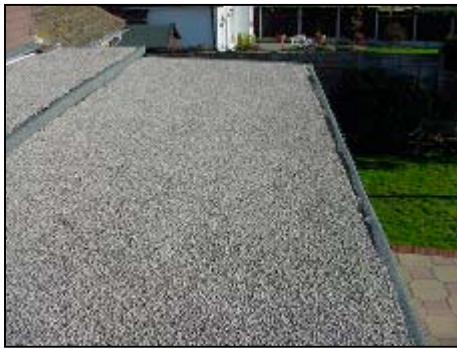
These were nearly in the ugly section. The low level flat roofs are of a reasonable quality; although they have had work recently carried out they are not up to current building regulations, which would require insulations added, and also ventilation. In fact, when we walked on them there was some give in the roof decking, which indicated a thinner decking than we would normally expect.

A view of the rear low-level flat roof.

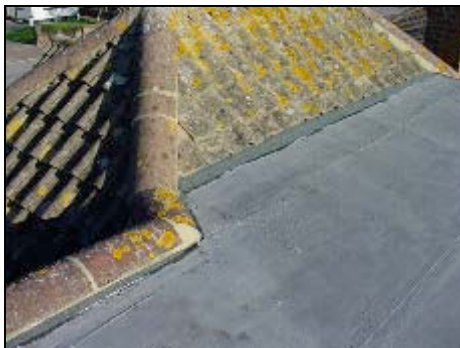
Here is the main high level flat roof, which we wish to bring to your attention, is the high level flat roof, which although work was carried out at the same time as the rear roof it has not been carried out with the same quality finish. It has been left without a protective layer of chippings – the chippings protect the roof from the extreme temperatures, they reflect the sun and they help stop frost attack. There was next to no fall on it. Please see the next section. We would say that this roof has a life of approximately ten more years assuming you are happy to carry out various repairs etc. Again, no insulation or ventilation has been added.

A view of the high level roof

ACTION REQUIRED: Although we could not see where the dampness was getting in we do believe that some dampness was getting in where the flat roof joins the pitch roof from what we can see internally. We would also recommend that solar paint is added to the bitumen finish to help prolong its life and protect it from the sun.

ANTICIPATED COST: We feel this is repairable; it is just a matter of doing the roofing job properly! We would anticipate costs in the region of a few hundred pounds to a few thousand pounds at the most. If you have to chase, as it is sometimes very difficult to identify exactly where water is coming in.

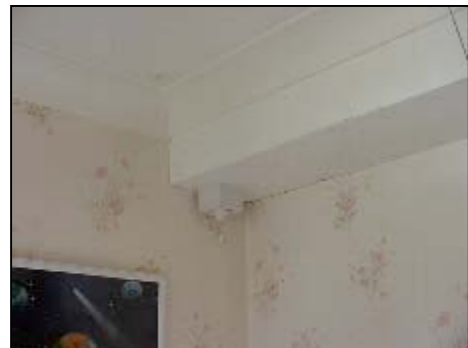
This is the beam internally where water looks to be getting in.

We think that dampness is likely to be getting in through the roof due to a defect in the flat roofing although we could not particularly see one. However, we cannot rule out the condensation option onto what is termed a cold bridge i.e. a cold part of the structure. The best way to resolve this is by process of elimination. We suggest that you add ventilation to the room which should stop the condensation occurring and then re-decorate and see if the plaster still deteriorates – we did not actually get any readings on our damp meter at the time of our survey which makes the problem more intriguing! Either way, we do not think it is sufficient to stop a sale going through. We do think you need to set aside some money to investigate further.

ACTION REQUIRED: As already mentioned, we believe repair works are necessary to the roof.

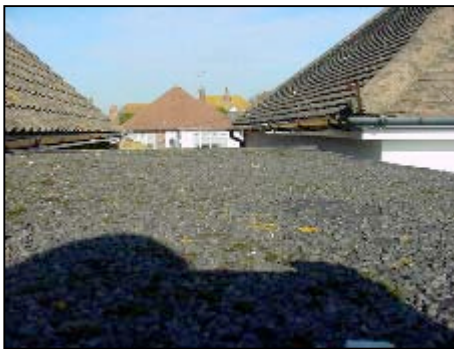
This is over what we would describe as the utilities area on the left hand side. It is in acceptable condition for a utilities area. With the roof, expect repairs on this from time to time but nothing that we can see immediately.

An older style flat roof

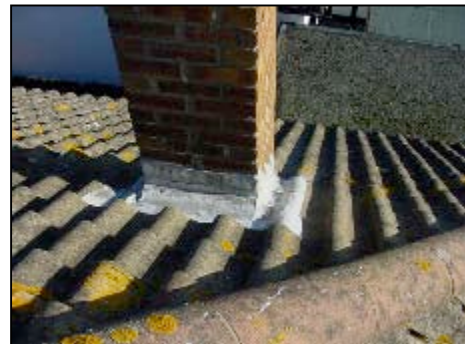
This chimney is brick finished with a lead flashing and has one chimney pot. It generally looks in reasonable condition with the exception of a split to the side of it. We believe this chimney is used as a flue for the boiler system.

A very small split to the chimney

ACTION REQUIRED: You need to occasionally check the chimney (whilst you are checking the flat roofs) and repair the split if it gets any larger. There are sometimes splits in these chimneys due to heat and condensation that occurs.

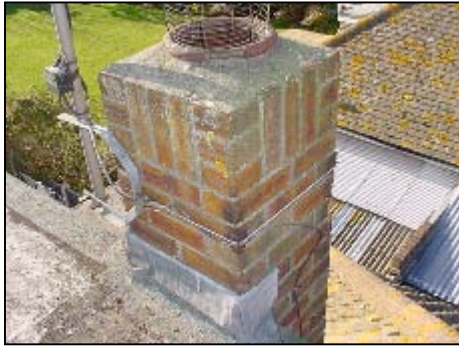
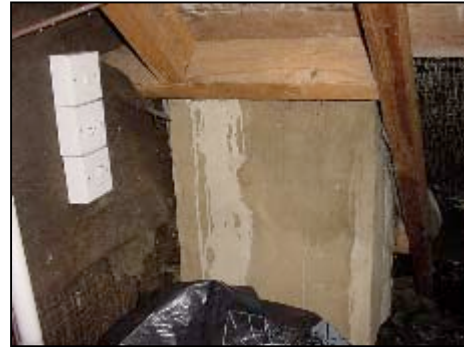
Right hand brick built chimney

Inside the roof we did find some dampness in the chimneys, the right hand chimney to be exact which we believe is probably condensation from the gas fire below. We could not see any obvious deterioration in the timber around the chimney, which would normally indicate that dampness is getting in via the flashings.

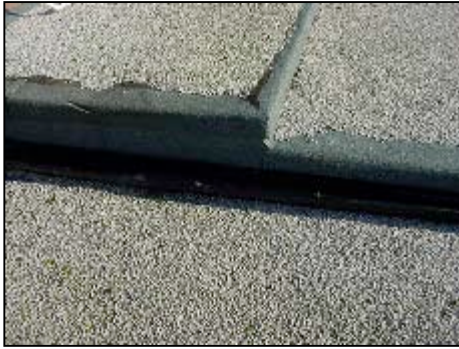
There is awkward detail where the roof changes levels and meets the main pitch roof. The roof looks relatively new. With discussions with the owner we are advised that it was replaced in April 2001, the same time as the main roof (although not to the same quality). However, they did not realise that the main roof was not the same quality of material as the lower roof. We believe the rear roof to have a life of 20 to 30 years with the main high-level flat roof to have a life of 10 to 20 years.

Awkward flat roof detail when we have changes in levels.

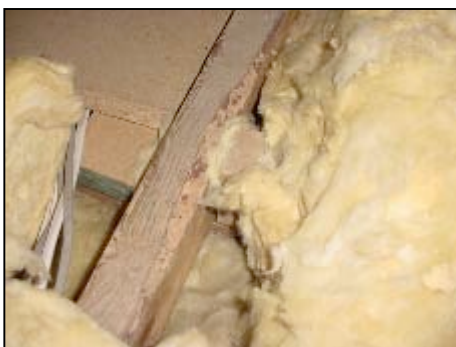
Old woodworm? Somewhat unusually, we found a section of the roof timbers had the markings of quite severe woodworm attack. It looked almost as if it had been there when the timber was cut – we have not come across this before.

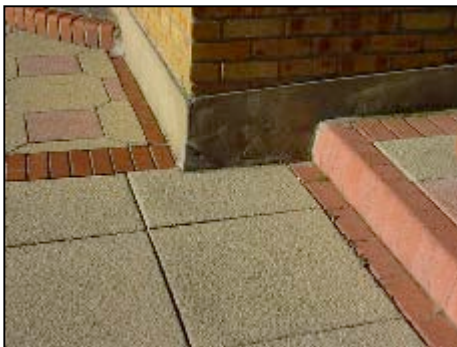
You often find accelerated wall tie failure. Please see our comments in the damp proof course section of this report.

Render to the base of the brickwork

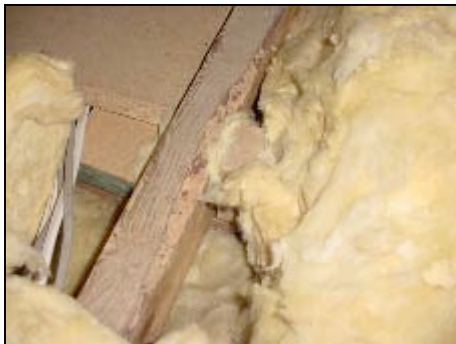
The roof is the main area that we look for woodworm. Within the roof we found no obvious visual signs of active woodworm, having said that, we do not consider what we saw to be ‘structurally significant’ damage. In many properties there is an element of woodworm that is not active. Our inspection is usually restricted by insulation covering some of the timbers and general stored items in the roof, as it is restricted throughout the property by general fixtures and fittings

Sorry to use the same photo twice but it does show the woodworm markings.

ACTION REQUIRED: If you wish to be 100 per cent certain get the property checked when it is empty of fixtures, fittings and furniture etc.
