JOB REF: J1059/RBS/MH

RESIDENTIAL BUILDING SURVEY
OF
Barton Road

FOR
Mr A

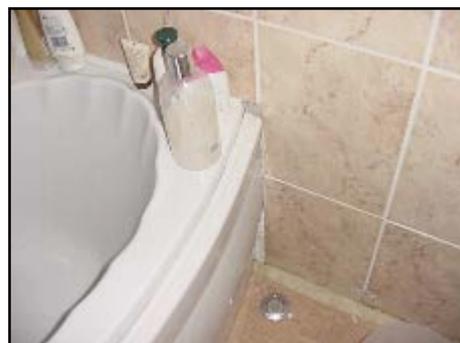
A closer look shows that the cuts have not been carried out.

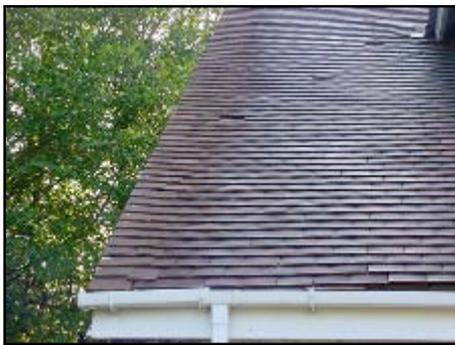
We noted that a few tiles had slipped, which is unusual in a roof of this age, which indicates that there may be more problems with this roof than meets the eye. Typically this sort of roof is meant to be nailed every other course, whoever put the roof covering on may have forgotten to do this.

A fairly high number of tiles were missing considering the age of the roof.

ACTION REQUIRED: We suggest you have a roofer make a general examination of the roof close up from crawler boards and replace any missing tiles and cracked tiles and check how frequently it has been nailed. Also ideally they should clip on the edge tiles.

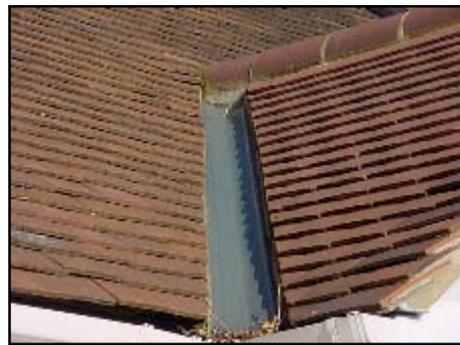
The valley gutters looked to have been formed reasonably well. Note the leaves at the bottom, they need clearing. This is a minor item in the scheme of things.

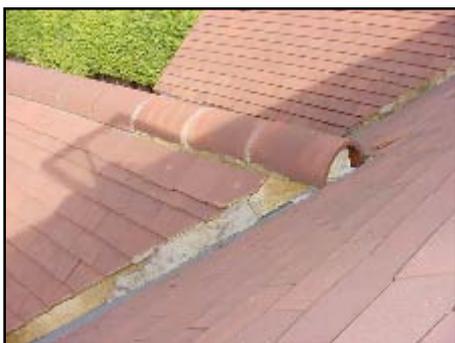
Evidence of repairs to the roof were noted, which is very unusual in such a new roof. Note also the ridge tile does not look to be bedded on that well.

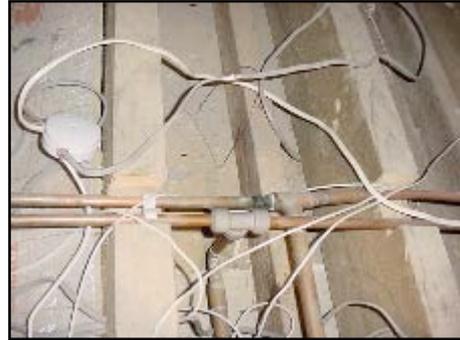
Some fairly heavy notching into the timbers has been carried out.

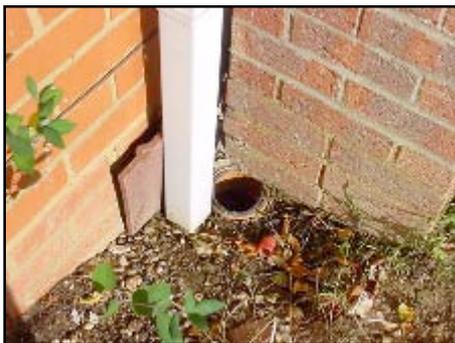
1. Front right hand corner: The down pipe misses the drainage point completely. This can fairly easily be amended but it will mean that the pipe is no longer vertical.
2. Rear right hand side: The 'S' bend from the gutter to the downpipe is horizontal, i.e. the water cannot flow down it. Again a fairly easy modification.
3. We also noted in other areas that the guttering seemed to fall away from the downpipes, rather than towards it.
4. The gutter does not appear to have been clipped into the joints properly and just seemed to be lying there in some instances.

The downpipe misses the drain, but not too difficult to amend, it is just surprising it has been left like this.

ACTION REQUIRED: A tradesman to spend a day or so sorting out the rainwater goods.

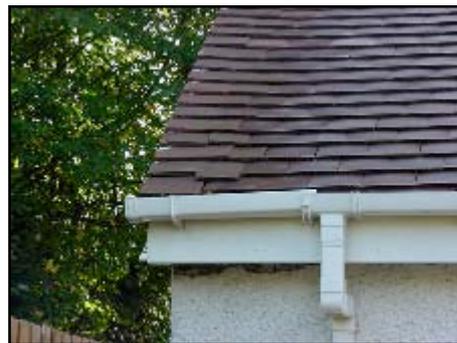
This is, we think, fairly typical of what you will find if you look closely at the rainwater pipe on the left hand side it has not been correctly clipped into the joint and therefore will leak.

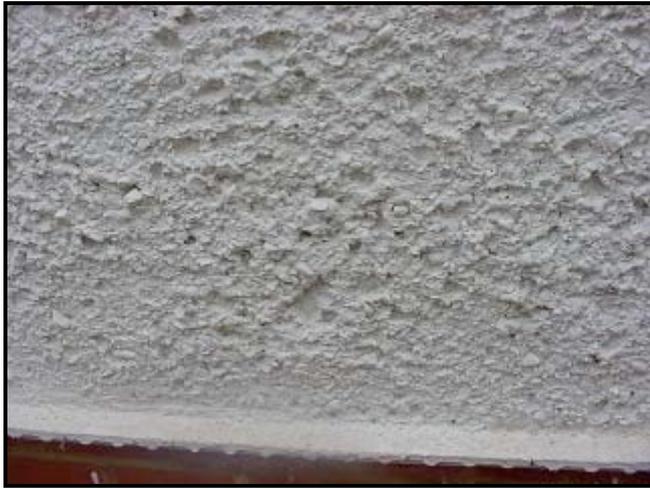
The new render to the property has not been correctly applied. To the rear left hand corner, for example, the render is allowing dampness to come through the structure. Bearing in mind how dry it has been recently, it rained the night before our visit for the first time in quite a while, we were surprised at the amount of dampness coming through – some of this could possibly be contributed to by the lack of render around the windows, which will be absorbing dampness, but not to the extent found.

If you look closely at this you can see how uneven the surface is to the render, which is partly why it is allowing water in.

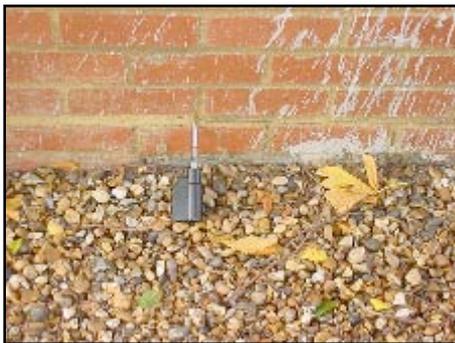
In this case, a damp proof course was visible in some areas and generally we noted a thickening of the cement to the base of the property, which usually also indicates that a damp proof course is present. We found that the damp proof course was approximately two courses to most of the property, although to the right hand side it petered away to only one course and almost to ground level at one point.

Low damp proof course level.
Notice too the paintwork from
the render that is splattered all
over the brickwork!

ACTION REQUIRED: The earth needs to be dug back on this side to expose two to three courses of brickwork. As this is not your land you will need to obtain permission to carry out this work. There are various legal ways of gaining access to someone's land to carry out maintenance work, but we would always recommend a friendly approach to start off with.

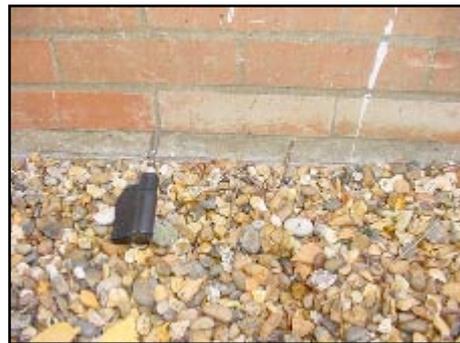
Lower damp proof course level.

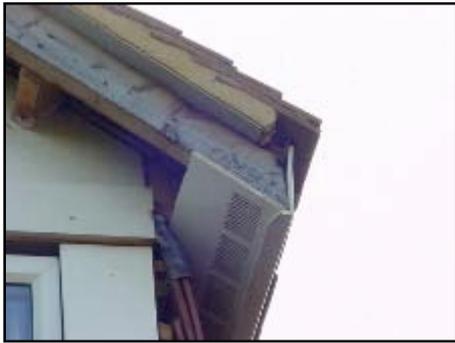
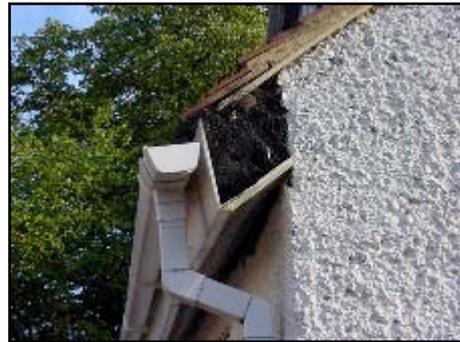
The fascia was finished in the rear of the property you have a fascia and soffit detail, where the rafter feature has not been cut back properly. Also notice that the render has not been made good up to the underside of the soffit.

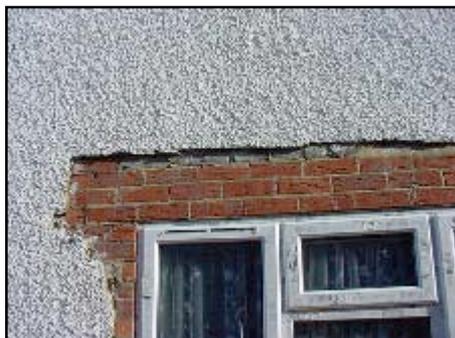
We believe these windows have been left like this for over two years, which could account for the dampness that is getting in through the walls.

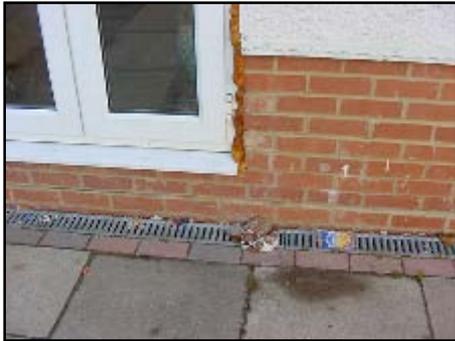
To the rear the doors simply have not been finished off properly. Unfortunately this is now harder to do than it would have been to have done it properly to start off with. The rear kitchen door, for example, has a gap underneath it.

Whilst we know we are pointing out the obvious, the finish around the doors is very poor and now will be harder to put right than it would have been originally to have been done correctly.

ACTION REQUIRED: Cut back the foam around the French doors and add a cover plate. To the rear door the gap needs to be filled in and again it needs to be made good around the door.

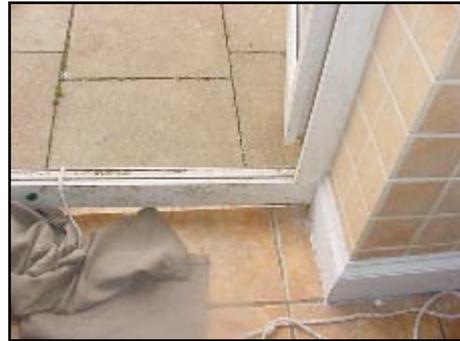
Gap under the rear door.

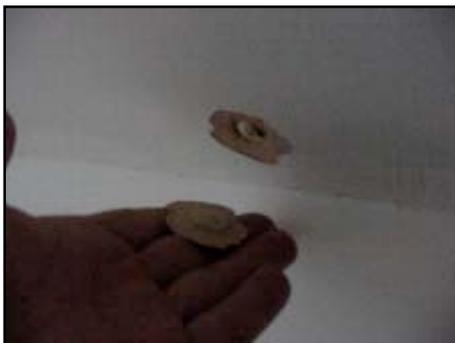
We noted also where plasterboard has been used, there is a phenomenon known as 'popping' that is occurring; this is where the plaster above the fixing point is coming away. Visually this can look very poor.

The phenomenon known as ‘popping’ that is occurring, where the plasterboard has not been nailed on correctly.

With regard to the popping, it depends how much you are concerned about the visual effect of this. You could simply fill and apply a lining paper or you may want to replace the plasterboard or plasterboard over the top of the existing plasterboard.

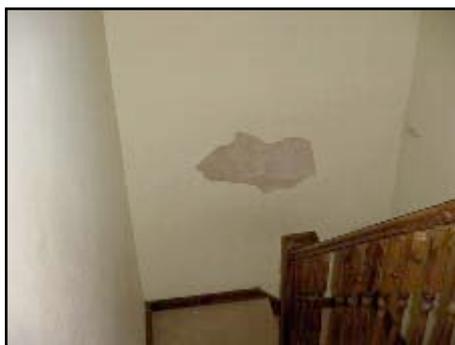
The internal plaster has lost its key. On the stairs, for example, the plaster has come away and in many other areas the plaster is hollow to tap. This situation could be being aggravated by the poor quality of render on the external of the property, but we feel there are also defects with the plaster.

You cannot fail to notice the layer of plaster that has come off on the stairway. There are hollow areas throughout the property indicating that the finishing coat of plaster has not been put on correctly.

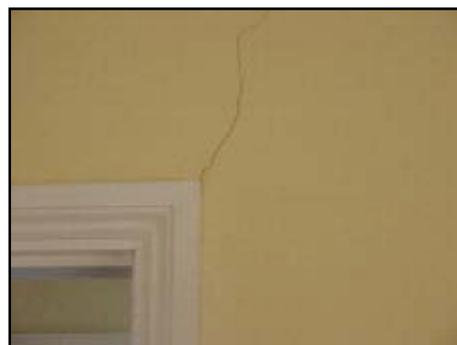
One of several cracks within the property.

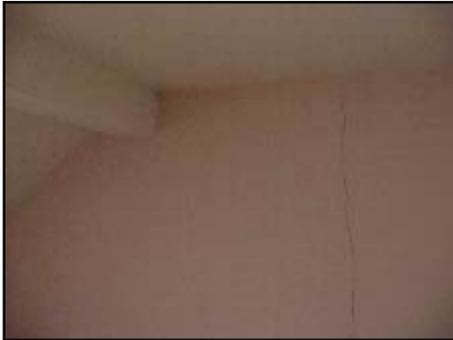
Crack in Bedroom

We feel that the rear crack runs vertically for approximately a meter or so and is at the position where the old and new buildings meet, and this could be because they have not been bonded in correctly and this may be initial differential settlement between the two structures.

This is not a very good photo of the crack. This, we believe, relates to how the property has been bonded (the new to the old). Without opening up the structure we cannot be 100% certain and we could argue that due to the general poor standard of workmanship it is likely not to be very good. However, it does take a lot for a property to fall over and we feel it is best to live in the property prior to taking any major decision on major works to be carried out.

ACTION REQUIRED: As already mentioned, normally you would monitor something like this for a year or so to see if the cracks are moving, however in this particular instance we do not have the time.

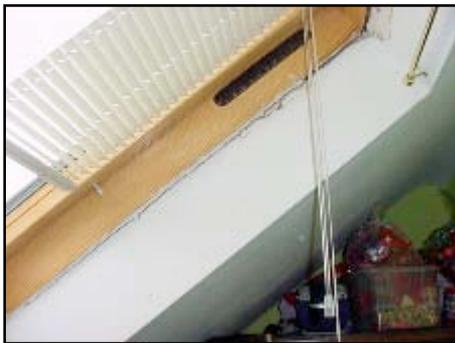
Making good required around the roof lights.

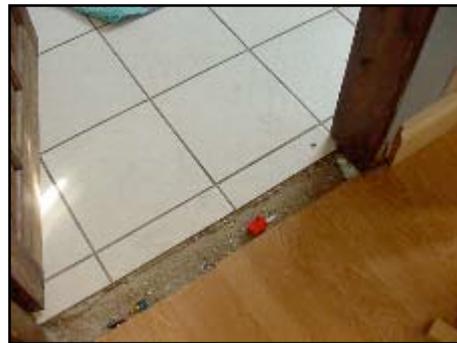
The thresholds were missing on nearly all the doors.

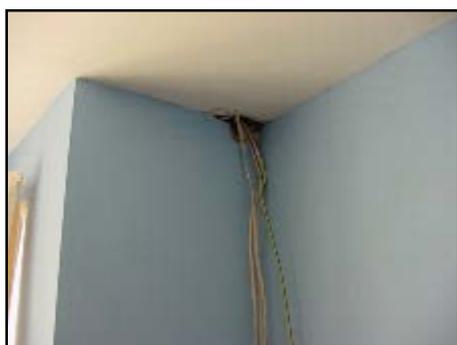
These electrics are obviously not finished.

If there is no record of an electrical test having been undertaken within the last five years, it is recommended that the installation be tested by a competent electrician (NICEIC registered) and all recommendations implemented. Thereafter, the installation should be re-tested every five years.

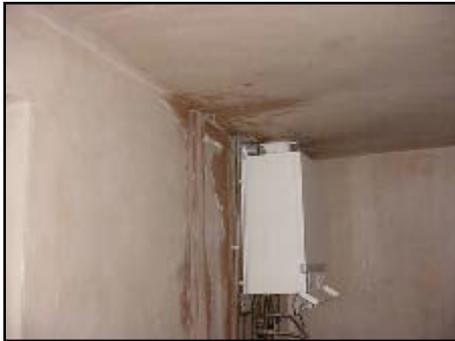
The water discharging down the wall, after we turned the taps on in the en suite bathroom – leak on wash hand basin.

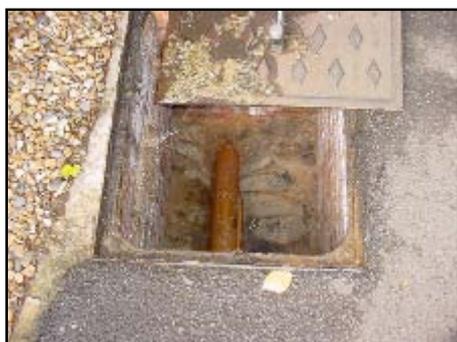
We found one manhole located on the right hand side of the property, this was duly lifted and found to be a traditionally built (brick) manhole and was free flowing at the time of our inspection. We did however notice tree roots in it.

Free flowing manhole, but there are fine roots, which will need to be monitored.

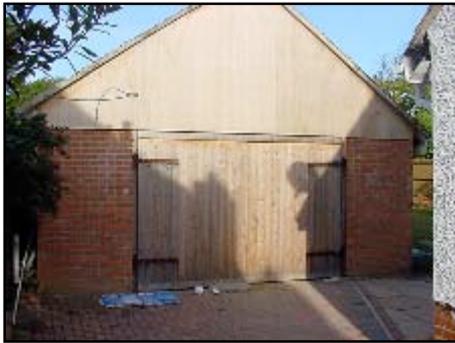
The timber used on the garage has not been treated at all. We could also mention that the fascia board does not appear to have been fixed correctly and the guttering leaves something to be desired.

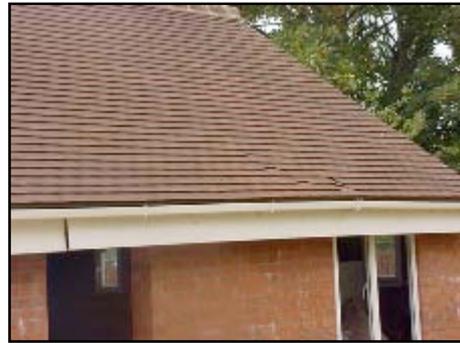
Some of the tiles are missing and the fascia board is not fixed properly.

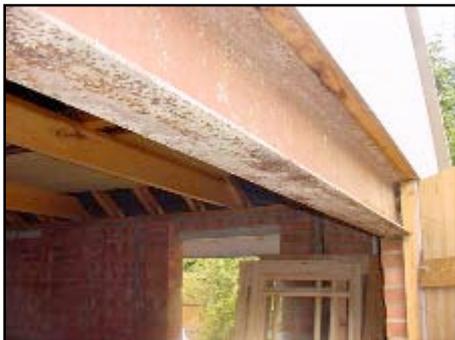
The metal to the front of the garage is rusting.

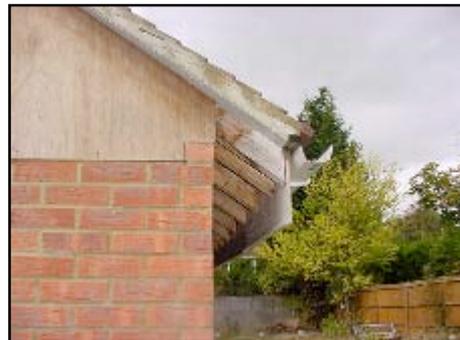
Here you can see the fascia board has not been fitted correctly, and you can also see dampness in some of the rafters and that the rainwater goods do not have a cap on the end.
