RESIDENTIAL BUILDING SURVEY
OF
The Hayloft

FOR
Mr N
PREPARED BY

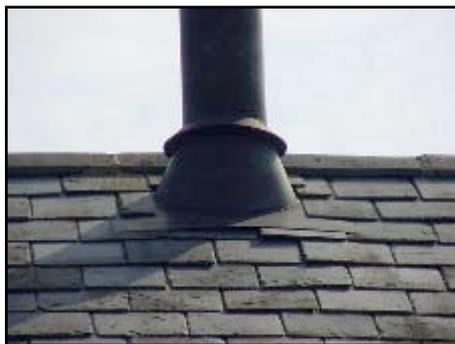
This is a metal flue with an integral flashing detail, which is bedded into the slates with no further lead work or, from what we could see, amendment to the slates. From what we could see in the roof this was in reasonable condition and reasonably watertight.

The detail at the base of the main flue.

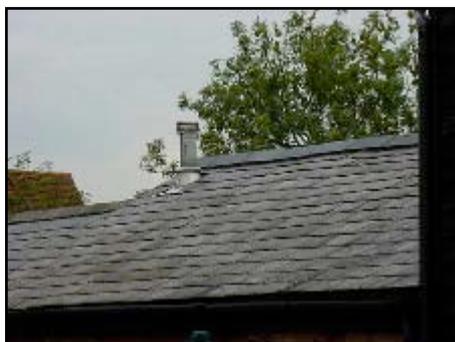
This has been formed in a similar manner to the main roof flue. We were unable to view the underside of this to confirm if it was dry or not. However there was no dampness visible in the main part of the property.

Kitchen Roof – with integral flashings

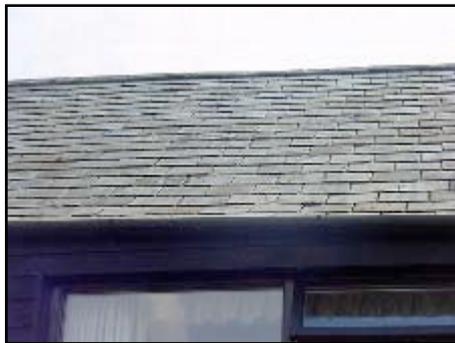
We note that some repairs have been carried out to the slate and that a slate was missing. This is not particularly good for such a new roof, however there did not look to be anything that would cause leaks at present.

Sample area of the main roof

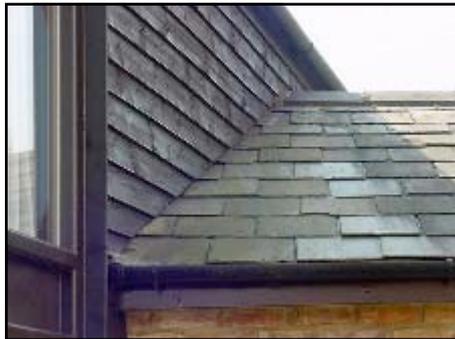
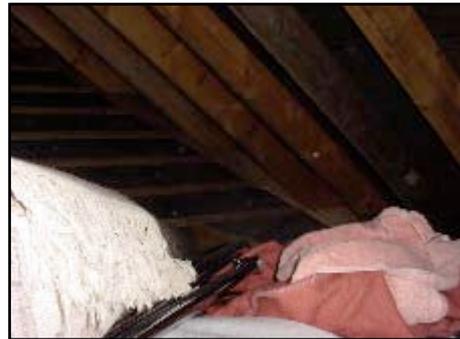
Here the slate abuts the weatherboarding. We were unable to see whether a lead flashing had been put in to the full length of the join, however we did note to the rear corner, near the double doors from the kitchen, that we could see lead work indicating that it probably has. We also noted on the far side that there was a lead detail just above the rainwater goods. We show a picture of this within the Rainwater Goods Section as it is a fairly awkward detail and could do with amending.

Junction of lower roof, which should have a lead flashing. It is difficult to tell if one has been incorporated or not, with the exception of possibly right at the top of the roof.

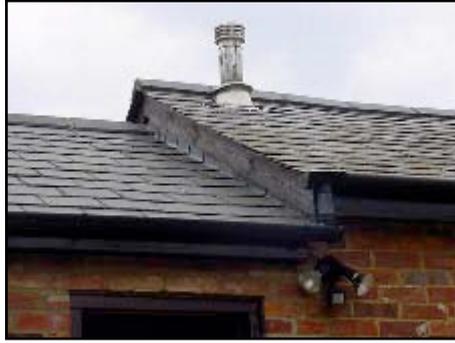
Step in lower roof. This is a weak area although it does look to have had a flashing. The fascia board will nevertheless need redecoration in the foreseeable future as you can see it was missed when the recent redecoration was carried out. Which is fairly difficult where people paint only the items that can be seen.

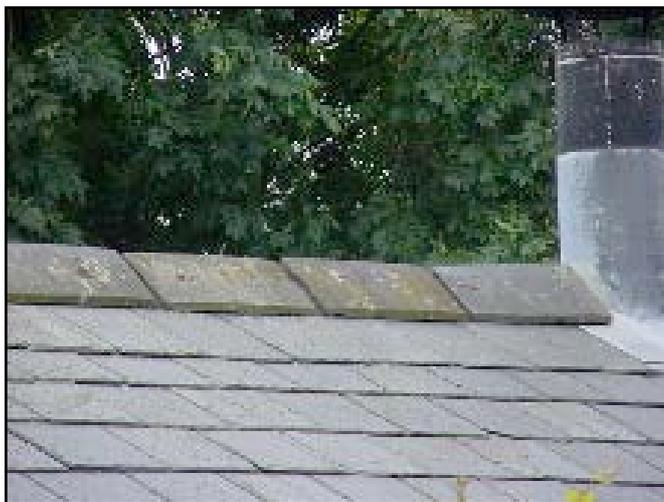
We noted that light could be seen through the joints of some of the ridge tiles, which means they either were not originally bedded in cement or it has been worn away, which is somewhat disturbing given the newness of the roof. We therefore feel that the ridge tiles were probably put on in a cement mortar mix, which had far too little cement in it. We therefore recommend that you have all the ridge tiles inspected.

If you look closely at this photo you will see that the ridge tiles do not have any mortar between them, which has led to some dampness getting in. These all need re-bedding and, as we say in the report, you need to check all of the ridge tiles.

We also suggest that at the same time the roofer has a close check of the roof slates as we are concerned that we could see that some had slipped and that some had been replaced already, which is quite unusual for a roof this young.

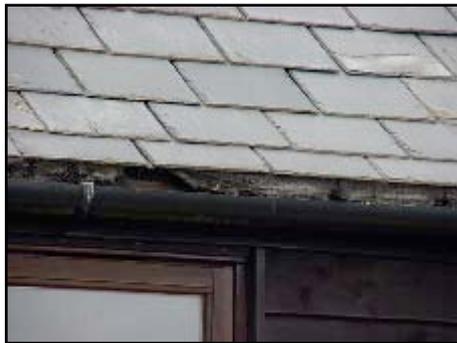
Close up of the roof. If you note the sarking felt underneath the slates should sit into the guttering. This is beginning to wear in some areas and could lead to dampness and deterioration.

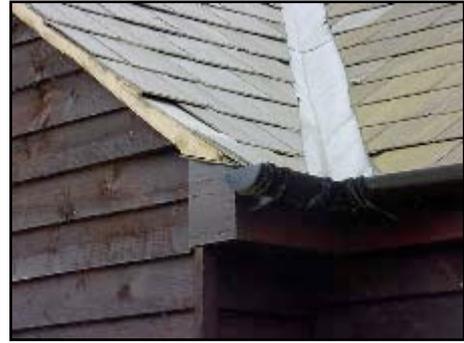
Close up of the valley gutter and also showing a missing slate. We also noted that there were no clips to the slates, which is a fairly common practice, particularly where the roof is exposed on slightly high areas such as this.

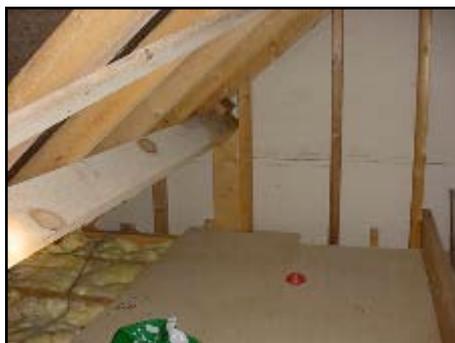
View of the end gable. The purlin is running horizontally on the left hand side. We were pleased to see this was chunkier than we would normally find. There are some splits within the common rafters; this is not unusual, although perhaps slightly excessive for a property of this age. Note also the plasterboard to the end gable, indicating the type of construction, which is fairly 'lightweight', this has the weatherboarding on the other side of it. Also notice the rat bait! Which was all

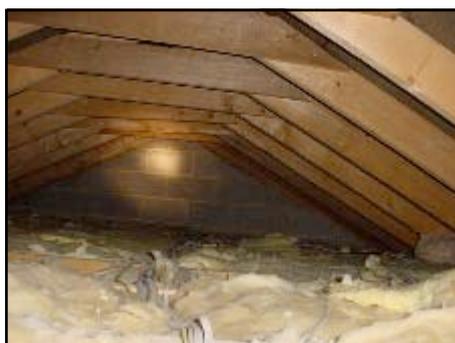
General view of the purpose made low level roof. Note the wasp nest to the right hand side; we are not sure if it is active. We were pleased to see the modern wiring.

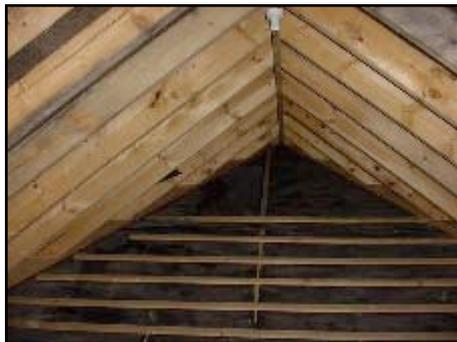
General roof view. You can see here the old hipped roof that formed the garage prior to the extension (the black battened area). You are in need of a light bulb in this area.

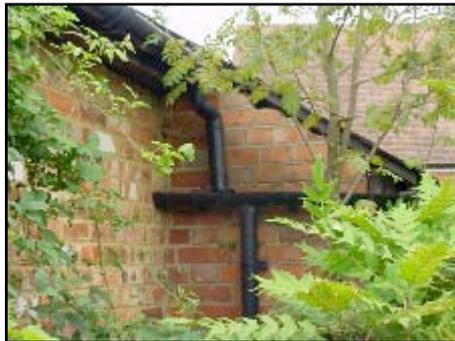
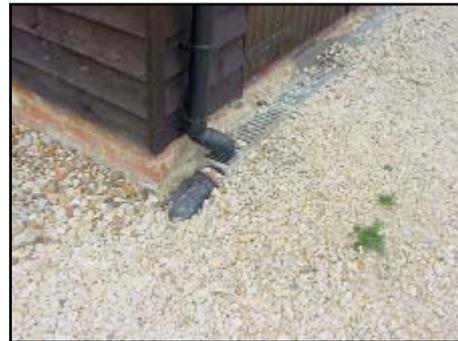
There are several awkward rainwater goods details. Such as this! Also note the brickwork has been cut slightly lower than the roof level and would benefit from a cement mortar fillet to stop any water getting in

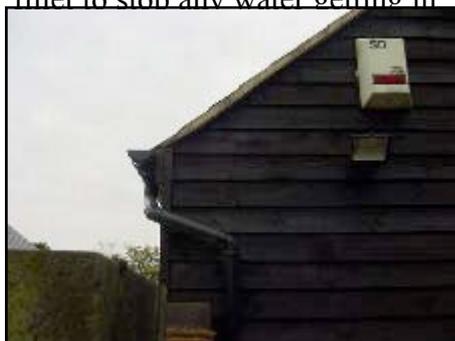
This photo shows where the downpipes drain away and is not ideal as the drainage should be much further underground. Care should be taken not to damage them.

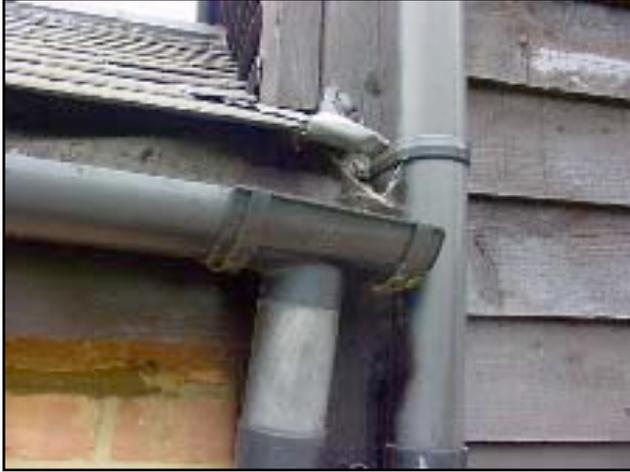
A very awkward detail on the rainwater goods, which could lead to some dampness running down the side of the weatherboarding, and probably already has. A hopper head would probably be better here.

ACTION REQUIRED: We would always recommend that the rainwater goods are cleaned out, the joints are checked and the alignment checked to ensure that the gutters fall towards the downpipes.

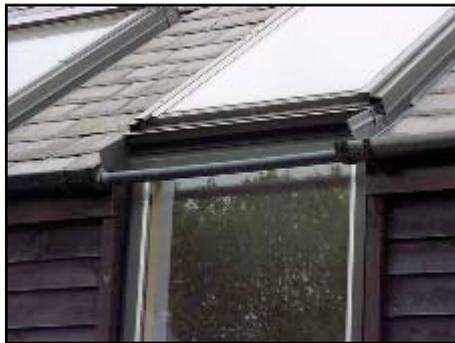
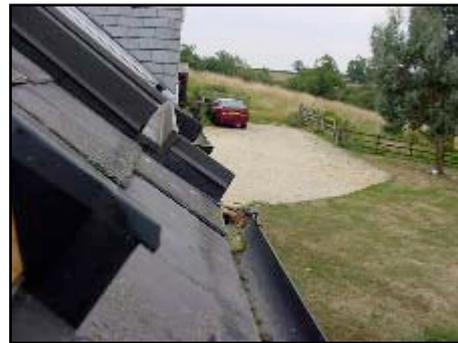
There is a fairly awkward detail where the window/roof lights are.

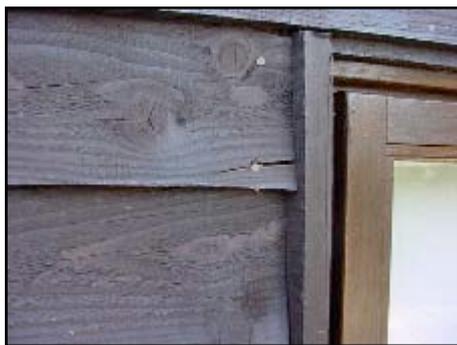
This shows a fairly typical detail where the nails are too close to the edge of the weatherboarding and have caused splitting.

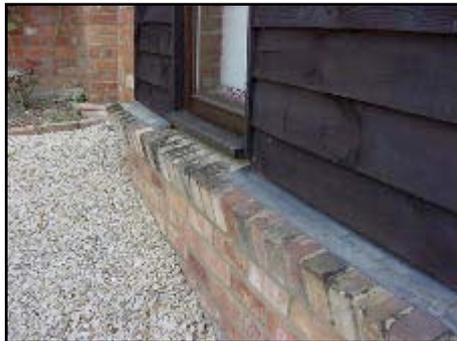
We were pleased to see the lead drip detail on the brickwork, although we cannot understand why it was not carried out underneath the windows as a precautionary measure to minimise future dampness.

ACTION REQUIRED: We would not recommend adding the lead detailing unless dampness started to occur internally as it is a very difficult job. We would however recommend that you remove the decking around the brickwork detail, just the one board should do, this can either be removed or lowered or adjusted to allow water to run off the brickwork.

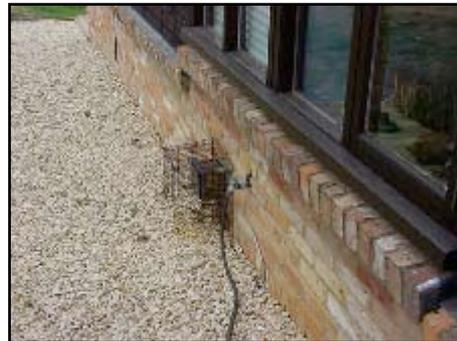
Whilst the bricks are angled a lead flashing underneath the windows would have been a much better detail.

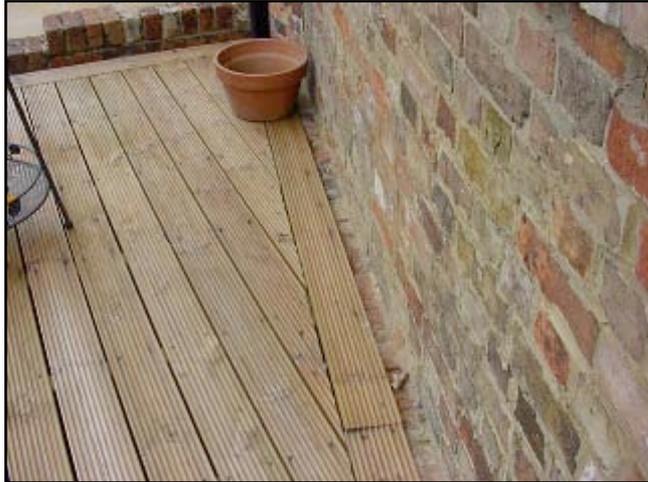
We are slightly concerned that the decking to the rear will cause some dampness due to the way it has been carried out, which will allow water to sit upon the brick plinth. A simple alteration to this should suffice with the removal of the nearest decking board to the building or alternatively making it slightly higher and therefore allowing the water to drain off the brickwork.

The decking may possibly add to dampness in the property as you can see it effectively stops the run off of water on the brickwork. We are talking a long-term process here, but nevertheless with the removal or adjustment of that plinth, by making it slightly higher it would allow the water to run away rather than to sit on the wall.

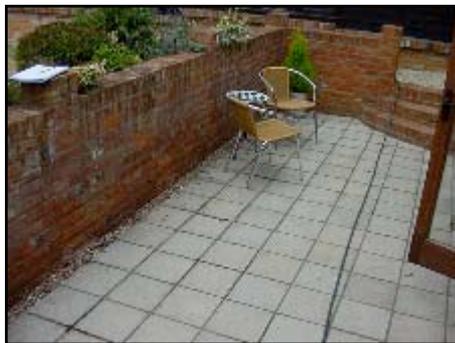
This is the retaining wall around the patio area to the annex, where ideally weep holes should be added.

ACTION REQUIRED: Core drill holes into the retaining wall to provide weep holes. To some extent it could be argued that the retaining wall has survived for a few years without weep holes, but we feel it would be better in the long term to add the weep holes. It is not an urgent job, but something to be on your list of things to do – particularly if the wall starts to lean over at an angle!

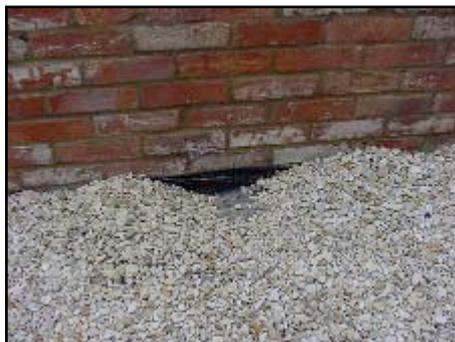
We are more concerned about the property where, due to the fact it is sitting on a sloping site, part of it goes below ground level. We dug around this area and was surprised that we could not find any tanking, although this could have been carried out on the inside of the walls and to be fair we did not find any dampness within.

This is one of our investigations to see how deep the damp proof course goes. Unfortunately it was only a few inches below the surface level and did not continue down any further. There is no sign of tanking on the side of the building.

ACTION REQUIRED: Open up the lower section of the annex. We would have to carry this work out for an agreed fee. Please telephone our office to discuss further.

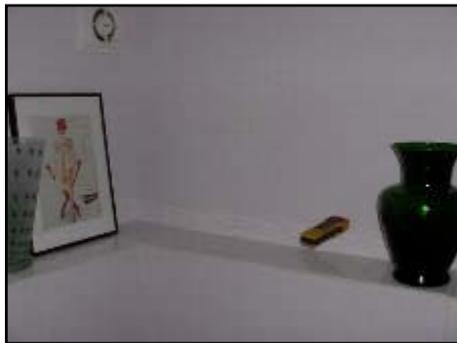
As mentioned in the report our electronic meter could not take any readings on the lower portion of the property due to it being dry lined. Above this we found everything to be satisfactory. (The yellow item is the electronic damp meter.)

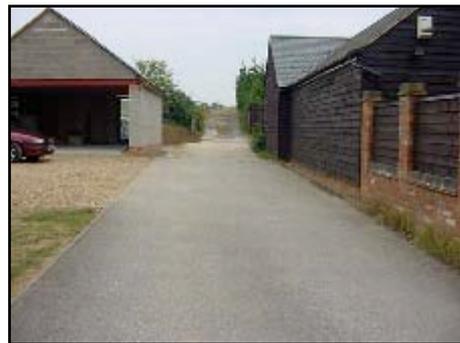
You can see the fall in the road which combines with the fall from the surrounding hills, which when it rains all the water will travel along the road. Note the new garage to the left hand side, which we feel will further direct water towards your annex.

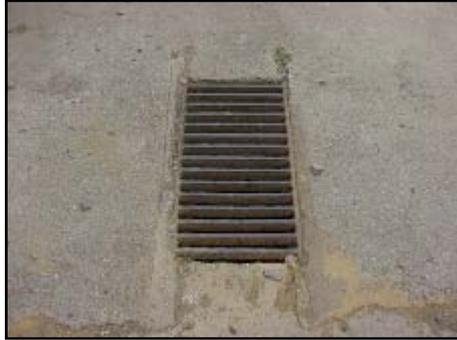
We also noted the drain in the road was full of water, which is interesting particularly when you consider how dry it has been this summer.

This is the land drain, which holds a tremendous amount of water, which is in the road adjacent to your annex, where we believe there could be problems.

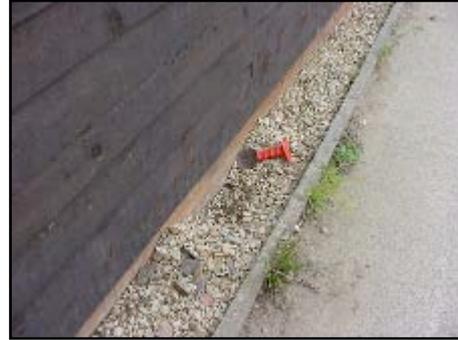
This is my further investigation to try to establish if there is any damp proof course or tanking to the annex, or indeed the main building that is built below ground level. There does not appear to be. This is a major area of concern and that is why we are suggesting opening up the annex walls.

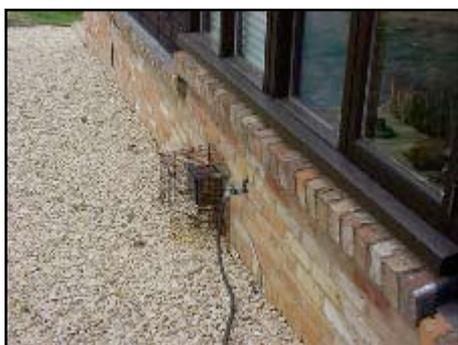
Sorry to come back to this but we think it would be a far better detail if lead was put underneath the windows as the run off water will equally sink into the brickwork below the windows as it would below the weatherboarding, which will lead to dampness. Ideally a lead flashing should be fitted underneath the windows. This however will be a very difficult task

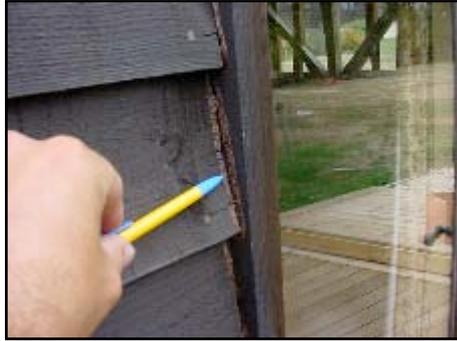
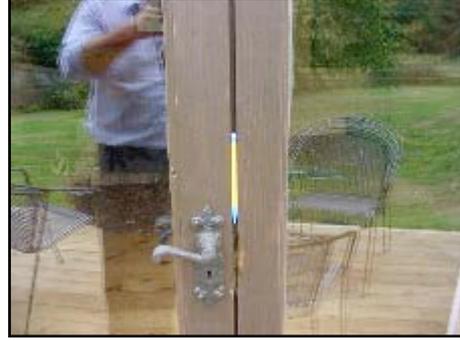
The mastic has now dried out from around the edge of the doors and we suggest it is replaced. We assume it was brown because the property was at one time painted brown.

If you can ignore the reflection and instead note the gap between the doors where the pencil sits. This is an open invitation, we feel, to any burglar wanting to gain entry and also generally poor craftsmanship.

We would recommend that alterations and improvements be carried out as we feel they are an open invitation to a burglar.

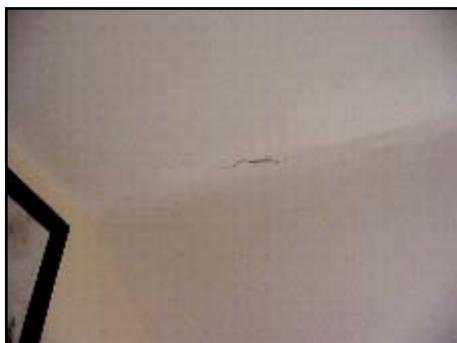
If you look closely at this picture you can see the flaking paint that alerted us to the possibility of a problem on the roof, which we later found to be the ridge tiles not having any mortar.

ACTION REQUIRED: As already mentioned, re-bed the ridge tiles and check all of the ridge tiles.

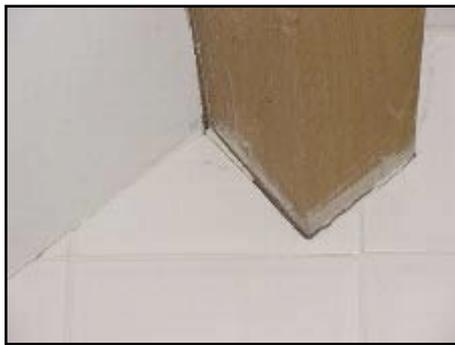
If you look closely at this beam you can see there has been slight movement. This is common and normal within a timber frame property as the property changes, adjusts and moves minutely with the seasons, what is termed as ‘breathing’, this will lead to hairline cracking and movement such as can be seen in this photo. If you note the gap between the beam and the tiles

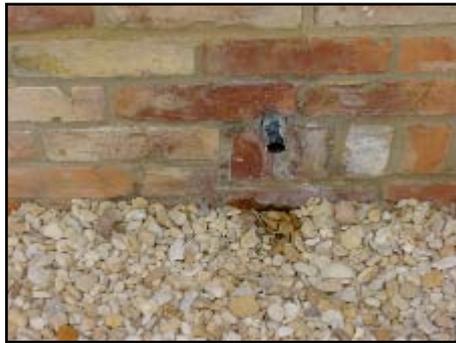
You have a slight leak from one of your tanks as is noted by a small amount of water coming from the overflow pipe.
