JOB REF: J1050/RBS/02

RESIDENTIAL BUILDING SURVEY
OF
Marlborough Road

FOR
Mrs J Little

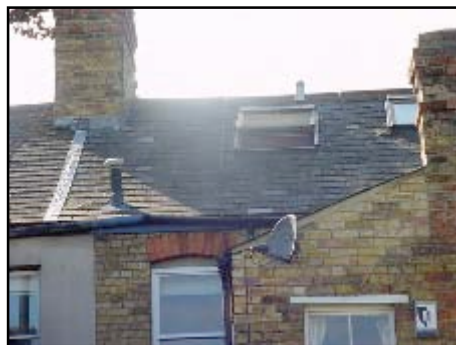
There is a very poor detail between your roof and the adjoining roof on the right hand side. The problem relates to next-door using a different roofing material, which has resulted in a changing level. The roofer has tried to make a watertight bond between the two and have used a product generically known as 'flashband', which is a sticky backed bitumen covered foil and is generally considered as a temporary roof measure. The difficulty is how to resolve this with a better detail.

The 'flashband' can be seen to the left hand side of the photo running down from the chimney.

ACTION REQUIRED: Replace in due course, it will appear to peel as it loses its stickiness.

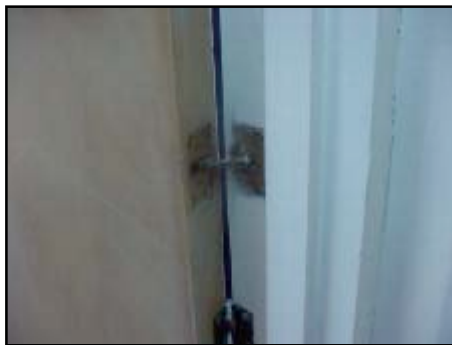
The fire door to the top floor room has not been fitted very well and there is a fair amount of space beneath it.

The door closer on the fire door to the top bedroom.

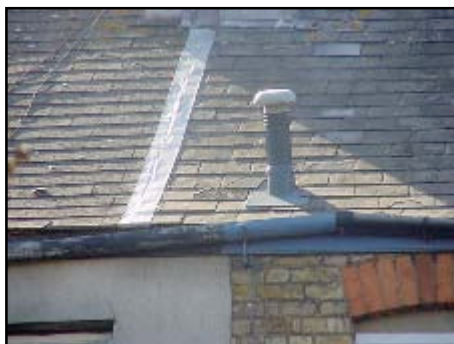
A section of the guttering has come away to the rear of the property. We would recommend that this be replaced to stop any future water damage.

Guttering completely out of alignment.

Anticipated Costs: A good jobbing builder with a set of long ladders should be able to resolve this for £100 or so.

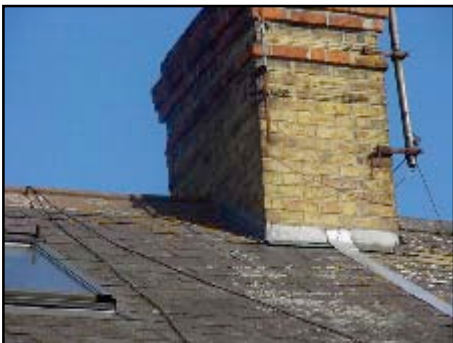
Brick built with a lead flashing and looks in reasonable condition. It has been re-pointed at some point in recent years. The pots were fairly straight, indicating that it is in acceptable condition. As can be seen in our photograph there is very minor pointing necessary, but not for some years.

A brick chimney with a lead flashing. You can also see in this photo the awful 'flashband' detail between your roof and the adjoining roof.

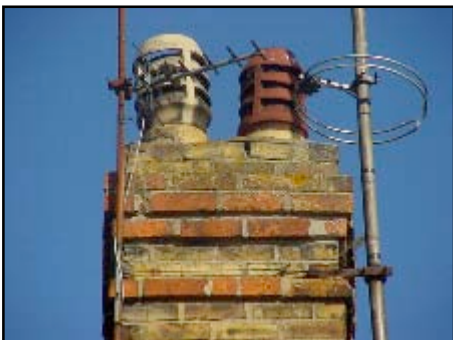
Close up of the top of the chimney. The flashing on the top is just starting to go and will need re-pointing, but not for many years. You can usually see when it needs re-pointing as the chimney pots start to lean.

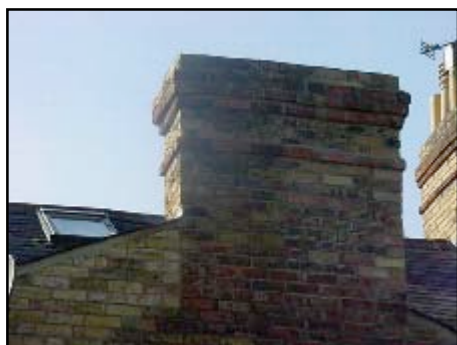
This is brick built with a lead flashing. It has been re-pointed but would benefit from additional re-pointing within, say, the next ten years or so.

Rear chimney in reasonable order.

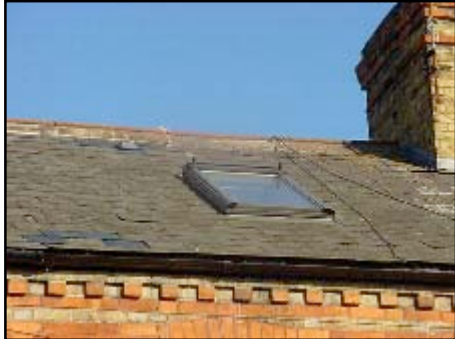
A modern roof light with surrounding drainage gutters, you can also see on the roof that some slates have been replaced with man made modern slates also some slates are missing. To the ridge you can just see a vent.

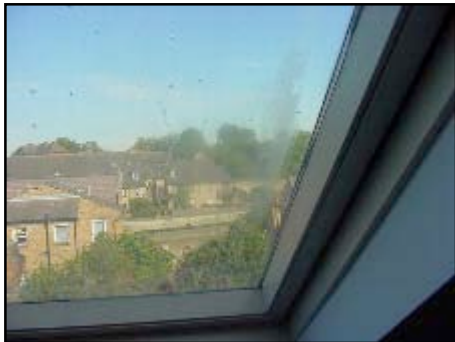
There also looked to be water staining around the timber frame of the roof lights, particularly the landing one, whether this relates to condensation being caused on the inside of the window or an actual leak is difficult to say. We suspect it is due to condensation.

Condensation occurring in the roof light.

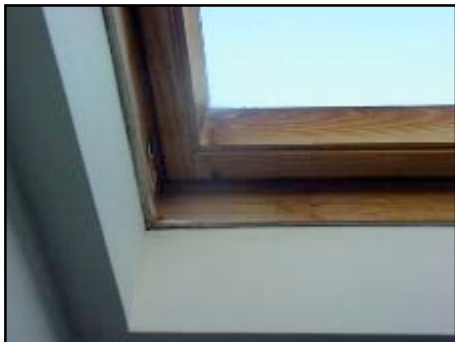
Staining to the roof lights

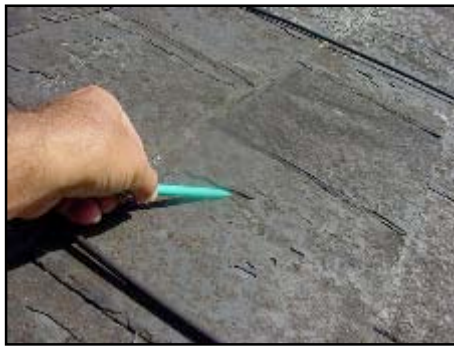
The property looks to have its original slate roof covering. This is in reasonable condition for its age but it is however starting to de-laminate.

Here you can see the slate is starting to delaminate.

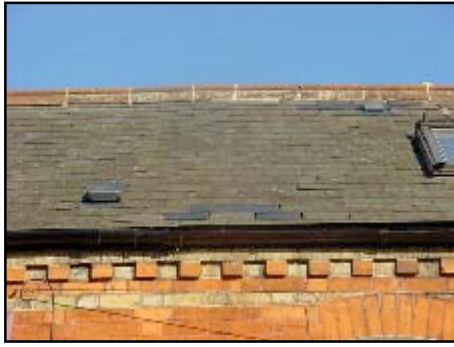
General view of the roof. Predominantly the original slates, but with some new man made slates mixed in. Also you can see the mushroom vents, which is a modern requirement for this type of roof.

Close up reveals that the mortar to the ridge of the roof is starting to deteriorate to the right hand side and you can see to the left hand side that some re-pointing has been carried out.

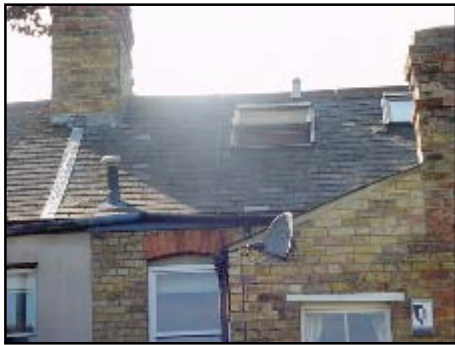
In this case a product generically known as ‘flashband’, which is a sticky backed bitumen covered foil, has been used. The adhesion on this usually does not last that long and it is normally considered as a temporary repair material for roofs.

General view of the rear roof, again slates can be seen to have been replaced. You can also see the ‘flashband’ between your roof and the adjoining roof. You can also see where part of the wall has been rebuilt on the rear gable on the right hand side of this picture above the window near the satellite dish. Finally, you can see where the guttering needs re-fixing in the centre of the picture.

ACTION REQUIRED: Whilst the detailing that has been carried out is very poor there is no easy or cheap way of solving this problem. We suggest it is almost worth waiting until the ‘flashband’ deteriorates before taking any action, then you have a choice of replacing the ‘flashband’ with lead, which is a far better detail, or biting the bullet, so to speak, and having an invisible gutter put in place. This however will be fairly expensive and should, in theory, be a shared cost with your neighbour as they have effectively caused the problem. However, it is far easier said than done to come to such an agreement with your neighbour.

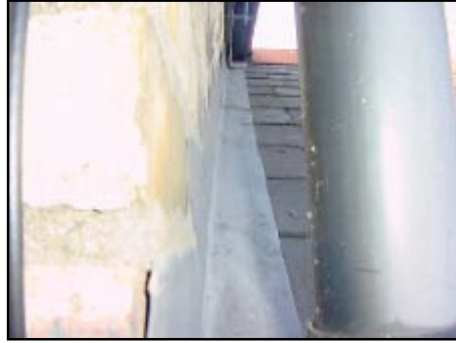
This is the only view we have of the joint between the main roof and the rear roof, taken whilst precariously leaning out of the window! We were pleased to see that there is a lead flashing, which should minimise any problems.

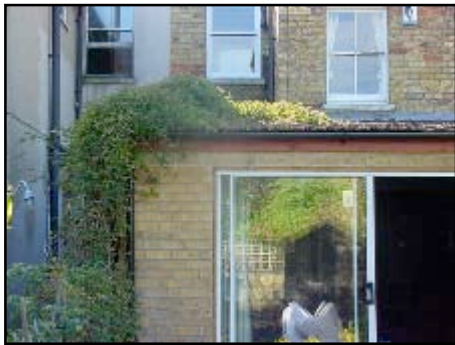
You will have noted the ivy that is on part of the roof. This is not ideal and should be cut back. We would normally recommend that a trelliswork be placed between the ivy and the building to stop any deterioration and damage.

Due to the rear roof being relatively flat, the bush should be cut back as it will allow water to sit on the roof.

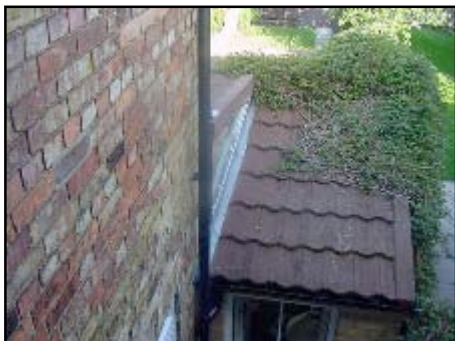
There is a slightly awkward roof detail where a second pitch has been added. If you look at the photos you will see that it is covered with the ivy and therefore it is difficult to see how it works properly, we assume it is just two pitches meeting each other, but there is normally a need for some sort of ridge joint.

The plant is taking over the roof and needs cutting back, as already mentioned.

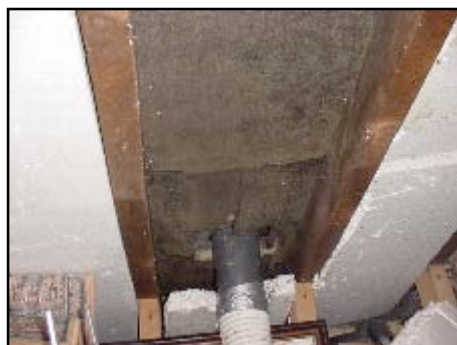
Insulation has been removed to reveal the Hessian base sarking felt (the black bit) and the common rafters (the timbers) to either side.

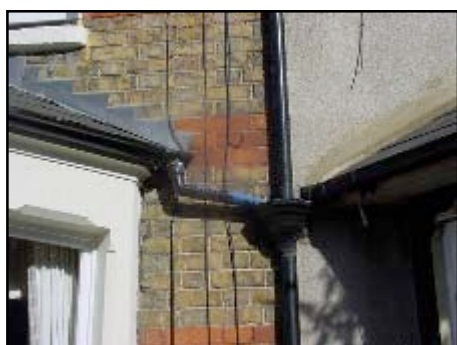
This photo shows the mix of rainwater goods. There is a cast iron gutter to the bay window, the downpipe from the bay window to the hopper head is painted plastic and the hopper head and the down pipe in this instance is cast iron. There is some rusting to the base of the hopperhead.

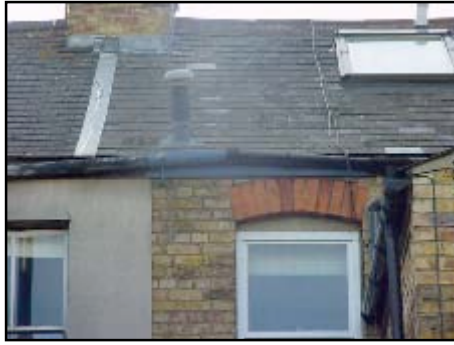
We noted to the rear a section of the guttering had come away, this section looked to be formed in asbestos, which was often used in the post war years up to about 1970. We pointed this out to the present owners.

The guttering is completely out of alignment, we thought possibly asbestos guttering was present on the left hand side and the additional weight is pulling the guttering down. You can also see in this photo quite clearly the difference in the two roofing materials.

ACTION REQUIRED: This is typical of what we would expect the present owners to resolve, prior to selling the property.

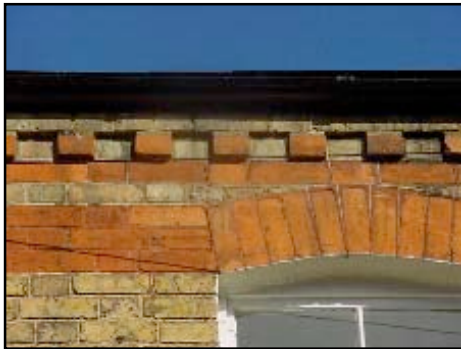
There is a hairline crack to the window. The brickwork is of Flemish bond construction. The decorative brickwork at eaves level is also shown. You may be interested to note new pointing to the soldier course of brickwork above the window, known as pinch pointing, which involves striking the centre of the mortar and pointing in white. At one time the entirety of the building would have had this look.

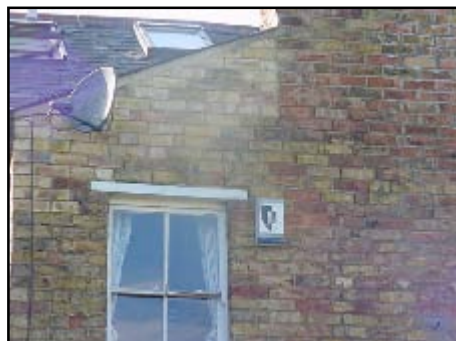
It is fairly common for movement to occur in the very rear portion of the roof. This is often due to failing lintels. Here you can see it has been re-built.

The wall has been re-built here.

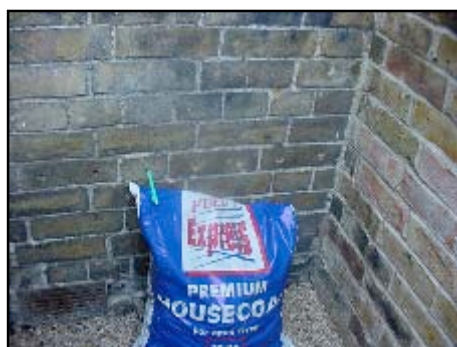
The pencil is within one of the old holes where the damp proof course should have been added. As you can see it does not extend pass the kitchen wall.

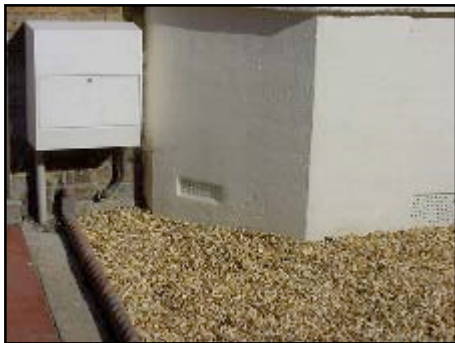
The floors to this property to the front are what is known as suspended timber floors. This means there should be a through flow of air beneath. Sub-floor ventilation is essential in discouraging rot and on no account should the air bricks be obstructed. In this instance whilst you have ventilation to the front of the property we could not see any to the rear. In theory there should be vents to the kitchen wall and where the step down into the lounge is.

The air bricks are the white grills. Also note your gas meter outside the door.

ACTION REQUIRED: As the property is damp we would recommend that vents are added to the rear walls.
