SPECIFIC DEFECTS REPORT

Relating to Damp Walls

1920s Property in Devon

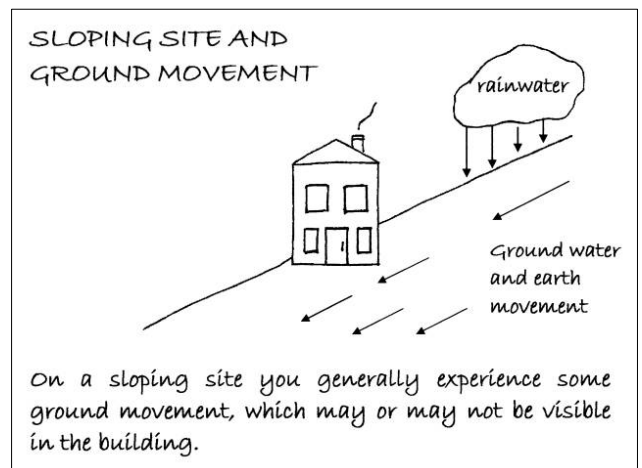
The Property sits on a Sloping Site

The property sits on a sloping site and as such rainwater travels from the top of the site/land to the bottom of the site/land. The property is presently in the way of this transfer of water from the top to the bottom with no defined route for the rainwater.

Action Required: Provide a defined route for the surface water.

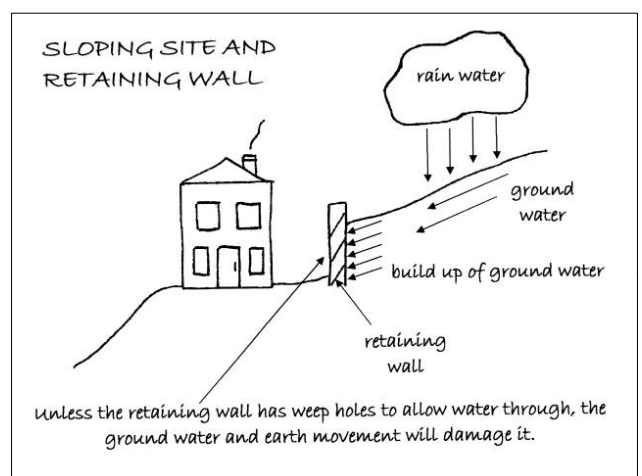
Retaining Wall and Field Water

There is a retaining wall holding back the adjoining field which would benefit from having some weep holes cut into it or cleared if they are already there, to help direct water which is coming from the field.

Action Required: Clear weep holes to provide a defined route for the water to discharge.

Contact the farmer who owns the field to ascertain whether there are land drains within it.

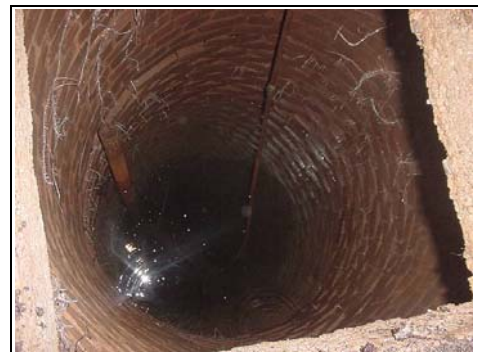
The Well

The well that you showed us within your garage appears to be relatively new. Based upon the brick work it looks to have possibly been constructed in the last 40 years. We also noted with interest the pipe work set within the well. It may also be a sump or storage area for water draining from the adjoining fields or it may just be a repaired original well.

Action Required: Speak to the local farmer to see if he has a recollection of the well. Also check local web sites to see if any residents are aware of it, if you wish to publicise the matter.

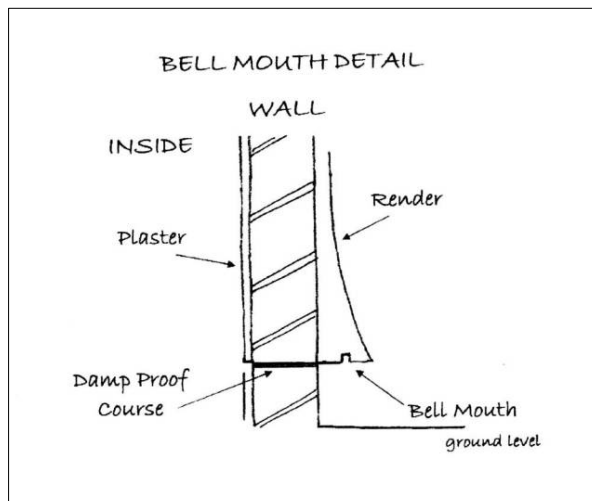
Render bridging the Damp Proof Course

Assuming that the wall construction does have a satisfactory damp proof course, the render on the outside of the property is currently bridging the damp proof course. As well as the detailing to the base of it (meaning that any rain water discharges against the base of the property), this is in addition to what we would term as “the pressurised water” coming from the adjoining field. The combination of the two, we believe is leading to the rising damp that is just visible internally and detectable.

Action Required: Add a Bell Mouth

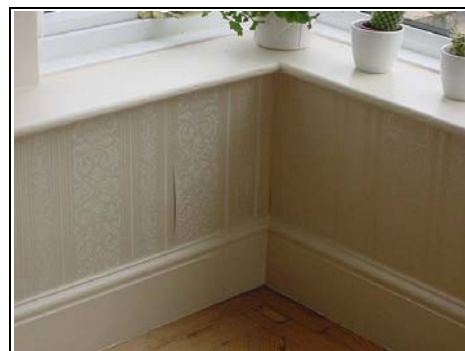
In one respect the visual effect of the additional water together with the various other points which we have mentioned are relatively minor. The electronic damp meter readings however paint a different picture of dampness throughout the property.

Wall paper coming away from the wall being one of the visual signs of dampness

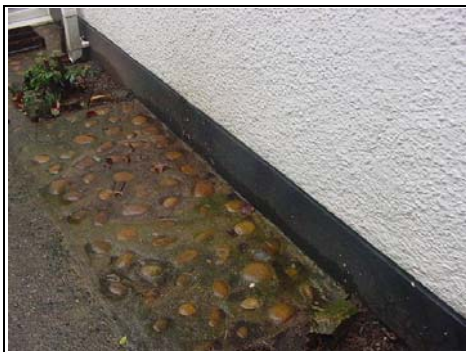
Location of new French gully. This looks to have been concreted over. Ironically a flower bed would have been more able to absorb the dampness

Once the test has been carried out, we would recommend the adding of a French drain to the rear of the property which then feeds into the drainage run. Please note appendices and our article on French Drains becoming French Ponds!

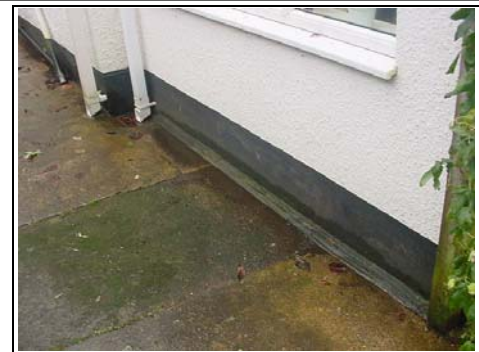
Location of new French gully. There looks to have been problems here in the past.

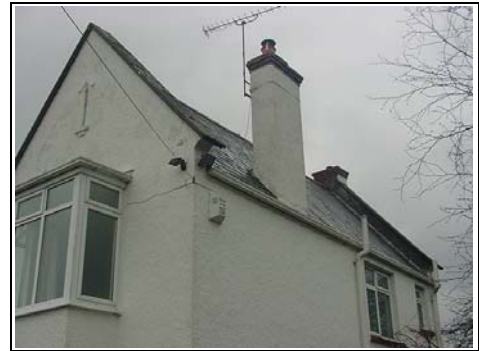
We believe that some of your chimneys may need repointing to stop the dampness getting into the property (known as falling dampness as opposed to rising damp). It is also worth checking the flashings and the roof slates at the same time.

Close up of the Flashing

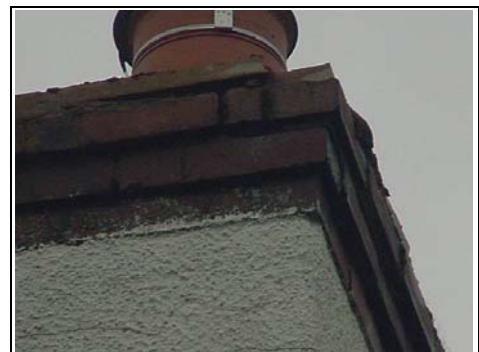
Close up of the defective brickwork to the top of the chimney

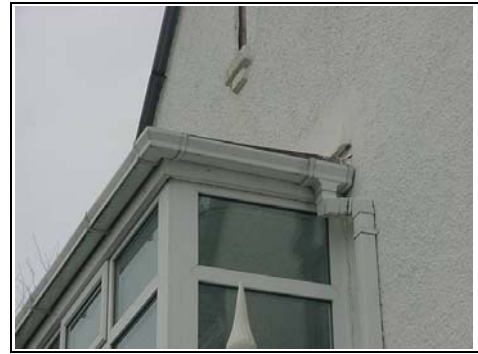
Close up of the Bay Window Roof

The roofs to the bay windows should be checked.

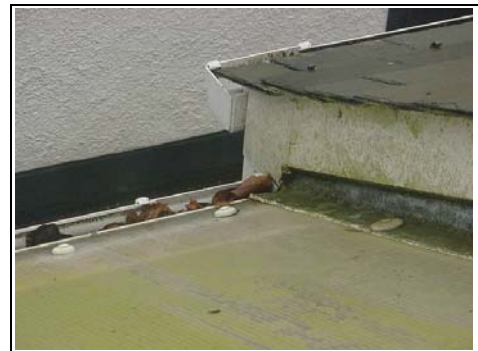
Leaves in a low level gutter

We would recommend that leaf protection is added to the gutters.

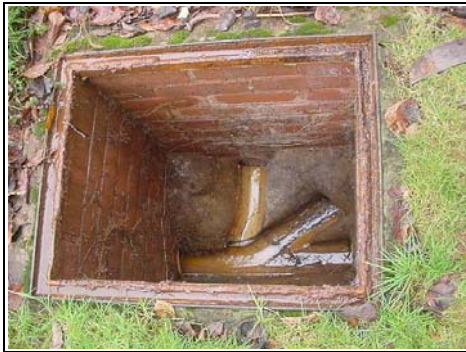
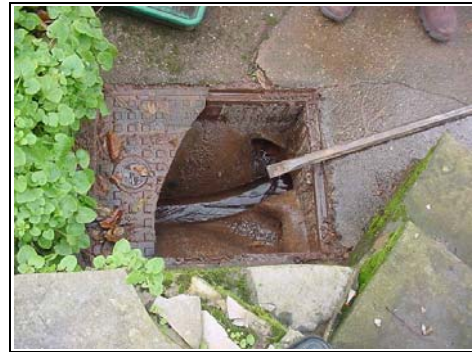
It would be interesting to know where the drains to the front of the property run and also why there appears to be a high level of water in them, other than the explanation which we discussed in that there are traps in them, which is most unusual for rainwater.

Neither of the brick side or the concrete haunching of the manholes look to have been affected
