# **SPECIFIC DEFECTS REPORT**

**Relating to Dampness (as specified on page 3)**

**Victorian Terraced Property with Dampness in Fulham**

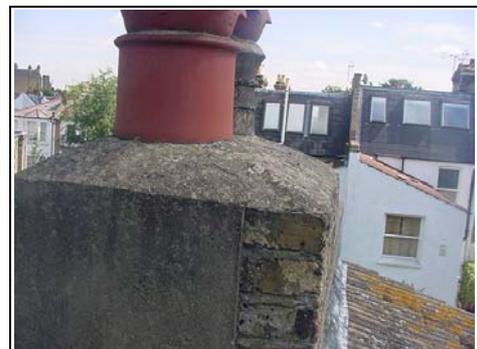
If you recall we discussed the possibility of water coming down the chimney either via the pots or via defective flashing on the top (the cement bit that holds the chimneys in) or the chimney itself.

Having inspected the chimney this would appear unlikely; however we are always surprised where wind driven rain can get!

Render to chimney in average condition

**ACTION REQUIRED:** We would recommend that the chimney is capped (assuming that neither you nor your neighbour are using it).

Capping involves the adding of paving slabs across the top, ensuring that there is a suitable drip, and adding airbricks to vent the chimney to avoid dampness at roof level, at first floor level and at ground floor level.

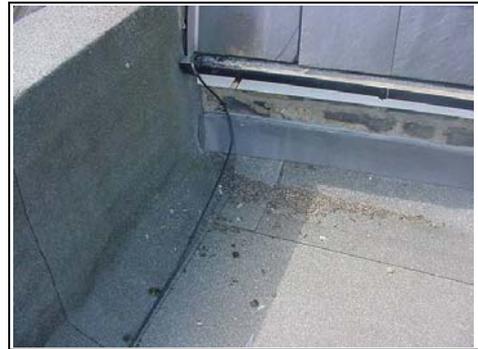
Both yours and your neighbour's flashings could be causing problems. Your flashing is a felt flashing and from its configuration the water could be coming in around this. Again, it is amazing how a little water causes a problem.

Felt flashing

**ACTION REQUIRED:** The flashings need to be replaced with lead flashings. We do believe this is an outside chance of where the dampness is coming from.

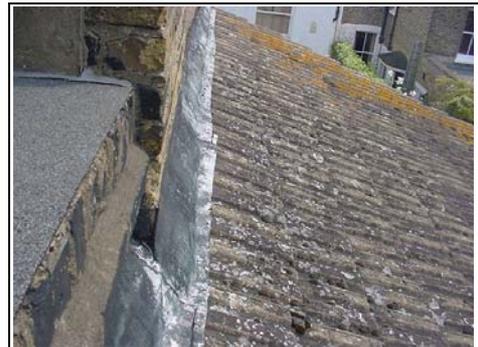
Alternatively, to your neighbour's side there is a Flashband (trade name) flashing, which is a temporary repair material which also could be allowing water in down the parapet wall.

Flashband repair to next door's roof

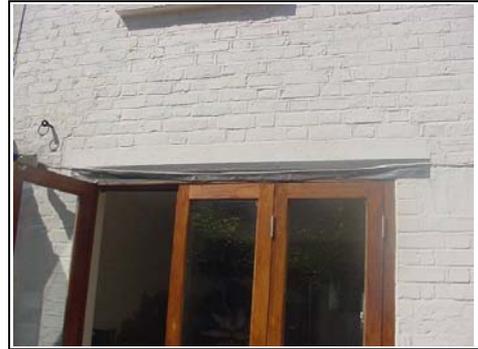
You have dampness around the base of the French doors and the reveal. The correct solution would be to remove them, check the vertical damp proof course, reposition it if required, reinstall the French door with a rebate of approximately 50mm (2 inches), and add a drip over the door. But, as you are about to be renting the property, the practical solution would just be to add a drip over the door and to redo the mastic joints.

Movement visible above the door – stepped diagonal pattern from the lintels. Also drip detail needs to be improved and / or the doors set within the frame and a vertical damp proof membrane added.

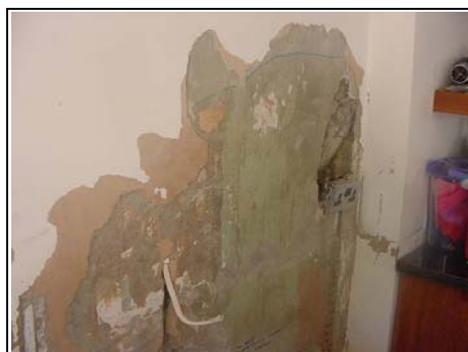
We found a mixture of rising damp and penetrating damp with minor lateral dampness to the left hand side wall. Our readings may have been distorted slightly by the pipework within the wall (you advised us it was a hot water pipe) but we believe there is an element of lateral dampness coming down the left hand painted wall which we believe relates to the gutters above and the poor flat roof detail.

**ACTION REQUIRED:** To solve the problem completely a new drip detail would need to be added to the roof. We believe the only way to carry this out properly is to use a lead roof detail which would involve re-roofing the entirety of the roof, which would be good as you could add a proper fall to it, but expensive. We also feel that the guttering may have to be realigned to ensure it is catching all the rain.

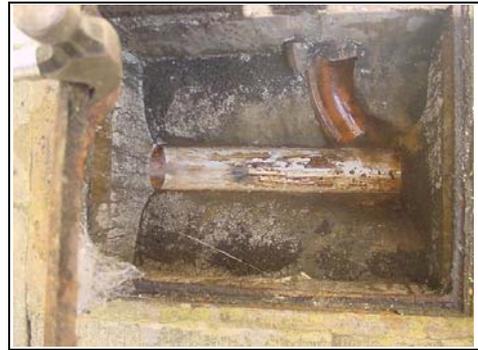
Next door's drains.

We could see that these have not been lined.

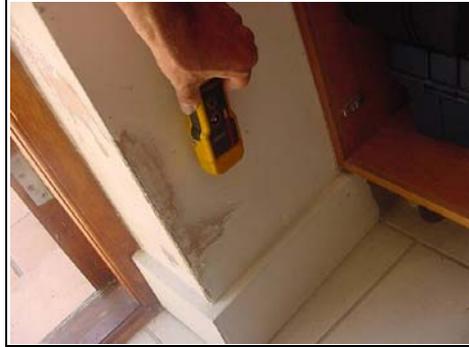
We detected rising damp to the rear walls and also lateral damp to the wall around the French doors.

Rising damp to the French door

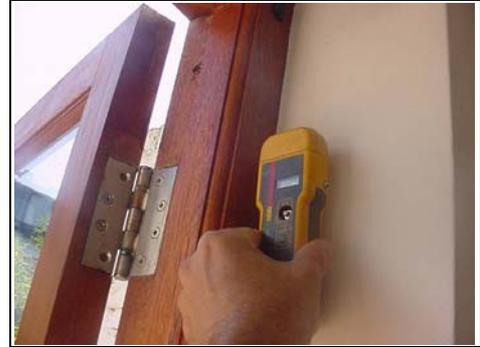
Dampness coming in via the frame.

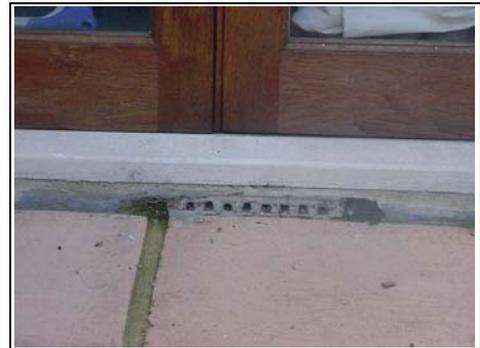
The airbricks to the rear are blocked and partially blocked to the front.

Blocked airbricks to suspended timber floor

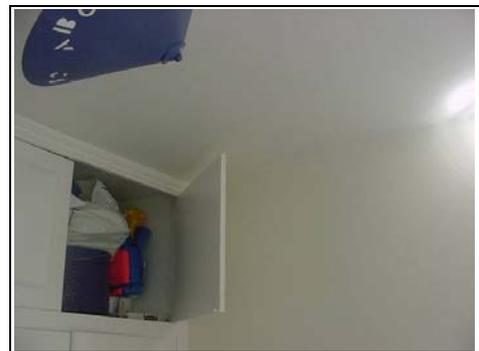
Blown plaster, particularly around the built-in cupboards, is likely to be from rainwater discharging from the roof to the gutter above. Please see our comments with regard to this in the ground floor section.

Blown plaster to left hand side wall

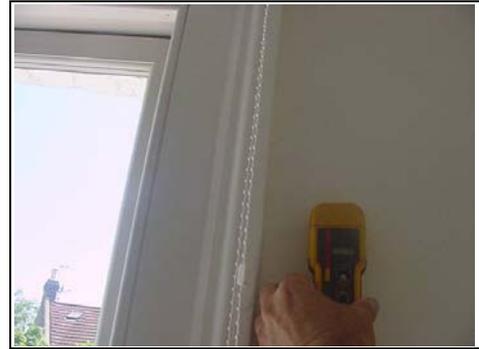
We noted some minor blown plaster, probably typical for this age of plaster.

Minimal dampness to rear wall

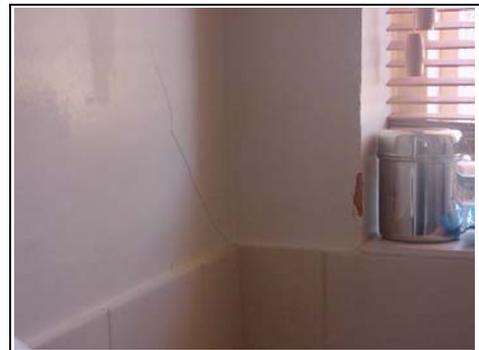
We noted signs of water penetration to the left hand side wall, which we believe relates to the poor roof detail.

There is diagonal cracking to the bathroom wall. We have spoken about the mixing of materials below. This is always difficult to resolve. We have found that a mastic or pliable filler is best in these cracks, then, of course, you need to resolve the water coming down the outside of the wall.

Diagonal cracking to bathroom wall

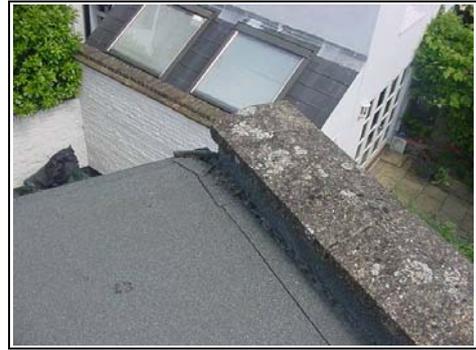
However, we can say that the drip detail to the left hand edge (all directions given as you face the property from the front) encourages the water to travel down the wall. Also, from the moss and lichen patterns we can see that water is discharged in certain areas off the flat roof. We would literally have to be there when it is raining heavily to be able to

Small lip to the parapet wall at the end of the flat roof does not resolve the problem of rainwater discharging down the length of the left hand wall. A proper drip needs to be formed.

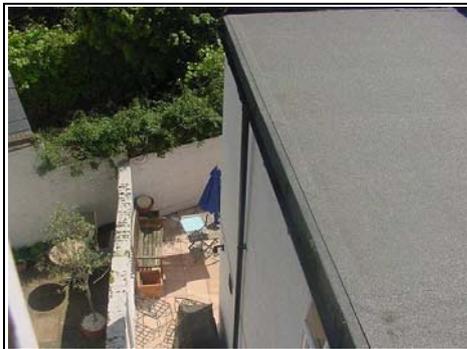
Edge of your flat roof

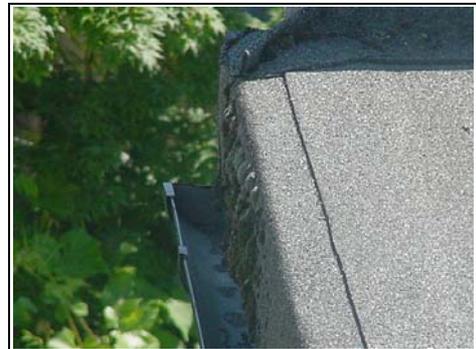
Close up of your flat roof

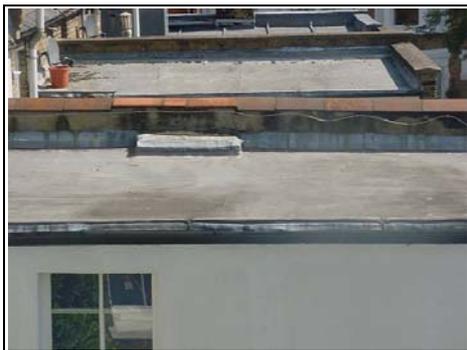
Neighbouring roof that has a better drip detail

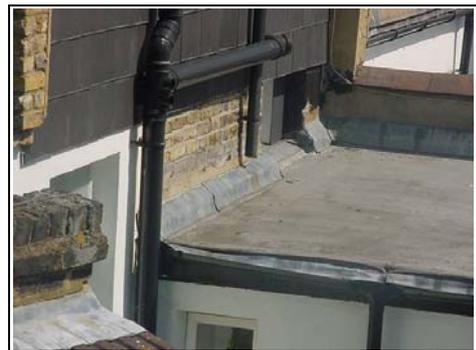
Close up of neighbouring flat roof
