PROPERTY REPORT

London Borough of Lewisham

This is a two storey office block set within a larger complex which includes shops and other office areas with a range of businesses. There is a loading and off-loading area to the rear of the property that has a security gated entrance. The front of the property sits directly onto the pavement; the rear of the property gives access to the loading area.

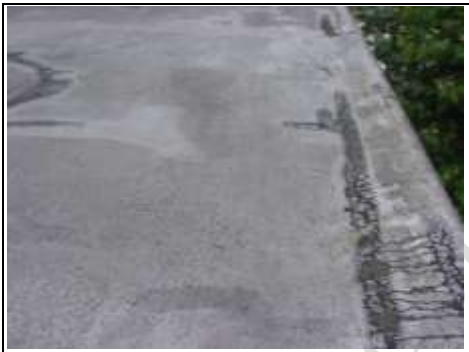
Above the offices is a flat roof construction, we can see that these have been repaired many times and we can also see from neighbouring roofs that repairs are still being carried out on a regular basis. The photos highlight three different types of problems:

- 1) Deteriorating asphalt
- 2) Blisters to asphalt
- 3) Previous poor quality repairs to the asphalt
- 4) In addition to this we would add that the solar paint is deteriorating (this protects the asphalt from deterioration from sunlight).
- 5) Detailing around roof lights and upstands.

Deteriorating asphalt

We would add that the flat roof is very flat, in our opinion too flat, and doesn't fall towards the two outlets (to drain the rainwater away) that we found on your roof. In addition to this, it is very common for these outlets to be blocked if there isn't enough fall on the roof to clear them. Internally surprisingly leaks can only be visually seen in the storeroom adjacent to the toilet at present, we would expect more leaks.

ACTION REQUIRED: Insulation cut to falls could be added to the roof with a high performance felt to resolve both the flatness of the roof problems, the energy efficiency and the roof water leaking. This would normally be landlord's work but we feel would offer an ideal solution.

ANTICIPATED COST: In the region of £10,000 - £20,000; please obtain quotations. You should draw your landlord's attention to the need for roof work.

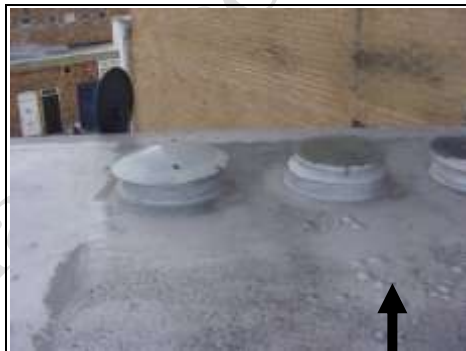
Blistering to asphalt

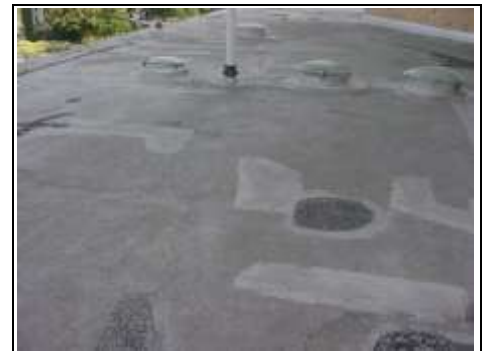
Previous repairs to asphalt

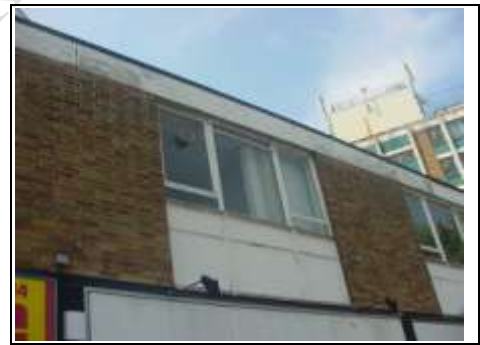
There are single glazed metal windows that are in a poor condition needing redecoration. We generally find that metal windows do warp and become difficult to open and shut over time and they can also be subject to condensation. As they are single glazed the property is poorly insulated.

Windows in need of redecoration

ACTION REQUIRED: Redecorate existing windows, ideally these windows should be appropriately secondary glazed. We note in many areas there is older style secondary glazing. A modern office would have double glazing.

ANTICIPATED COST: This would be a landlord's improvement costing tens of thousands of pounds. There may be a compromise where you insulate the lower part of the window (the part which is painted over) with something like a Kingspan insulation. There are varieties of this solid style insulation which have plasterboard finishes to them already. Please obtain quotations.
