SPECIFIC DEFECTS REPORT

Relating to dampness

Highbury,
London N5

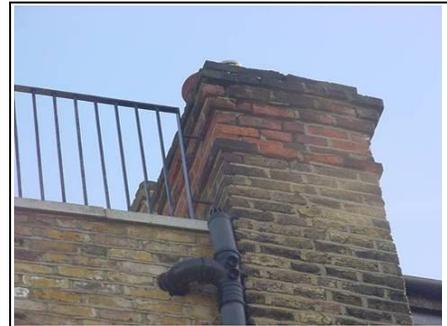
- 1.1 The chimney has been incorrectly repointed in a cement mortar. This tends to mean water gets trapped within it, particularly the softer red brick, and also some of the brickwork is starting to spall, therefore the bricks are more susceptible to drawing in dampness, particularly the red bricks.

Repointing to rear chimney

ACTION REQUIRED: We would recommend repointing of the chimney and the installation of a chimney pot that rain cannot go directly into.

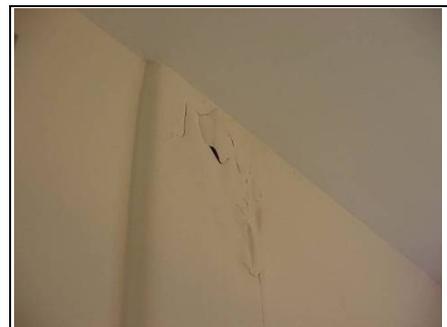
- 1.2 It may also relate to a leak in the roof above. A water test or thermal imaging will be required to check and confirm this.

Dampness to study rear left hand wall

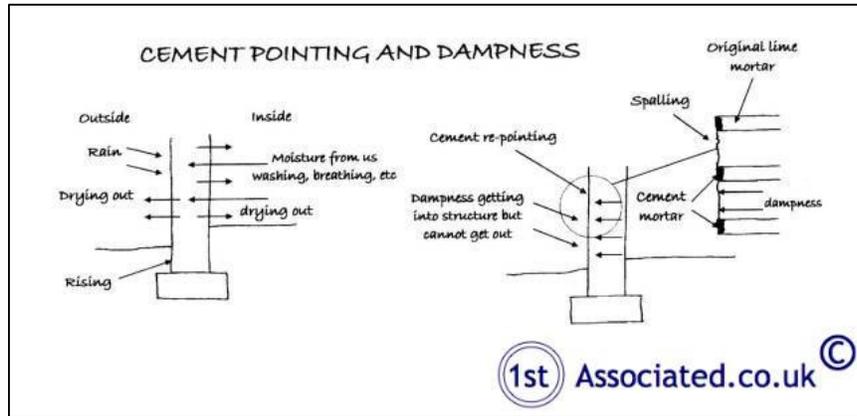
- 1.4 It may relate to a defect on your neighbour's side.
- 1.5 The parapet wall coping stone around the flat roof drips, are not sufficient to throw the water away from the roof and we could not identify a damp proof course.

The above sketch shows how dampness dissipates in a solid wall and how the use of cement is effectively allowing this to happen.

We would remove the coping stones and add a damp proof course and then add new coping stones with appropriate drips.

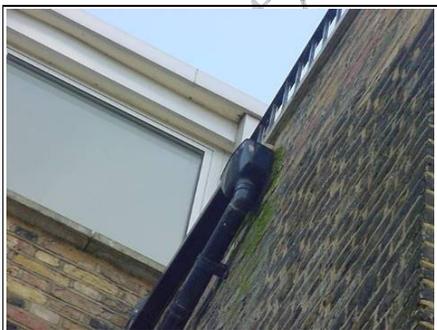
- 2.1 Rainwater goods and particularly the hopper head not being able to cope with the rainfall and therefore discharging down the wall and coming in.

Hopper head too small and overflowing

ACTION REQUIRED: We would recommend a much larger hopper head; you may well have to have one purpose made. Ideally we would recommend larger downpipes but as you advised you would like to limit the cost to avoiding scaffolding this may not be possible, we feel a larger hopper head would improve matters.

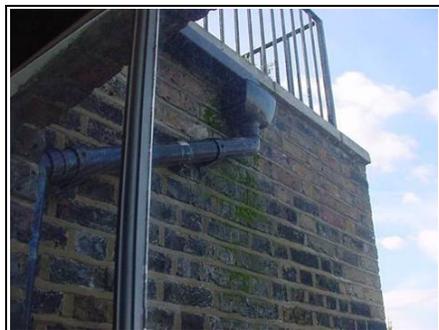
Close up of hopper head. Mossing around hopper head indicating it is overflowing and leaking
Independent Chartered Surveyors

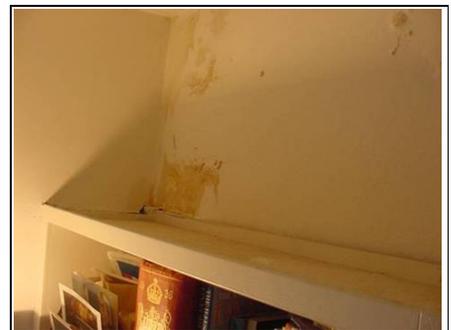
Dampness to study rear right hand side, believed to be partly caused by the hopper head

Within the study we would recommend that you add a false wall. As mentioned you could use tinted glass that we have seen before and more light to illuminate at high level, which is a nice way of lighting a room and the small false wall will allow you space to add concealed wiring.

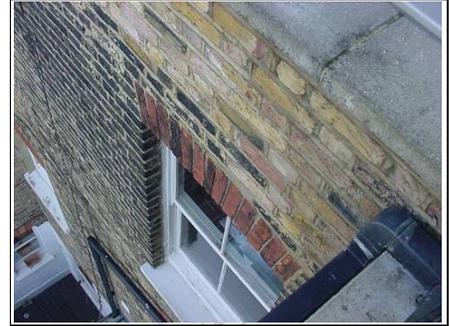
2.4 Sorry to repeat ourselves but the parapet wall coping stone around the flat roof drips are not sufficient to throw the water away from the roof and we could not identify a damp proof course.

Leaking joints from coping stone

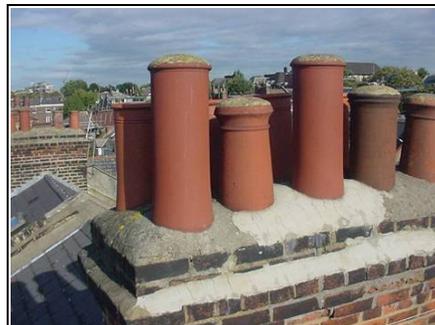
We believe the dampness is coming via the capped chimney that is to the right hand side of the main property. The chimney has been repointed in a cement mortar and has spalling brickwork, particularly the red brickwork. In addition to this it has been capped and therefore should be vented to reduce dampness and the haunching across the top looks to have been repaired (where you can see the lighter cement).

Capped chimneys, therefore chimney needs venting

ACTION REQUIRED: Again, we would recommend repointing and adding vents to the chimney.

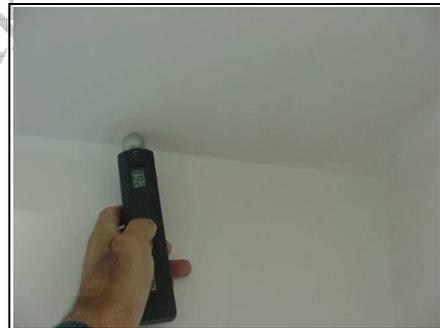
Readings in 90's taken with damp meter in top bedroom

Room	Readings Obtained	Typical Readings
Left hand wall (chimney wall)	92 and 95	40 to 60
Right hand wall (hopper head wall)	95 and 98	40 to 60
Study	90's	40 to 60

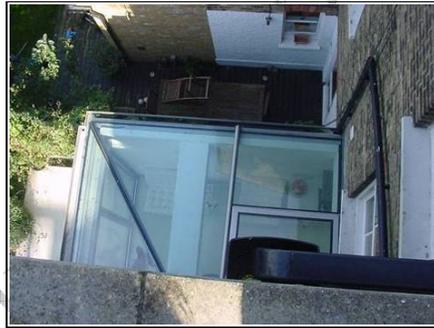
Water discharging from top roof into the hopper head which is too small – it will be a delicate operation to put a new hopper head on due to the glass roof below.

With regards to the rainwater goods the hopper head simply cannot cope with the amount of water going into it. We feel a larger hopper head would be very beneficial but do make sure it is securely fixed and ideally put a leaf guard over as the last thing you want is the hopper head rotting and filling up with water when it is situated over your glazed roof.

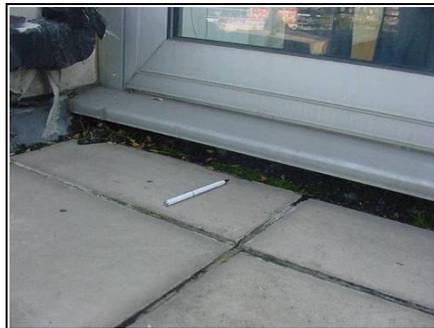
Our initial thoughts on the detailing of the bedroom flat roof is that it is poor. For example, it is flat and does not fall sufficiently towards the outlet and therefore allows water to sit upon it, which is a scenario we never like. We much prefer to remove water as quickly as possible and we prefer pitched roofs. If you do wish to sit out on it then put a framework above that is level.

Moss sitting on roof indicating fall not sufficient to take water away
