SPECIFIC DEFECTS REPORT

Relating to Condensation

XXXX London. N6 XXX

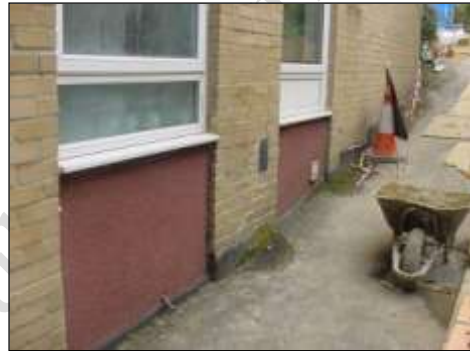
Dampness and moss sitting against the property

1. the location and surrounding environment such as trees and close proximity of other large properties which affects air circulation and air movement which means the building is not dried and also as it sits on a sloping site in a semi valley micro-climate situation.
2. The building construction
3. What your neighbours are doing in their properties.

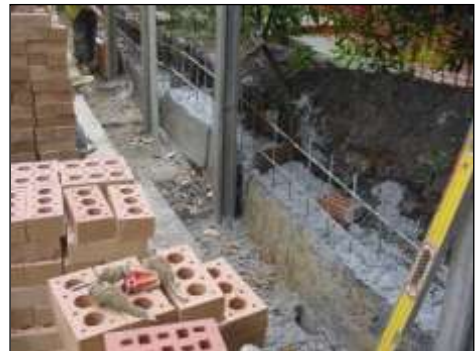
We would comment that a new factor that is introduced that may be effecting how ground water moves around your property which in turn will be effecting the ability of the walls and floor (remembering it is a concrete floor which acts like a sponge) to adjust and adapt to the moisture is the building of the party boundary wall with the far deeper foundation that it would have originally had which would have changed the path that the water takes.

Wall possibly redirecting the water

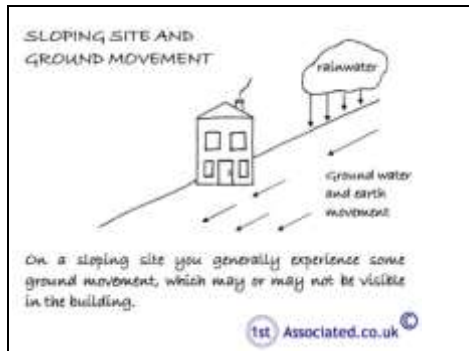
Sloping site

The building sits on a sloping site, water needs to get from the top to the bottom and the building is in between.

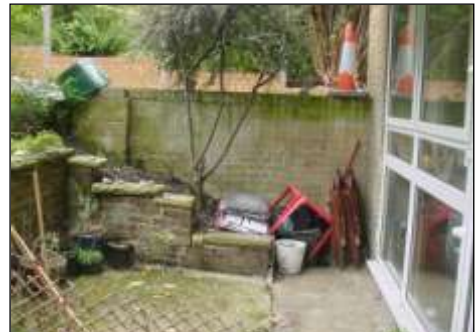
No weep holes present.

Retaining wall with no weep holes therefore water is being diverted

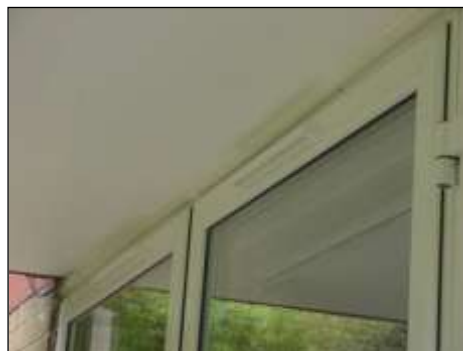
Trickle vents

We recommend fully openable windows the present windows are not good quality (apologies we forgot to check this). Can the kitchen and bathroom windows open fully?

ACTION REQUIRED: Look into changing the windows to have an openable top light as this would encourage the airing of the bathroom and the kitchen.

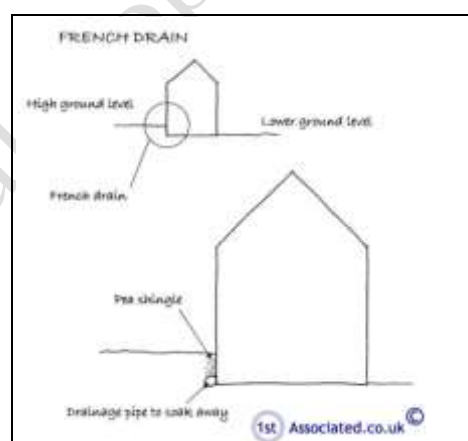
Construction as described on the front elevation in addition to this there is a driveway running down the side on the sloping site, this means part of the building is below ground level therefore we would recommend a French drain (note our comments in the Appendices and how not to make into a pond).
