INITIAL FINDINGS REPORT

Relating to damage to extension floor timbers.

XXX
Barnet, Hertfordshire.
EN5 XXX

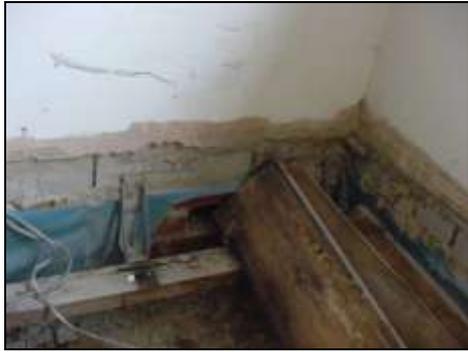
Corner airbrick from within the extension

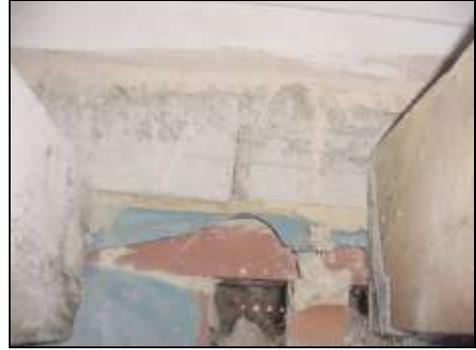
- 2) The construction detailing would appear to be the cause of the wet rot and in particular the covering of the airbricks and the water table level would have aided the problem with wet rot.

Partially blocked airbrick

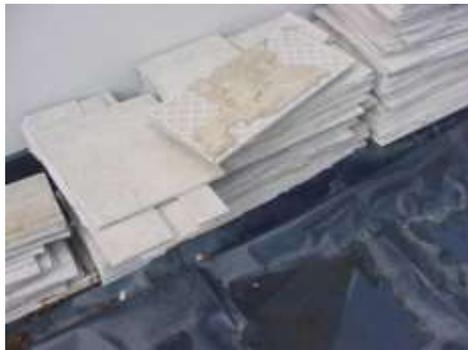
Floor tiles that have been removed

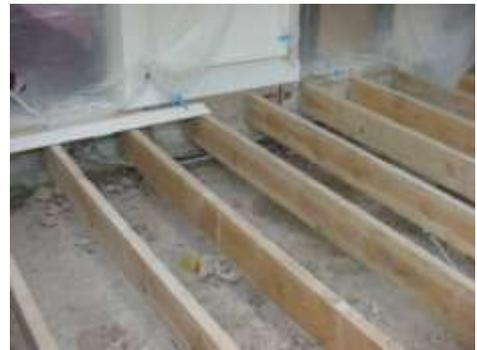
Floor joists in kitchen running from side to side

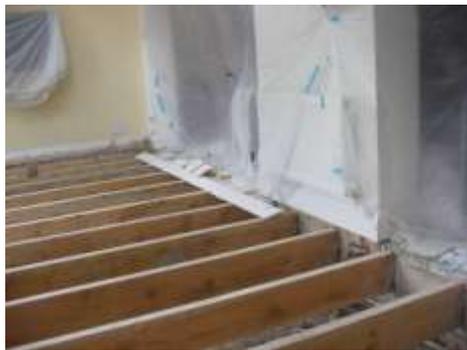
Breakfast room joists run from front to back

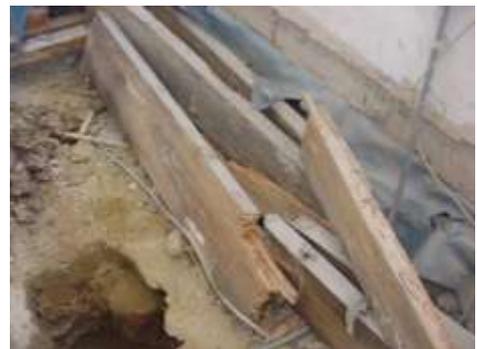
Decaying timber

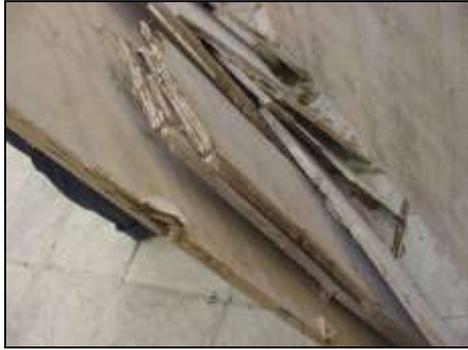
Decaying timber decking stored outside

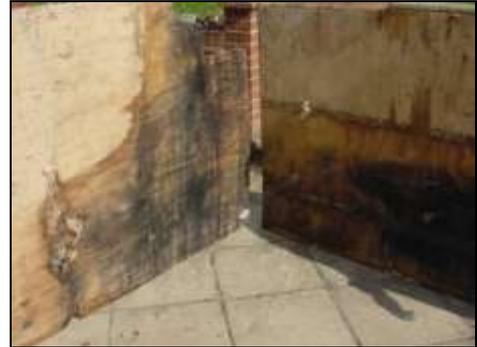
Underside of decking showing deterioration around the white goods area

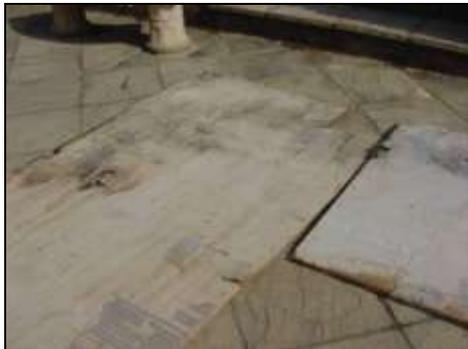
Ply wood formed decking set on outside paving showing signs of deterioration

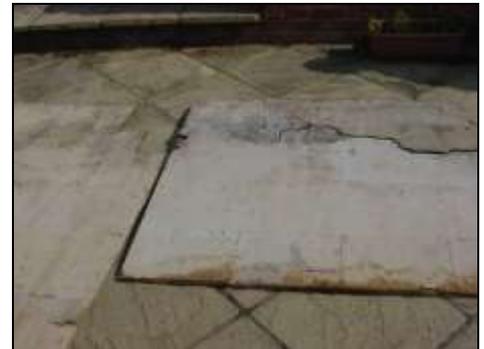
Ply wood formed decking set on outside paving showing signs of deterioration

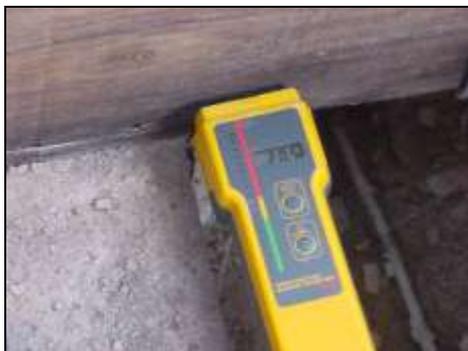
Proto meter damp meter reading 20.5

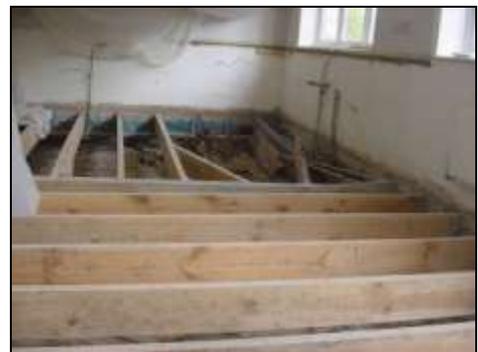
Overview of floor

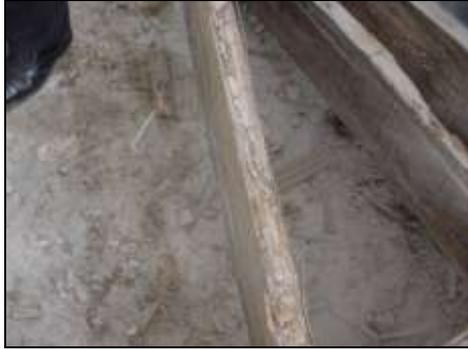
Deteriorating floor joists kitchen side

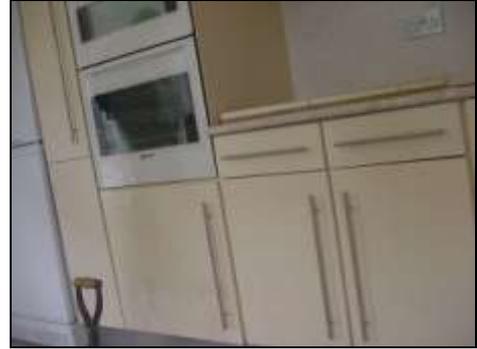
Example of kitchen unit still present

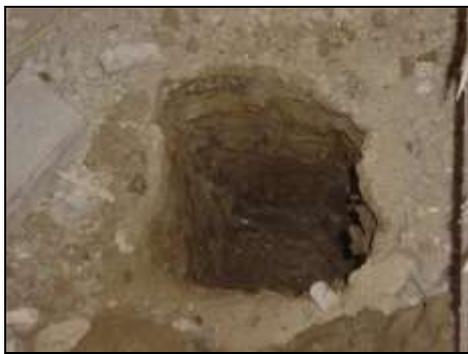
New trial hole to establish water table level

- iii. Sub floor – the sub floor consisted of a oversight although this was shown not to be very deep when trial holes were dug at the time of our inspection.

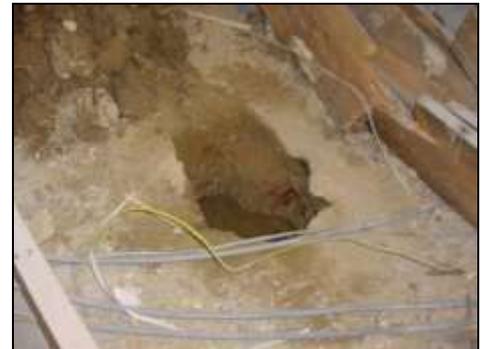
Previous trial hole

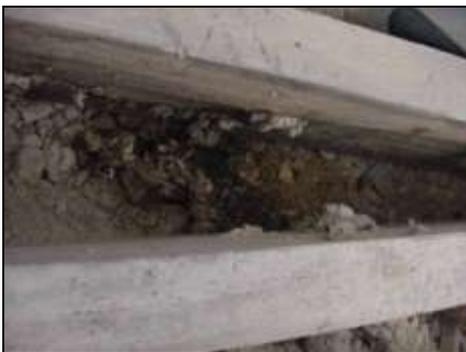
Fruiting body

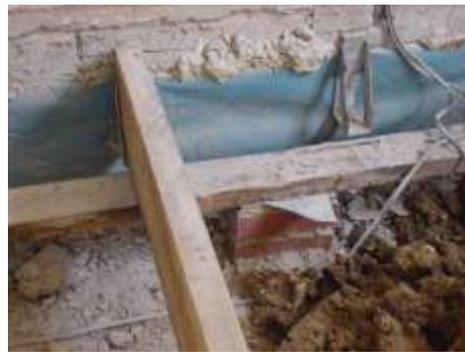
Support to the joists – is it called a honeycomb floor??????

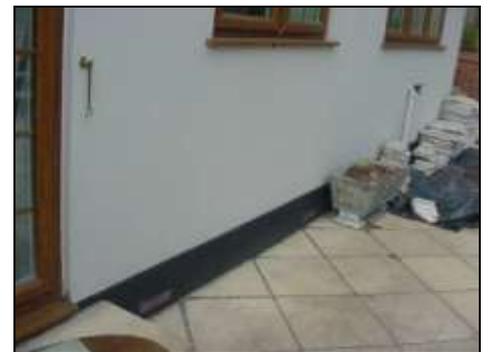
Airbricks to rear

1. From our visual external inspection we noted:
 - i. Walls – we noted airbricks slightly lower than we would expect and we also noted it was on a sloping site
