SCHEDULE OF CONDITION

Office

Reading, Berkshire. RG1

Prospective Tenant: Mr X

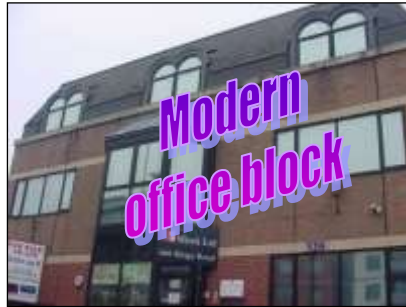
Front elevation

DESCRIPTION	CONDITION	ACTION REQUIRED
<p>Roofs:</p> <p>Man-made slate Mansard style roof with a flat roof section not visible</p>	<p>Visible from ground level Signs of moss to the slates Ponding and deterioration</p>	<p>Clear moss Make the roof watertight</p>
<p>Gutters and Downpipes: Guttering to the flat roof</p> <p>Box gutter detail</p>	<p>This is leaking Leaking, damp patches in some areas, clearing of moss and debris needed.</p>	<p>Ensure all gutters are watertight and falling towards the downpipe. Repair and secure as necessary, ensure downpipes are clear.</p>
<p>Walls: Stretcher Bond brickwork</p> <p>Structural frame</p>	<p>Pattern staining</p> <p>Not inspected</p>

<p>Resolve problems with gutters</p>
<p>External Detailing: Windows: Timber double glazed</p>	<p>De-grading with moss visible to many windows</p>

<p>Repair, prepare and redecorate.</p>

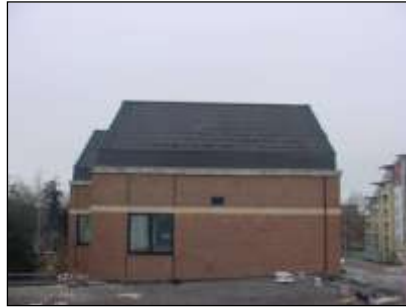
Left hand side elevation

DESCRIPTION	CONDITION	ACTION REQUIRED
<p>Roofs:</p> <p>Man-made slate Mansard style roof with a flat roof section not visible</p>	<p>Visible from ground level Signs of moss to the slates Ponding and deterioration</p>

<p>Clear moss</p> <p>Make the roof watertight</p>
<p>Gutters and Downpipes:</p> <p>Guttering to the flat roof</p> <p>Box gutter detail</p>	<p>This is leaking</p> <p>Leaking, damp patches in some areas, clearing of moss and debris needed.</p>	<p>Ensure all gutters are watertight and falling towards the downpipe. Repair and secure as necessary, ensure downpipes are clear.</p>
<p>Walls:</p> <p>Stretcher Bond brickwork</p> <p>Structural frame</p>	<p>Areas of efflorescence visible indicating that the wall is constantly wet.</p> <p>Not inspected</p>	<p>Repair, prepare and redecorate.</p>
<p>Windows: Double glazed timber Doors</p>	<p>Suffering from moss and de-grading</p>	<p>Repair, prepare and redecorate.</p>

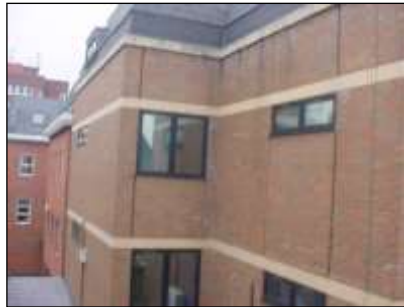
Rear elevation

DESCRIPTION	CONDITION	ACTION REQUIRED
<p>Roofs:</p> <p>Man-made slate Mansard style roof with a flat roof section not visible</p>	<p>Visible from ground level Signs of moss to the slates and some have slipped Ponding and deterioration</p>

<p>Clear moss</p> <p>Make the roof watertight</p>
<p>Gutters and Downpipes:</p> <p>Guttering to the flat roof</p> <p>Box gutter detail</p>	<p>This is leaking</p> <p>Leaking, damp patches in some areas, clearing of moss and debris needed.</p>	<p>Ensure all gutters are watertight and falling towards the downpipe. Repair and secure as necessary, ensure downpipes are clear.</p>
<p>Walls:</p> <p>Stretcher Bond brickwork</p> <p>Structural frame</p>	<p>Areas of efflorescence visible indicating that the wall is constantly wet.</p>	<p>Repair, prepare and redecorate.</p>
<p>Windows: Double glazed timber</p>	<p>Suffering from moss and degrading</p>	<p>Repair, prepare and redecorate.</p>

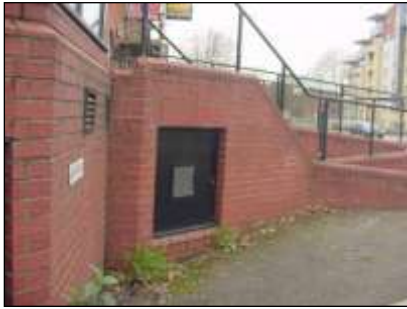
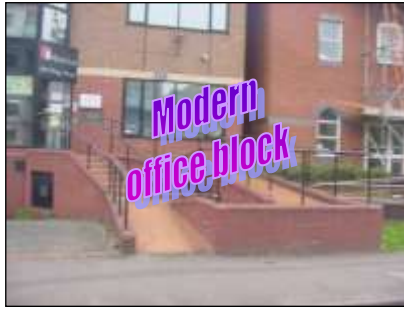
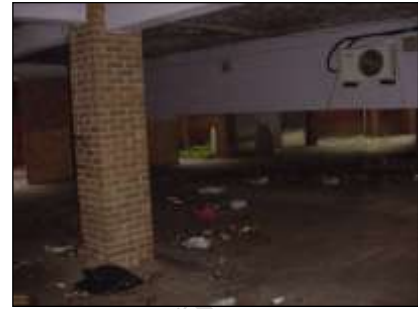
DESCRIPTION	CONDITION	ACTION REQUIRED
Access stairs and ramp: Tiled	Defective tiles, some cracking, broken and missing. Tiles are slippery when wet and not appropriate for an outside entrance area	Repair. Replace all the tiles to make the tiles safer for pedestrian traffic
Parking Tarmac - Front	Area slopes towards building, vegetation growing	Add running gully to ensure that water is taken away from the building

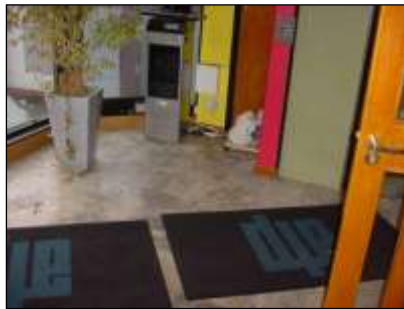
Reception

DESCRIPTION	CONDITION	ACTION REQUIRED
Ceilings: Plasterboard Painted	Poor quality painting	Repair, prepare and redecorate.
Walls: Painted	Poor quality painting	Repair, prepare and redecorate.
Floors: Marble type	Slippery	Replace with a more suitable tile.
Joinery: Windows: Balustrades	Deterioration Marked	Repair, prepare and redecorate. Repair, prepare and redecorate.
Services: Lift	No access, not working at the time of our inspection	Service record required

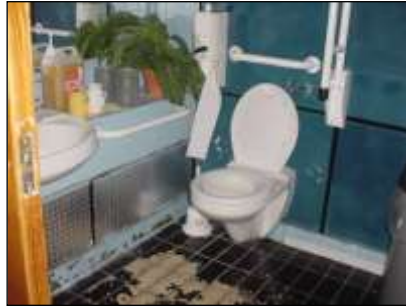
Less able/Disabled toilets

DESCRIPTION	CONDITION	ACTION REQUIRED
Ceilings: Small suspended tile with a hidden grid system	Dated	Clean
Walls: Floor to ceiling tiles Access panels to WC	Ingrained dirt	Deep clean
Floors: Tiles	Worn	Replace
Sanitary Ware WC and wash hand basin		Deep clean
Joinery: Door	Marked	Repair, prepare and redecorate.
Services: See Services section

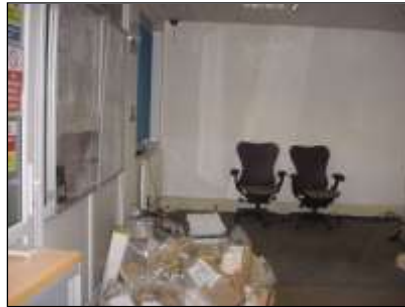
Middle office

DESCRIPTION	CONDITION	ACTION REQUIRED
Ceilings: Rectangular suspended ceiling system with visible grid	Some impact damaged tiles	Repair, prepare and redecorate.
Walls: Painted	Marked	Repair, prepare and redecorate.
Floors: Carpets	Marked	Clean and/or replace
Joinery: Windows	Degrading	Repair, prepare and redecorate.
Services: See Services section

Lots of stored items that limited our inspection

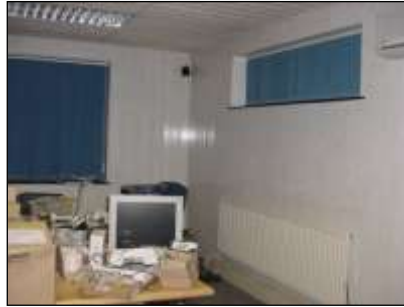
Office – left hand side

DESCRIPTION	CONDITION	ACTION REQUIRED
Ceilings: Rectangular suspended ceiling system visible grid	Some impact damaged tiles	Repair, prepare and redecorate.
Walls: Proprietary melamine wall system	Some marks	Repair, prepare and redecorate.
Floors: Carpets	Some marks	Clean and/or replace
Joinery: Windows Doors	Degrading Marked	Repair, prepare and redecorate. Repair, prepare and redecorate.
Services: See Services section

Lots of stored items that limited our inspection

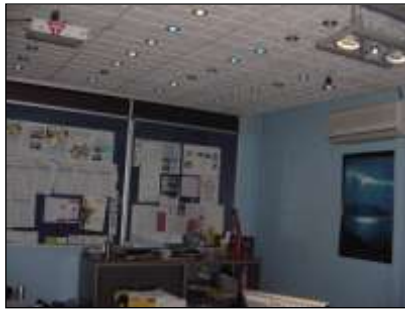
Office – right hand side

DESCRIPTION	CONDITION	ACTION REQUIRED
<p>Ceilings: Rectangular suspended ceiling system visible grid</p>	<p>Large number of ceiling lights inappropriate for most offices</p>

Lots of stored items that limited our inspection

<p>Replace ceiling grid and lights</p>
<p>Walls: Painted</p>	<p>Marked</p>	<p>Repair, prepare and redecorate.</p>
<p>Floors: Carpets</p>	<p>Marked</p>	<p>Clean and/or replace</p>
<p>Joinery: Windows</p>	<p>Degrading</p>	<p>Repair, prepare and redecorate.</p>
<p>Services: See Services section</p>

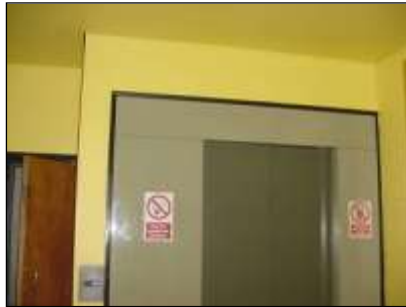
Stairs and Landing

DESCRIPTION	CONDITION	ACTION REQUIRED
Ceilings: Yellow painted plaster	Poor quality painting	Repair, prepare and redecorate.
Walls: Yellow Painted	Poorly painted	Repair, prepare and redecorate.
Floors: Carpet	Marked	Clean/Replace
Joinery: Timber staircase balustrade	Partly been painted over. Considerable wear.	Sanding back, make good and re-staining.
Window: Timber Splayed Bay, double glazed	Degrading. Moss to the outside	Repair, prepare and redecorate. Internally redecorate and repair some of the ironmongery.
Service Hatch:	Stored items	Remove

Services:		
Lift	Unable to access and not working	
Service duct	Hole

Repair

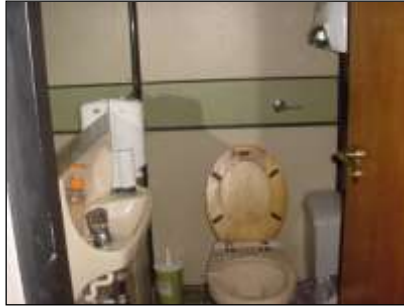
Gent's toilets

DESCRIPTION	CONDITION	ACTION REQUIRED
Ceilings: Small suspended tile with a hidden grid system	Marked	Clean
Walls: Tiles floor to ceiling – green and beige Removable access panels to rear of WC	Marked, ingrained dirt. Marked, ingrained dirt.	Deep clean Deep clean
Floors: Tiles	Worn. Ingrained dirt	Deep clean
Sanitary Ware WC and wash hand basin		Deep clean
Joinery: Door	Marked	Repair, prepare and redecorate.
Services: Lighting: 1970s style down lights Extract fan – not working

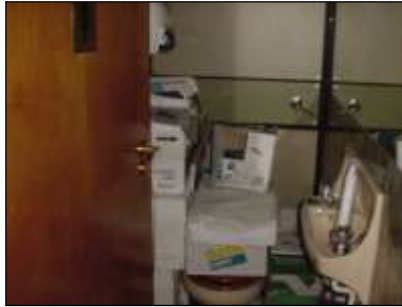
Ladies toilets

DESCRIPTION	CONDITION	ACTION REQUIRED
Ceilings: Small suspended tile with a hidden grid system	Marked	Clean.
Walls: Tiles floor to ceiling – green and beige Removable access panels to rear of WC	Marked, ingrained dirt.	Deep clean.
Floors: Tiles	Worn. Ingrained dirt.	Deep clean
Sanitary Ware: WC and wash hand basin		Deep clean
Joinery: Doors	Marked	Repair, prepare and redecorate.
Services: Lighting: 1970s style down lights Extract fan – not working

View restricted due to the stored items which need to be removed.

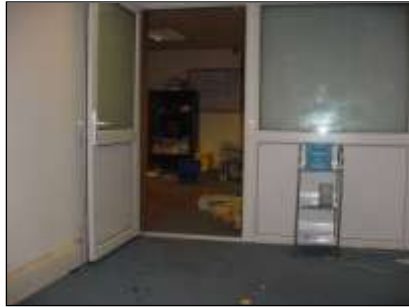
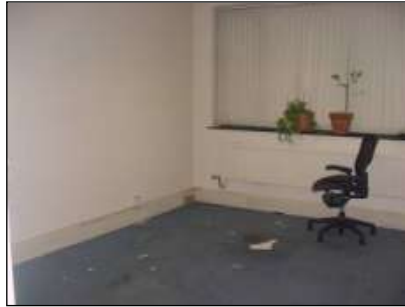
Small Office – right hand side

DESCRIPTION	CONDITION	ACTION REQUIRED
<p>Ceilings: Suspended ceiling system visible – rectangular</p> <p>Service Cover</p>	<p>Average, some marks and impact damage to right hand corner and some painting over the grid system</p> <p>Blocked and damaged</p>	<p>Repair, prepare and redecorate.</p> <p>Clear and fix</p>
<p>Walls: Painted</p> <p>Skirting – Painted</p> <p>Partition: Plastic</p>	<p>Hairline cracking underneath window.</p> <p>Average, marks to left hand wall and old fixing points that need making good</p>

<p>Marked</p> <p>Marked</p>	<p>Repair, prepare and redecorate.</p> <p>Requires redecoration</p> <p>Requires cleaning</p>
<p>Floors: Carpet tiles</p>	<p>Stained</p>

<p>Joinery: Windows: Large, rectangular with two opening lights</p> <p>Door: Partition door Double glazed door</p>	<p>Degrading. Moss on window outside</p> <p>Marked Needs removing</p>	<p>Repair, prepare and redecorate.</p> <p>Sand, restrain/replace. Remove</p>
<p>Services: Single panelled Radiator – needs redecoration</p>

<p>Clean/Replace</p>

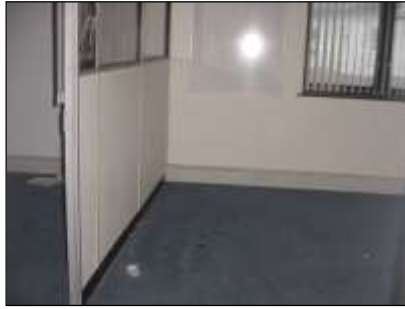
Left hand Office

DESCRIPTION	CONDITION	ACTION REQUIRED
Ceilings: Rectangular suspended ceiling system visible grid	Some impact damage particularly to the rear and right hand side	Repair, prepare and redecorate.
Walls: Painted Studwork partition Plastic studwork partition Skirting - Painted	Marked with holes Marked Marked Marked	Repair, prepare and redecorate. Clean Clean Clean
Floors: Carpet tiles	Heavily marked	Clean/ Replace
Joinery: Windows:	Degrading	Repair, prepare and redecorate.
Services: Two radiators – need redecoration

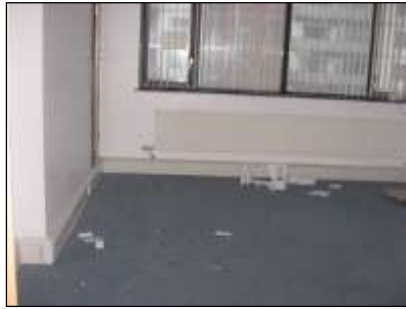
Two offices – left hand side

DESCRIPTION	CONDITION	ACTION REQUIRED
Ceilings: Rectangular suspended ceiling system visible grid	Some impact damage	Repair, prepare and redecorate.
Walls: Painted	Marked	Requires redecoration.
Partitioning	Marked	Requires redecoration
Plastic partition to right hand side	Marked	Clean/replace
Skirtings	Marked	Clean and redecorate
Floors: Carpet tiles	Heavily marked	Replace
Joinery: Windows: to rear and left hand side in both cases	Moss on window outside	Clear moss. Repair, prepare and redecorate.
Doors: Missing door to right hand partition	Missing door	Re-positioned or removed currently way it is hinged it will partially block the inner door
Services: See services section Radiator – rear radiator leaks – repair, paint.

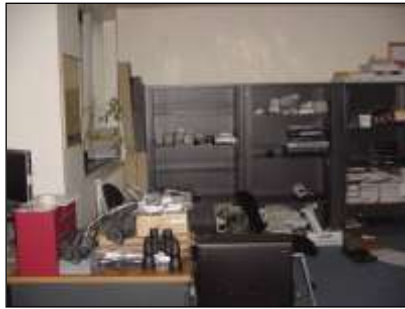
Middle Office

DESCRIPTION	CONDITION	ACTION REQUIRED
<p>Ceilings: Rectangular suspended ceiling system visible grid</p>	Some impact damage and painting of suspension system	Repair, prepare and redecorate.
<p>Walls: Painted</p> <p>White Board – left hand wall</p> <p>Skirting</p> <p>Rear Partition - plastic</p>	<p>Marked, hairline cracking to front left hand wall either side of the radiator, associated defects need to be excluded from the Lease</p> <p>Marked</p> <p>Ingrained dirt</p>	<p>Repair, prepare and redecorate.</p> <p>Remove</p> <p>Clean and redecorate</p> <p>Deep clean</p>
<p>Floors: Carpet tiles</p>	Heavily marked	Clean/Replace
<p>Joinery: Windows: Two high level windows</p>		
<p>Services: See services section</p>

Lots of stored items that limited our inspection

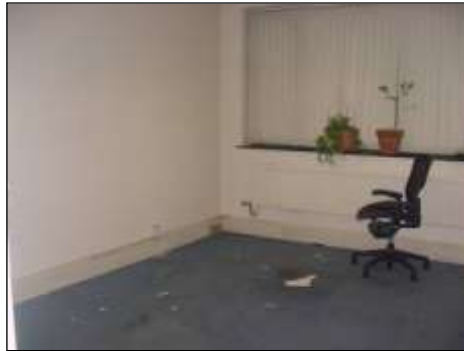
Office – right hand side

DESCRIPTION	CONDITION	ACTION REQUIRED
<p>Ceilings:</p> <p>Rectangular suspended ceiling system visible grid</p>	Some impact damage and painting of suspension system	Repair, prepare and redecorate.
<p>Walls:</p> <p>Painted</p> <p>White Board – left hand wall</p> <p>Skirting</p> <p>Rear Partition - plastic</p>	<p>Marked, hairline cracking to front left hand wall either side of the radiator, associated defects need to be excluded from the Lease</p> <p>Marked</p> <p>Dirty</p>	<p>Repair, prepare and redecorate.</p> <p>Remove</p> <p>Clean and redecorate</p> <p>Clean</p>
<p>Floors:</p> <p>Carpet tiles</p>	Heavily marked	Clean/Replace
<p>Joinery:</p> <p>Windows:</p>	Degrading	Repair, prepare and redecorate.

Services: See services section
Repaint radiators

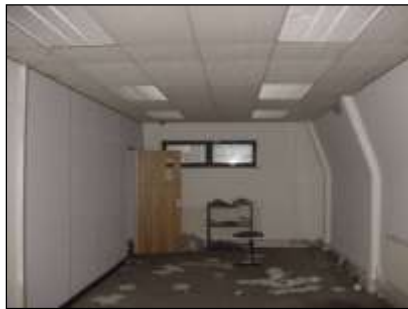
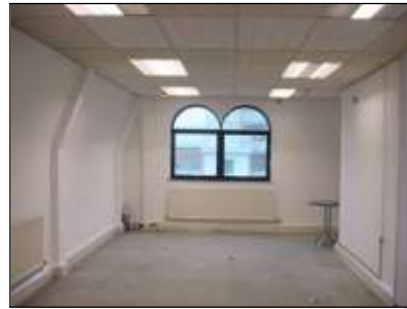
Office and Kitchenette – right hand side

DESCRIPTION	CONDITION	ACTION REQUIRED
<p>Ceilings: Rectangular suspended ceiling system visible grid – with inset lighting system</p>	<p>Damage to tiles to the front, new replacement tiles to the front and middle more damaged tiles to the middle left hand side. Likely cause – a roof leak?</p>

<p>Replace tiles. Repair, prepare and redecorate.</p>
<p>Walls: Painted Partition</p>	<p>Hairline cracking to rear walls. Some paint on the skirtings, partition and front and rear window frames. Staining to left hand side</p>

<p>Floors: Carpet tiles</p>	<p>Marked</p>	<p>Clean/Replace</p>
<p>Joinery: Windows: double arched to front, double glazed, timber</p> <p>Door:</p>	<p>Degrading. Moss externally. Accidentally painted over internally in white.</p> <p>Marked.</p>	<p>Clear. Repair, prepare and redecorate.</p> <p>Sand and make good.</p>
<p>Services: See services section Radiators – single panelled under front and rear windows, needs painting.</p>		
<p>Kitchenette area</p> <p>Stainless steel sink and drainer – note long drainage run</p>

<p>Repair, prepare and redecorate. Clean</p>

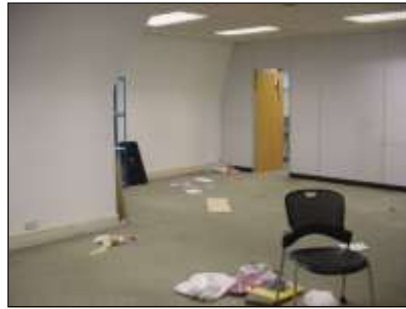
Middle Office

DESCRIPTION	CONDITION	ACTION REQUIRED
Ceilings: Rectangular suspended ceiling system visible grid with inset lighting system	Diffuser panels missing

Replace diffusers. Repair, prepare and redecorate.
Walls: Painted Two studwork dividing partitions	A section of wall where paintwork has been missed. Damp staining to rear left hand side. Marked

Repair, prepare and redecorate. Clean
Floors: Carpet tiles	Marked	Clean/Replace
Joinery: Windows: two set at high level	Degrading	Repair, prepare and redecorate.
Services: See Services section

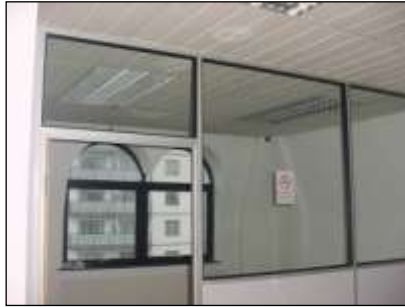
Small Office

DESCRIPTION	CONDITION	ACTION REQUIRED
Ceilings: Rectangular suspended ceiling system visible grid –with inset lighting system	Water leak damage centrally	Repair, roof and change ceiling tiles
Walls: Painted white Service skirting - Painted	Marked Poor painting	Repair, prepare and redecorate. Clean
Floors: Carpet tiles	Marked	Clean/Replace
Joinery: Windows: Two arched, timber, double glazed Doors: vision panels One access panel to service duct	Moss externally. Accidentally painted over internally in white.	Clear Moss. Sand, restaining. Repair, prepare and redecorate. Repair, prepare and redecorate.
Services: Radiator – single panelled needing painting. Service Cupboard, stored items, needs clearing

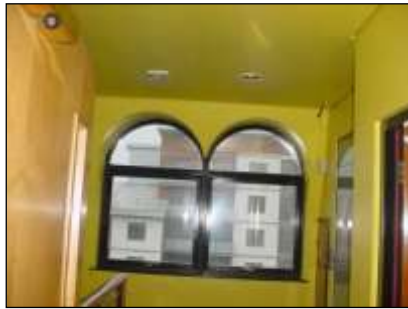
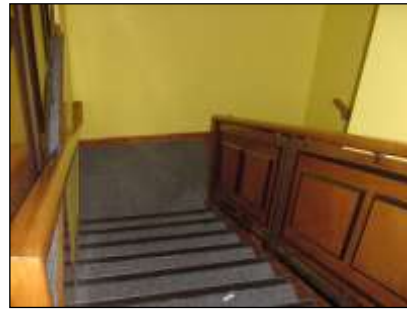
Landing and Stairs

DESCRIPTION	CONDITION	ACTION REQUIRED
Ceilings: Plasterboard with inset lights Access to roof	Painted over emergency light

Repair, prepare and redecorate
Walls: Painted yellow	Poor quality painting

Repair, prepare and redecorate
Floors: Carpet	Marked	Clean/Replace
Joinery: Timber staircase balustrade Windows: Arched, timber double glazed Fire Door: Two vision panels	Marked Degrading. Chipping around windows, moss covered.	Sanding back, make good and re-staining. Clear moss, make good. Repair, prepare and re-staining.
Services: Lift: Service Cupboard accessed via left hand office

Unable to gain access Stored items	Clear stored items.

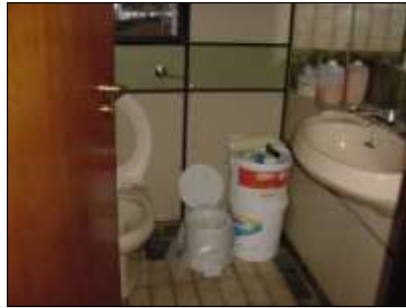
Shared toilets

DESCRIPTION	CONDITION	ACTION REQUIRED
<p>Ceilings:</p> <p>Small suspended tile with a hidden grid system</p>

<p>Dated</p>	<p>Deep clean.</p>
<p>Walls:</p> <p>Tiles floor to ceiling</p> <p>De-mountable partitions</p>	<p>Marked, ingrained dirt.</p> <p>One missing above the WC</p>	<p>Deep clean.</p> <p>Replace – found behind the door</p>
<p>Floors:</p> <p>Tiles</p>	<p>Ingrained dirt.</p>	<p>Deep clean</p>
<p>Sanitary Ware:</p> <p>Peach WC and vanity unit</p>	<p>Dirty</p>	<p>Deep clean</p>
<p>Joinery:</p> <p>Windows</p> <p>Doors</p>	<p>Marked</p> <p>Marked</p>	<p>Repair, prepare and redecorate.</p> <p>Repair, prepare and redecorate.</p>

Extract fan – dirty, needs cleaning
