COMMERCIAL BUILDING SURVEY

An Modern Office

GEM Associates Limited

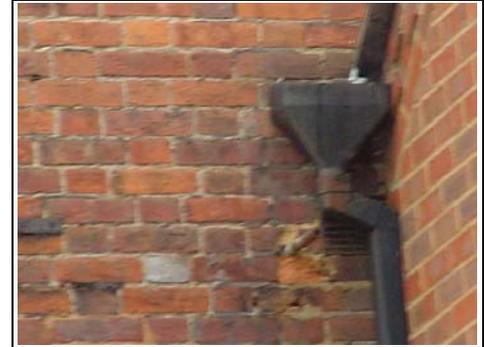
1) **Overflowing Hopper Head**

The hopper head is overflowing and discharging down the wall. This really needs to be seen when you next have a good downpour of rain. Also check to make sure it is your rain that is going into the hopper head!

ACTION REQUIRED: Probably a larger hopper head.

ANTICIPATED COST: In the region of £500 - £1,000, as we believe one may have to be purpose made.

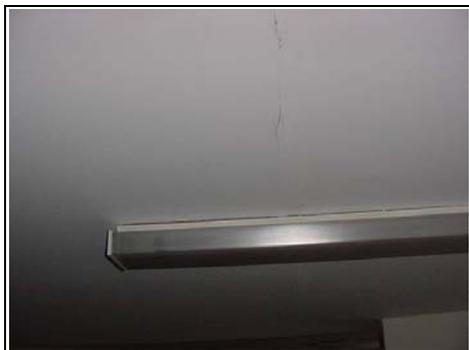
Throughout the property there is hairline cracking where movement has occurred for a variety of reasons. These reasons range from the differential movement that is occurring between the studwork, the solid walls and the ceilings which is also being added to by movement in the structure, to the hairline cracking in the kitchen area which appears to be from the point loading of the staircase above.

Hairline cracking to the ceiling.

ACTION REQUIRED: Fill and decorate, but expect the cracks to re-emerge periodically.

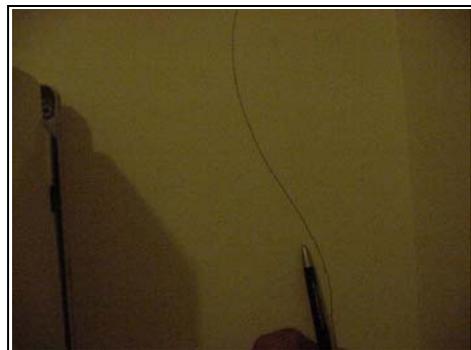
Hairline cracking to the walls.

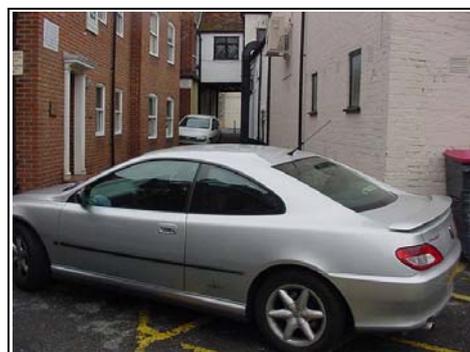
4) Parking!

We have spoken to the surrounding neighbours with regard to the parking and they have advised that there are problems with parking that have involved court proceedings, costs were mentioned of £35,000 and £70,000 respectively in regard to legal cases to establish who has rights of access and who has rights to park.

ACTION REQUIRED: You need to establish and be certain of your access rights and parking. Our understanding, from the discussions we have had, is that there is no parking or vehicle right of access to this property. You need to confirm and clarify this and make certain that you are happy to live with this.

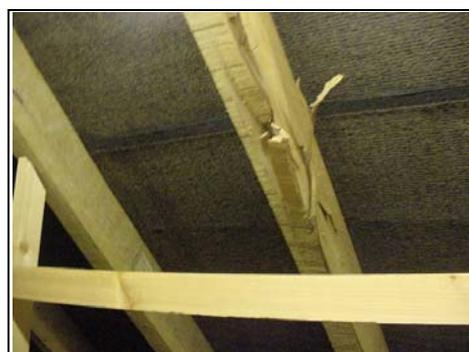
We found the roof timbers generally in reasonable condition, with the exception of a few twisted joists, which we believe relates to the defective flooring, which we have mentioned in the Executive Summary, which has been transferred through the structure. As you can see in the adjoining photo one of the common rafters has split. Ideally this should be replaced, but in this instance we would leave it as to replace it would be very difficult. When you have rectified the cause of the problem it should not be a further issue.

Slit joist, possibly due to movement in the structure.

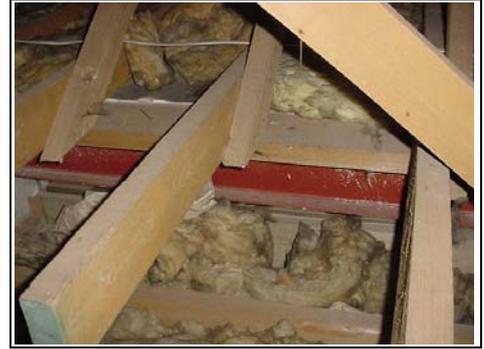
We were surprised by the amount of deflection in the first floor and we noted twisting in the roof timbers above, which does indicate the lintels (that we believe are steel) that have been used are not suitable for the loading required. In practical terms this will mean that you will not be able to have too many loaded filing cabinets in the room, particularly to the centre.

If you look closely the red 'I' beam is a steel lintel/joist running through the structure. There is likely to be a similar one where the office has been opened up.

ACTION REQUIRED: Please see our comments in the Executive Summary.

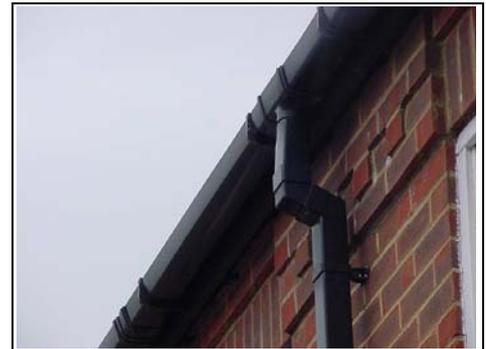
From ground level the gutters and downpipes looked to be plastic and appeared in reasonable condition, with the exception of the hopper head that is leaking and discharging down the wall. Please see our comments in the Executive Summary.

ACTION REQUIRED: We would always recommend that the gutters and downpipes are cleaned out, the joints are checked and the alignment checked to ensure that the gutters fall towards the downpipes. This is a DIY / handyman type job.

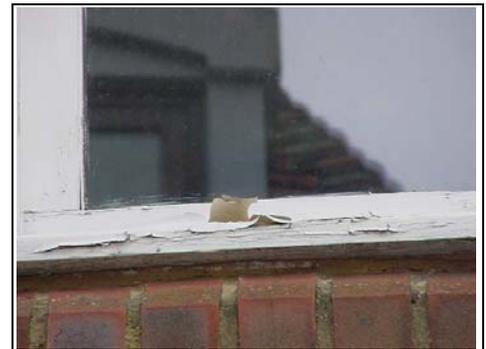
You have modern double glazed sliding sash windows. The paint is peeling on some of them and they would therefore benefit from redecoration in the next few years.

ACTION REQUIRED: Redecorate in the next few years.

ANTICIPATED COSTS: In the region of £1,000 - £2,000 with some minor repairs.

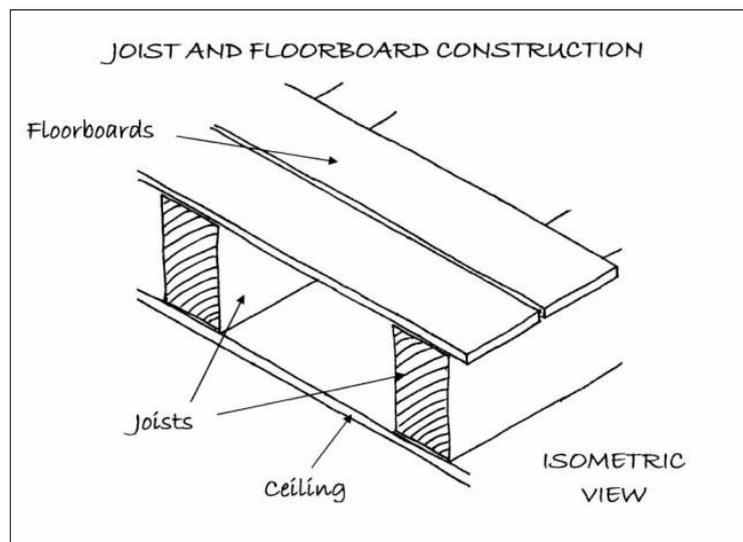
We noted excessive deflection. Please see our comments in the Executive Summary. We have not opened up the floor, but we do feel that it has an above average level of deflection; it is certainly more than we typically see. This can be for many reasons, from under sized timbers to lack of lateral restraint, to wet rot and woodworm. In this instance we feel it is likely to be due to the undersizing of the lintel and the timbers and the lack of lateral restraint.

We have checked the roof timbers directly above this area and found some twisting and splitting in one of the common rafters.

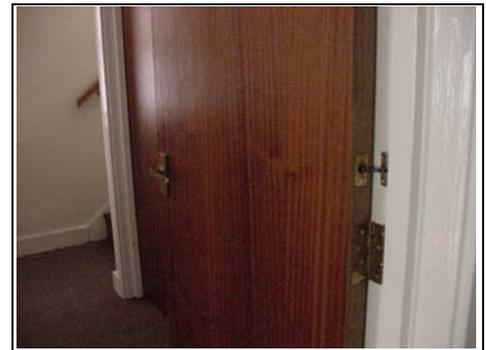
We noted that some of the doors have fire door closers, known by the tradename of 'Perco' door closers (see the right hand side of this photo). When you have your check carried out by a fire services company they will need to pick up whether any door closers require maintenance or whether any need adding.

ACTION REQUIRED: Door closers and doors to be checked by a fire services/maintenance company.

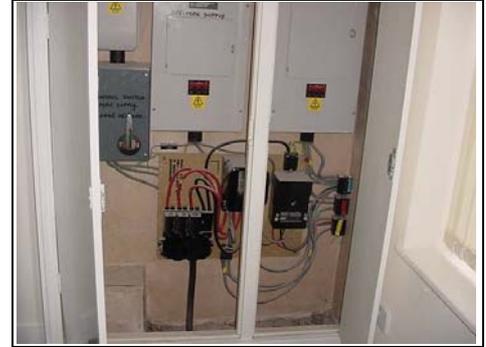
The electric fuses and consumer units were located in the services cupboard. We would date the fuse board as being from the 1980s and, whilst not the best now available, is reasonable.

ACTION REQUIRED: If there is no record of an electrical test having been undertaken within the last five years, it is recommended that the installation be tested by a competent electrician (NICEIC registered) and all recommendations implemented. Thereafter, the installation should be re-tested every five years.

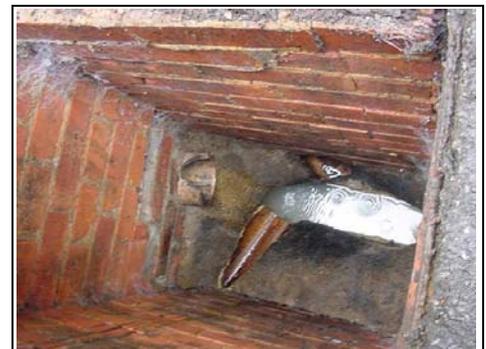
Manhole – Right Hand Side Middle

We duly lifted the cover and found it to be free flowing at the time of our inspection.

From what we could see it is brick built.
