COMMERCIAL BUILDING SURVEY OF A Nursing Home

FOR
Mr A Client

GEM Associates Limited

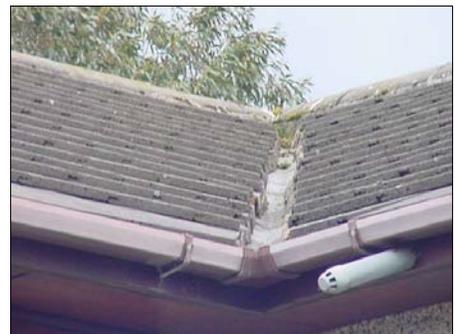
As is common on this type of property the valley gutters are starting to deteriorate slightly and would benefit from some future preventative work.

This photo shows an awkward valley gutter. This type of valley gutter is prone to leaking.

ACTION REQUIRED: Generally check the cement mortar to the ridges and sides of the valley gutters and repair appropriately. At the same time check the flashings and replace missing/damaged concrete tiles.

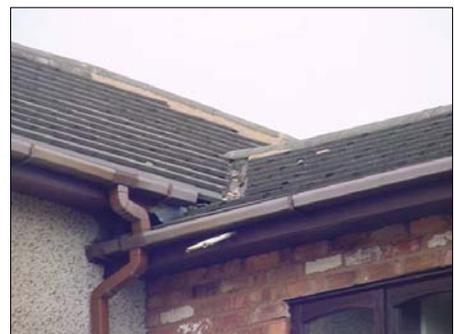
Deterioration is starting to occur to the ridge tiles.

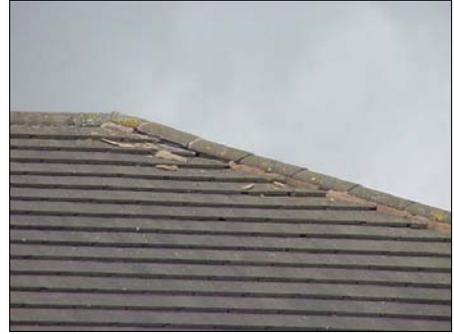
There are the occasional displaced tiles.

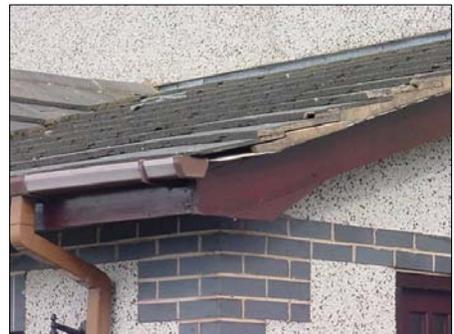
Cement Fillets Missing to Perimeter

A slightly different issue is the cement mortar that is starting to come loose to the perimeter of the tiles. We were surprised that the perimeter tiles were not clipped in place.

ACTION REQUIRED: We suggest you contact the original manufacturer and carry out investigations with regard to the correct detailing to these perimeter tiles. As the property is in a fairly exposed location it may be prudent to add tile clips.

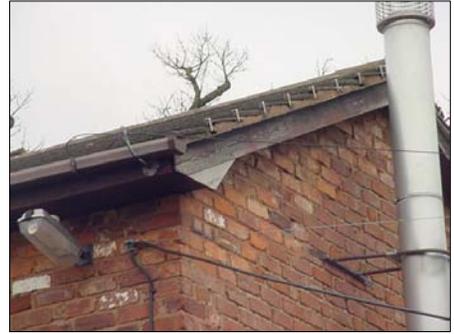
Tile clips were noted in some areas.

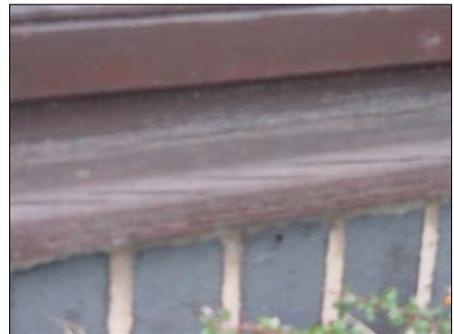
This photo shows a close up of one of the windowsills. The timber to the base is starting to crack and open up.

ACTION REQUIRED: It would be prudent to redecorate all external joinery, including the windows and fascia and soffit boards, together with some minor repair.

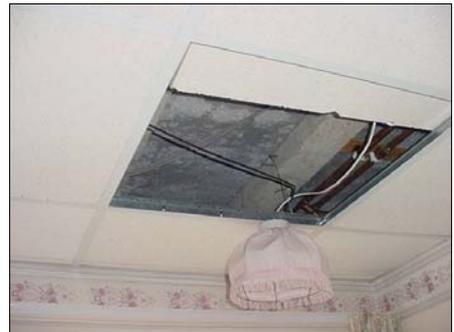
We believe this dampness is due to either a leak from the pipework or condensation from the pipework. We have opened up the ceiling but could not see any specific reason for the dampness.

This photo shows the staining to the underside of the beam and block floor.

ACTION REQUIRED: Further investigation is required.

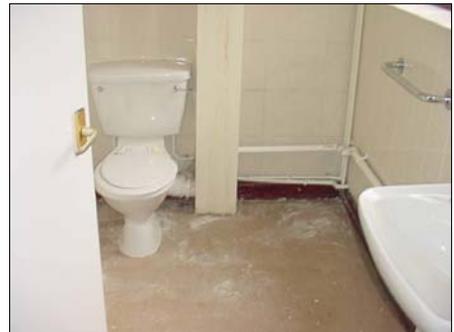
The leak was found to one of the first floor bathroom areas, which may have caused this dampness.

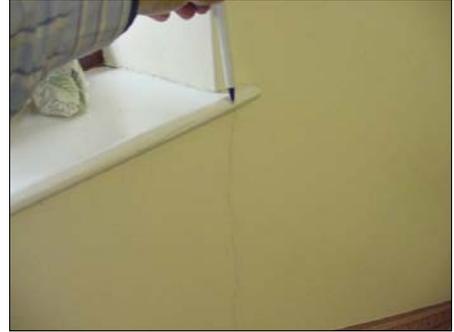
We were able to identify some hairline cracking in the property to the rear, indicating that there has been some movement, which may be due to initial settlement or the surrounding trees. It was simply not possible to tell from a one-off inspection.

In this photo the location of a vertical crack is indicated by our pen.

ACTION REQUIRED: We would recommend that an arboriculturist (not a tree surgeon) is asked to comment upon the trees and that any recommendations are carried out.

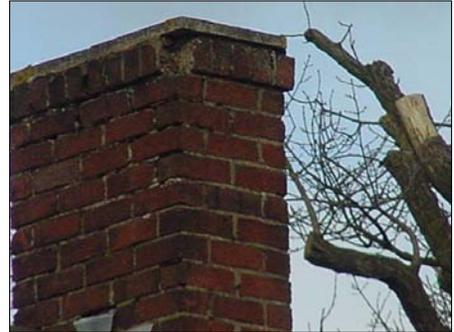
Re-point the right hand chimney and check the middle chimney (all directions given as you face the property from the grassed side).

ACTION REQUIRED: Re-point the right hand chimney and check the middle chimney.

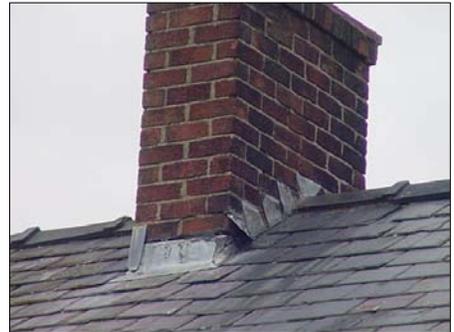
We also noted sulphate attack in the central chimney. This also indicates that there is dampness in this area. The flashing looks to need some repair work, there is certainly a considerable amount of dampness coming in through this chimney.

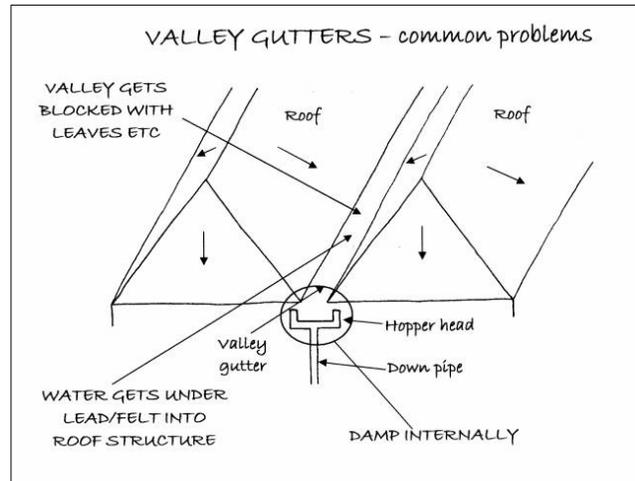
We noted some displaced slates and awkward valley gutters. We also noted that the Main Roof to the original part of the property does not have an underlayer and therefore dampness can get into the property.

A general check of the roof is required.

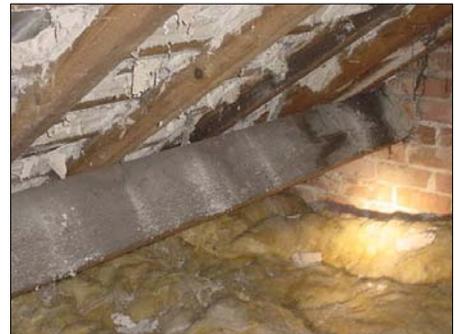
This photo is taken inside the roof. You can see dampness visible to some of the timbers. This may be coming in via the chimneys and walls, but we think also an element is via the roofs.

ACTION REQUIRED: There is no obvious reason for dampness getting into the roof. It may be wind driven rain or it may be that the property has been empty. A general overhaul of the roof is required. This will require replacement of slipped, broken and missing tiles together with general clearing of the valley gutters, checking of base materials and flashings and checking of gutters and downpipes.

ANTICIPATED COST: In the region of £500 - £2,500 to carry out investigation work and repairs as necessary.

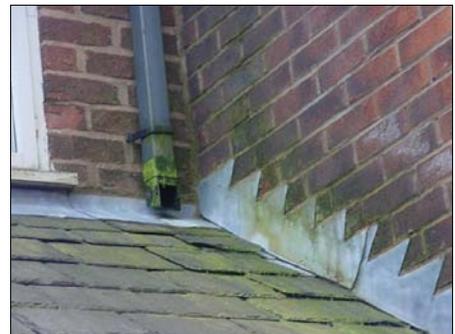
Dampness may be getting in via poor detailing to the gutters and downpipes. We believe dampness is getting in to the wall above the actual flashing.

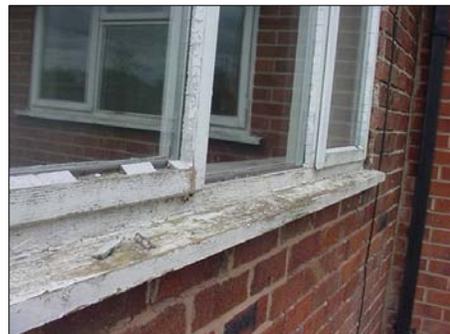
This photo shows flaking paint and bare timber visible to some of the windows.

ACTION REQUIRED: Paint/re-stain external joinery and repair as necessary.

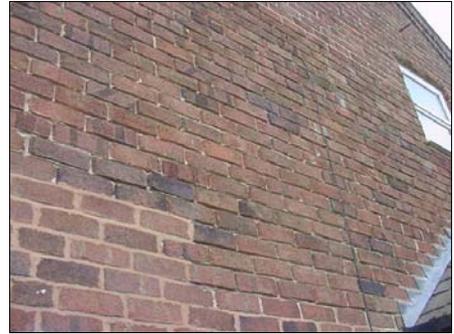
The pointing to the brickwork is weathered and re-pointing is required.

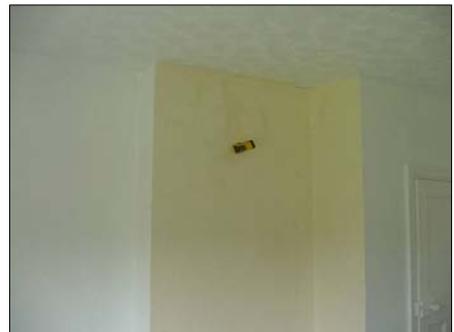
This photo shows a newly painted room with dampness visible to the chimney breast. The yellow item in the middle of the photo is our electronic damp metre.

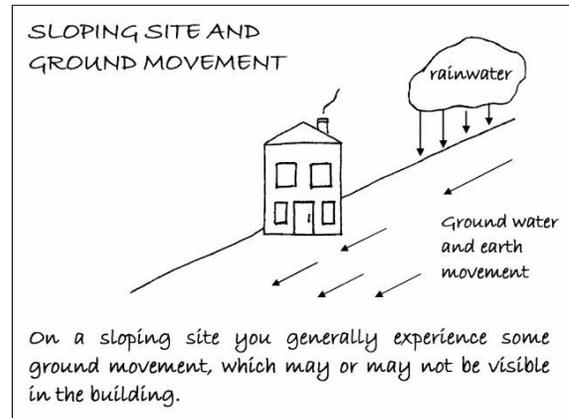
13) Cracks

As already mentioned we have noted cracks in the property, for example to the green stairwell area and to the yellow first floor level.

These are difficult to identify as the property has been newly decorated. These cracks would indicate minor settlement has occurred in the property. This is not unusual for a property sitting on a sloping site and being surrounded by trees and, in addition, this was once a coal mining area.

These cracks would indicate that minor settlement has occurred in the property. This is not unusual with a property sitting on a sloping site and being surrounded by trees, particularly in what was once a coal mining area.

As mentioned earlier we would also recommend that an arboriculturist (not a tree surgeon) is asked to visit the property and advise on the surrounding trees.

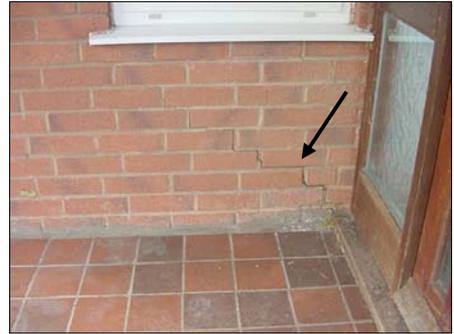
Stepped cracking was found to the brickwork and also to the floor indicating that there is movement to the property.

ACTION REQUIRED: This will very much depend upon the future use of the property. We would recommend that the cracking is monitored to establish whether it is moving.

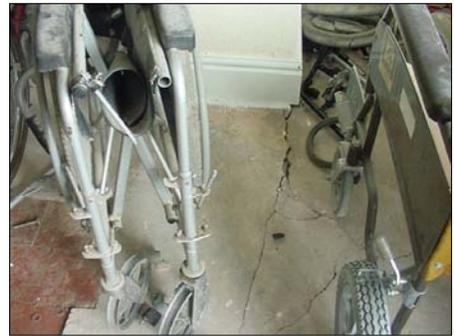
This photo shows internal cracking.

Whether the movement is on-going can only be established by long-term monitoring.

However, our initial thoughts on this matter are that the movement is on-going and caused by the adjoining tree and the general poor standard of construction.

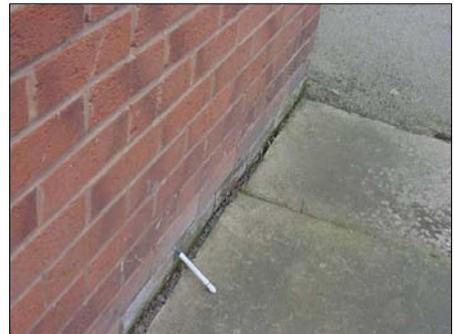
We found rising damp within the property. This may be due to the property not being occupied and/or heated for some time; equally it could be due to a defective/poor damp proof course.

In this photo the level of the damp proof course is indicated by the pen, there should be two courses of brickwork between the ground level and the damp proof course.

ACTION REQUIRED: Reduce the level of earth around the property.

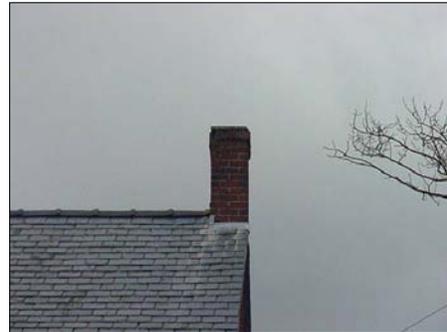
This chimney is brick finished with a lead flashing and has no chimney pots. The chimney is not in particularly good condition and will require general re-pointing and repair. Unfortunately we were unable to see the flashing but we suspect that there is a defect, we therefore cannot comment upon them.

ACTION REQUIRED: A general overhaul of the chimney, the sooner this is carried out the better. We would recommend work is carried out in the summer of 2005.

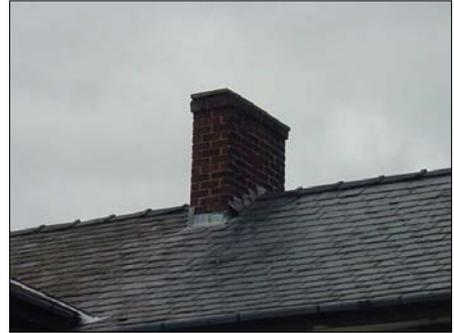
This chimney is brick built and whilst it looked in reasonable condition we did find considerable dampness internally.

ACTION REQUIRED: This chimney should also be checked in the summer or 2005.

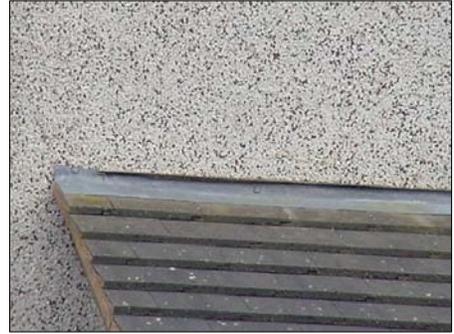
The low level roofs are clad with an interlocking concrete tile. They are generally single pitched roofs and in reasonable condition. The only area they do need checking is where the flashing meets the main property as in some areas we noted that the mortar has started to come loose.

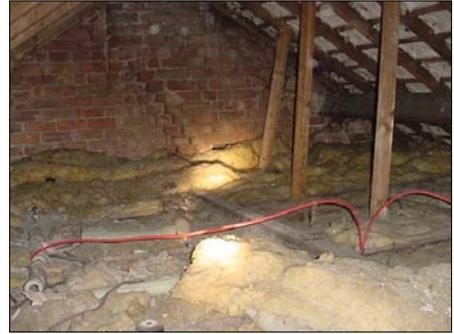
We have accessed the roofs within this area and would comment that within the original part of the roof we could see that dampness is getting in, which is why we have recommended work to the roof. We also noticed signs of vermin within the roof. There may also be woodworm in this roof given its age, although we did not physically see any. We were only able to access part of this roof.

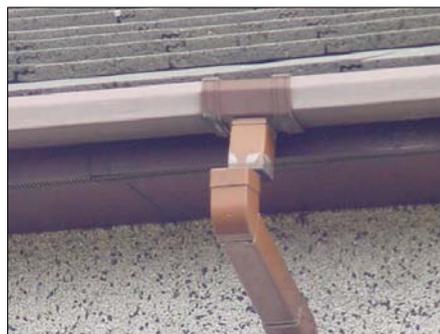
A profile guttering has been used. The property's gutters and downpipes are fairly typical of what we see; they are in average condition. There are some minor leaks where we noted that the pipes have been incorrectly fixed or parts of the gutter and downpipe were missing. These should be picked up in your day-to-day general maintenance.

ACTION REQUIRED: General maintenance to the gutters and downpipes. We would always recommend that gutters and downpipes are cleaned out, the joints are checked and the alignment checked to ensure that the gutters fall towards the downpipes. This applies to both roofs.

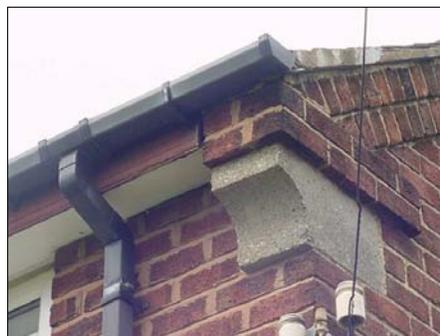
If you look closely in this photo you can see a repair to the downpipe and you can also see a repair to the perimeter of the roof tiles. Please note our earlier comment about clips being required to the roof.

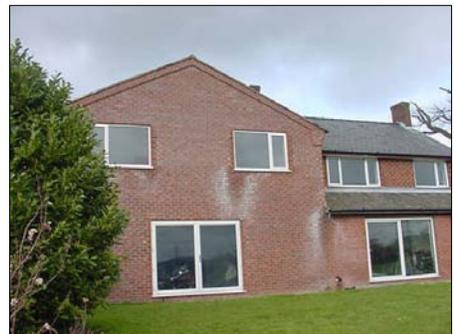
However to the Adjoining House (see photo on right) we believe it is due to dampness getting into the structure over and above that which would normally be expected. We have highlighted some of the areas where it may be getting in elsewhere within this report.
