PRE-LEASE SURVEY AND WANTS OF REPAIR

Surveyed on xxxxxxxxxxxxxxxx

Offices in Northamptonshire

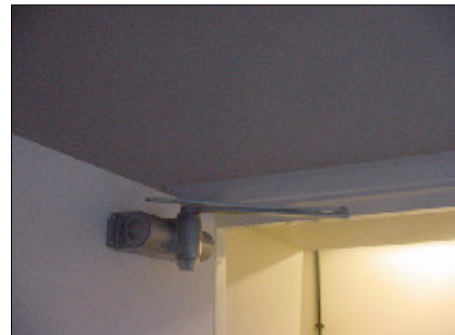
Door Closers Missing to Fire Doors

We noted that some of the doors to the property are fire doors. These should have door closers on them that prevent the spread of fire. This photo shows a broken door closer, but in most cases they are missing. We also noted that there were no fire extinguishers throughout, although you do have some signage.

ACTION REQUIRED: Before legal completion of the Lease contact a fire protection company and ask for a quotation to bring the property up to current Fire Regulations standards and also the cost of a regular maintenance contract.

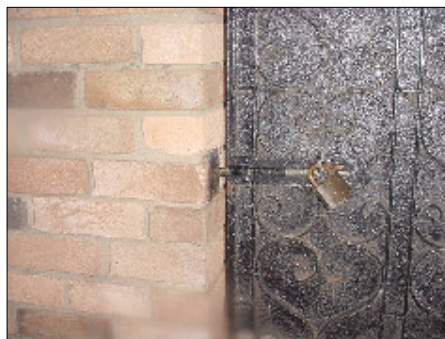
Shared Fire Exits

We believe there has to be some overall Fire Policy/fire protection system where a property is in multi occupation, such as this one. If a Fire Policy is not in place then problems can occur, for example a problem such as the padlocked shared exit to the front right hand side spiral fire escape.

ANTICIPATED COSTS: Quotations required, but in this instance we would expect costs to be in the region of a few thousand pounds, based upon what we have seen.

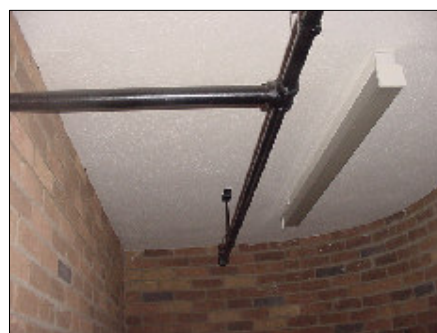
Lighting

The lighting that is present in the office areas is not to modern day standards. You currently have florescence strip lighting, as can be seen in this photo.

As owner occupiers you can make a decision with regard to how you wish to deal with this, however, when you have employees the requirements then fall under the Offices, Shops and Factories Act.

ACTION REQUIRED: In due course suitable lighting will be needed throughout the property. We suggest that you obtain a quotation from an NICEIC registered electrician.

ANTICIPATED COST: Quotations are required, but we believe in the region of £1,000 - £2,000.

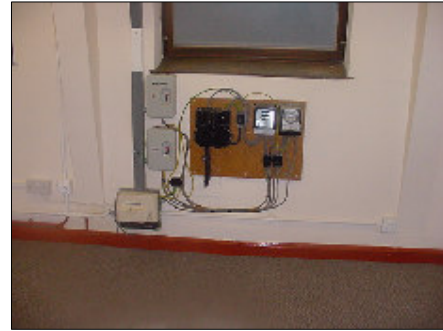
Electrics

We suggest that you box-in the exposed fuse board and associated electrics to give a half hour fire protection.

ACTION REQUIRED: Box-in using a half hour fire protection box.

ANTICIPATED COST: In the region of £200.

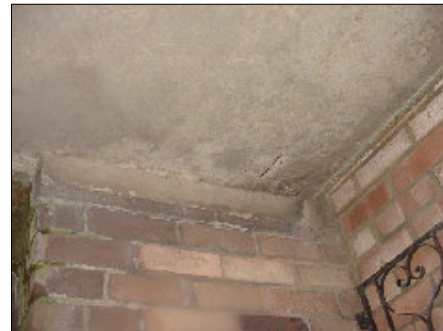
4) Spalling Concrete to the Underside of First Floor

The first floor is a reinforced concrete slab (from what we could see). We could see that this is spalling and deteriorating in areas, for example around the front fire exit.

If you look closely at this photo you will see that the concrete to the left hand side looks to have been repaired in the past and to the right hand side you can see the exposed reinforcement rod, which is not ideal, as it should be covered.

ACTION REQUIRED: Although under the Full Repairing and Insuring Lease this would be your responsibility we do feel you should draw it to the attention of the Landlord and get some sort of agreement to repair it.

ANTICIPATED COST: All costs should be met by the Landlord.

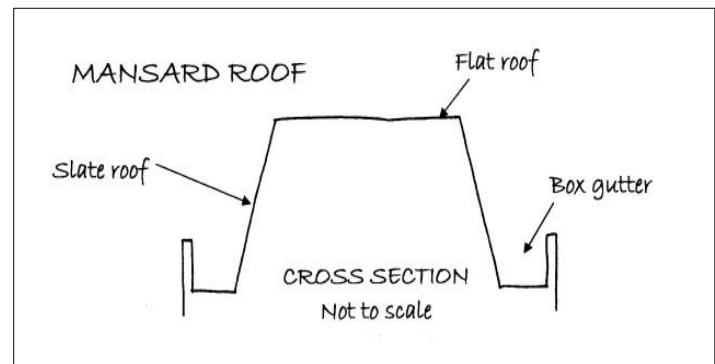
5) Mansard Roof

The roof and roof drainage is via a flat roof that forms the top of the mansard roof and the mansard walls that also form the roof, which are clad in slates and then discharge into a box gutter where the water is taken away via downpipes.

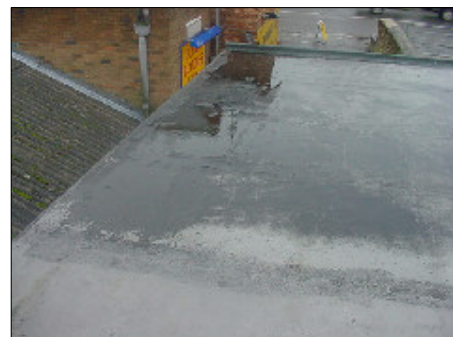
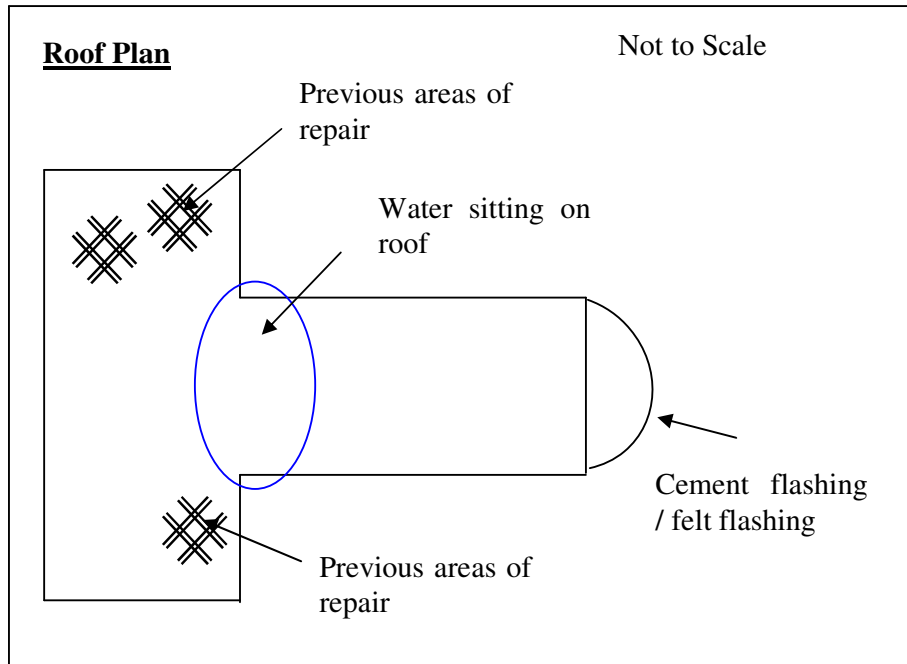
Main Flat Roof

During the course of our inspection it was raining. We were therefore able to go onto the main roof and discover that there were large areas of ponding, which will lead to accelerated deterioration. We noted areas where the asphalt has started to deteriorate and/or has had previous bitumen repairs.

ACTION REQUIRED: All of the issues with regard to the flat roof need to be addressed. We can see two options on this, either completely re-roof the property with a high performance felt and insulation cut to falls, appropriate lead flashing detailing, completely removing any flat areas and weak areas on the flat roof and in addition to this any liability with association to the box gutters needs removing.

Alternatively the liability with regard to the roofs and the box gutters should be removed completely from the Lease.

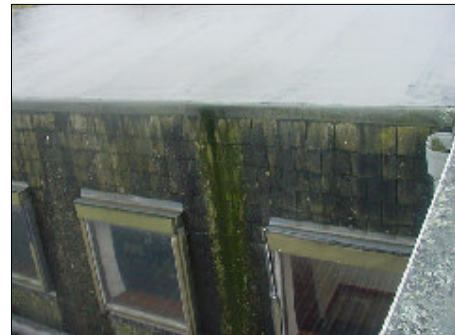
There is what we consider to be bad design detailing to the perimeter of the flat roof (or possibly this has been amended by the people that last did the roof). A few particularly bad areas need amendments to stop water discharging in these areas. In this photo you can see the staining that is occurring due to this poor detail.

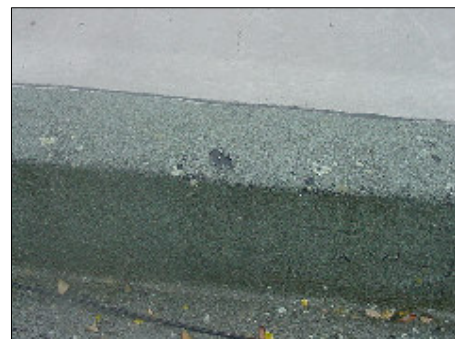
This is a close up photo of the deterioration to the perimeter of the flat roof.

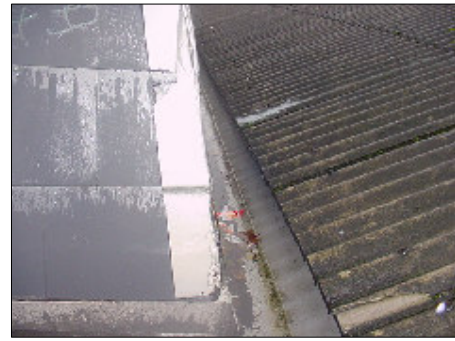
A product known as Flashband (trade name) has been used to repair the edge details of the slates. This is not ideal, as Flashband is generally considered to be a temporary fixing material.

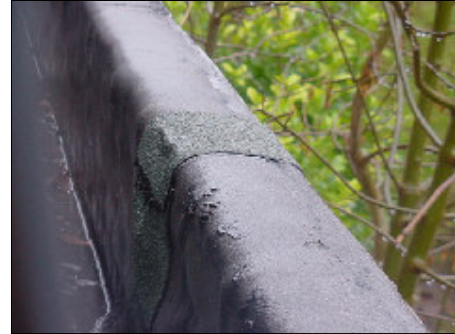
Although this is the only area of repair that we could see to the parapet wall, it does show that there must have been problems or no-one would have taken the trouble to carry out the repair work otherwise.

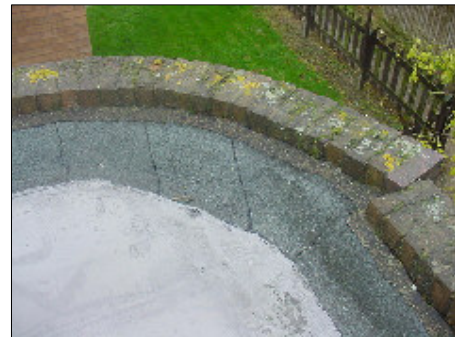
This photo shows the roof over the left hand stairwell. We believe that dampness is getting in around the cement fillet on this parapet wall.

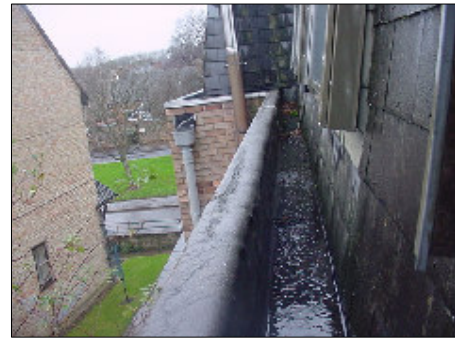
Box Gutters

We are particularly concerned about the poor quality detailing to the box gutters to the property as a whole. Any leak would cause fairly rapid deterioration and would be costly.

In this photo you can see the box gutter to the right hand side of the property (all directions given as you face the property) looking towards the front of the property. You can see that water sits in the box gutter, even when it is not raining and also that the asphalt is deteriorating if you look on the of the box gutter.

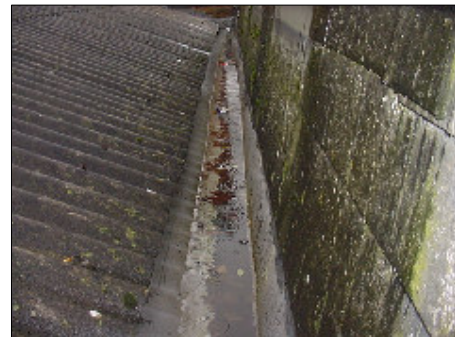
This is a photo of the box gutter alongside the gym that we are discussing above. Here you can see that water is sitting in it and winter has only just begun.

ACTION REQUIRED: Your Legal Advisor needs a clear understanding of who is responsible for what with regard to the roofs and to fully explain this to you.

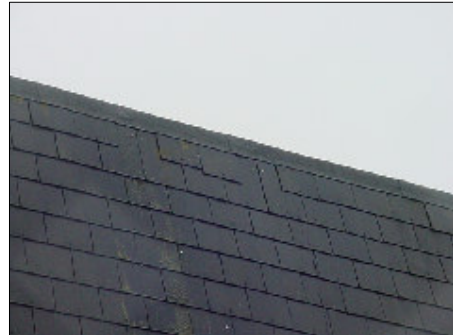
Slates

The slates look in reasonable condition, although some are missing.

ACTION REQUIRED: Repair will be needed in due course. This should form part of the works to the roof.

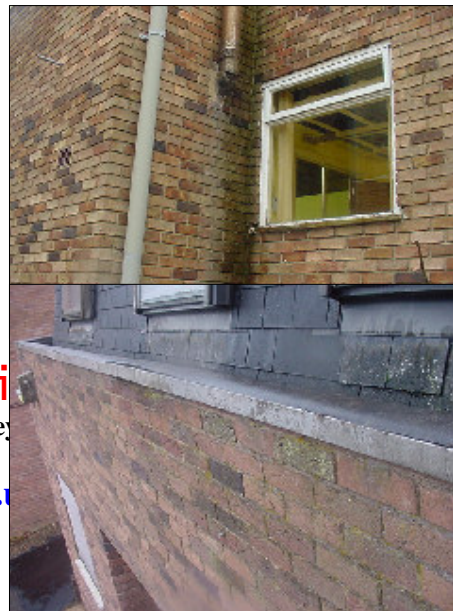
Brickwork

We noted some staining to the rear walls. This is due to the poor roof detail above, which needs amending to resolve this problem.

We are also concerned about the single

skin brickwork detail to the top of the box gutters, which we think may allow dampness into the property. Indeed there looks to be some minor spalling to the brickwork in this photo.

ACTION REQUIRED: The roof detailing needs amending. Please see our comments in the Roof Section in the Executive Summary.

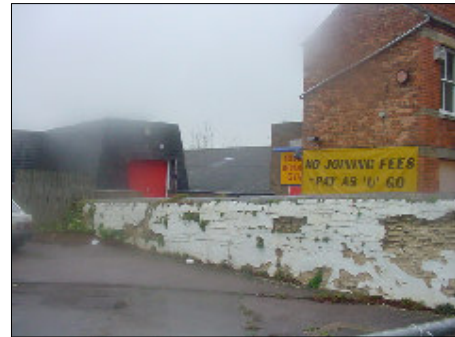
14. **Boundaries**

As we have not seen the lease it is difficult to advise about the boundaries of this property. Our main concern when we walked the boundary is that there is a wall to the rear right hand side that is in a poor state of repair. You really do not want this included in the lease. We think it is unlikely to be your responsibility but we have mentioned it just in case.
