SCHEDULE OF CONDITION

Prepared in xxxxx
OF
CHERRY'S SANDWICH BAR

<u>Address</u>	Cherry's Sandwich Bar, xxxxxx
<u>Prospective Leaseholder:</u>	Mrs xxxxx
<u>Repairing Covenants:</u>	We have not seen a copy of the lease and we have therefore assumed the property has a full repairing and insuring covenant – or will have under the propose lease. We have assumed it is a standard lease with no unusual or onerous clauses. Your Legal Adviser should confirm this and advise us of any unusual or onerous clauses immediately.
<u>User Class:</u>	We are advised that A3 User Class is presently being applied for.
<u>Photographs:</u>	We typically take approximately 100 photographs during the course of a Schedule of Condition. We reserve the right to produce these photographs to establish the condition of the property over and above the ones included in the report.
<u>Orientation:</u>	All directions are taken as if viewing the property from the front.

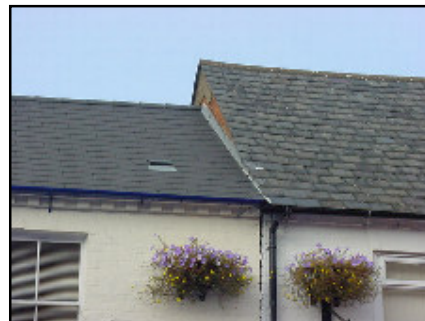
General view of the roof.

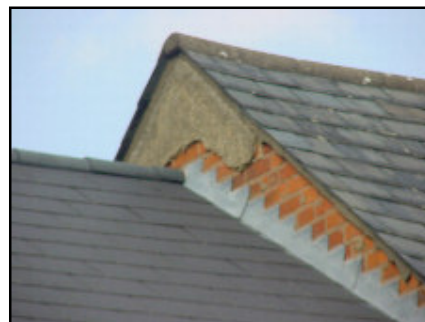
Close up of gable end. To the left hand gable end the render is coming away, or may well have been hacked back by next door when they put their new roof on.

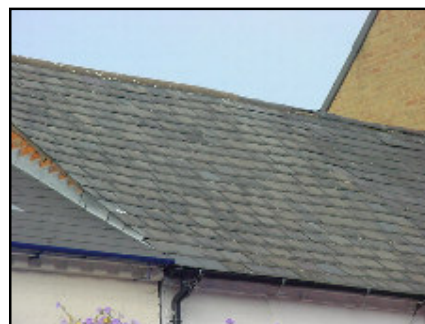
This shows the base of the step in the roof, which is always a weak area, in this instance it looks to be protected by a lead flashing.

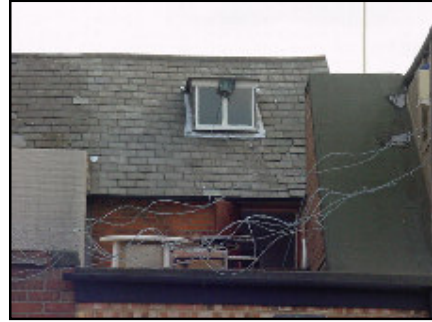
Main Roof – Rear Elevation

This shows a view of the rear roof. Lead tingles can be seen around the dormer window and also distortion/deterioration to the slates.

ACTION REQUIRED: General overhaul of the roof, particularly to the rear where some slates need re-securing and cracked and missing slates need replacing.

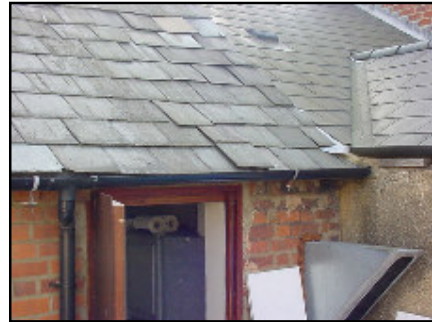
Close up of rear roof. Note slipped slate and tingles.

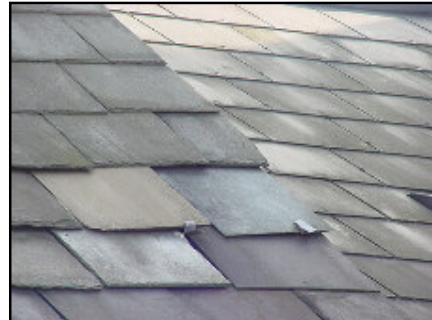
Close up of two tingles and also a manmade slate that has been fitted in.

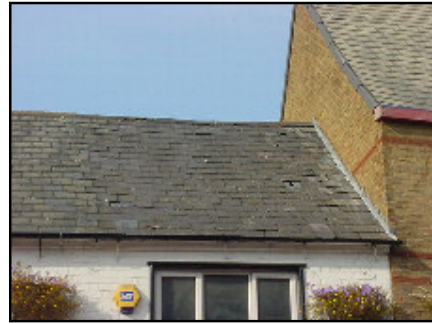
We feel we must comment on the adjoining roof, which may well affect your roof due to its condition, if it is not already affecting it. We would comment, if we were asked to recommend a course of action for this roof by the owners we would suggest it is re-roofed.

The neighbouring roof above Kodak Express.

ACTION REQUIRED: A letter to your landlords asking them to contact the adjoining property and to put their roof into a good state of repair. Ask them to contact the adjoining property owner to put the roof into a good state of repair, as if left this may impact upon your roof and you cannot be held responsible for this.

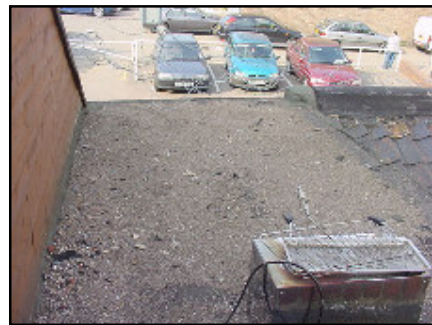
This is the very rear portion of the flat roof. If we take a closer look at this area we find the following:

ACTION REQUIRED: Re-felt rear roof and bring up to current Building Regulations by adding suitable ventilation and insulation.

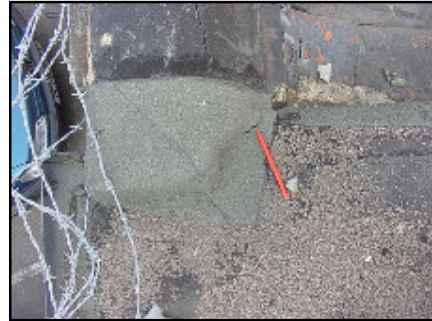
Splitting within the felt.

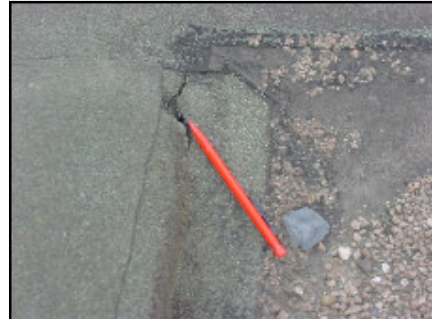
Much of the splitting is completely through the felt.

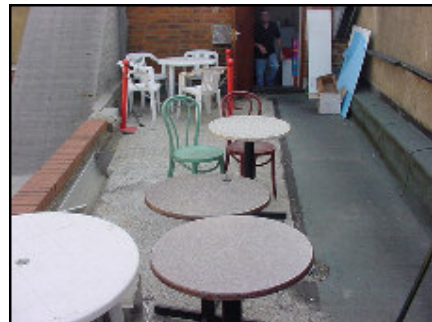
Chairs and tables were noted on the rear flat roof, which will produce point loadings onto the felt which may have caused latent damage that we cannot see due to the chippings that cover the roof. To the right hand side (directions given from the front of the property) is an asphalt covered parapet wall, this is starting to split.

ACTION REQUIRED: Repair asphalt.

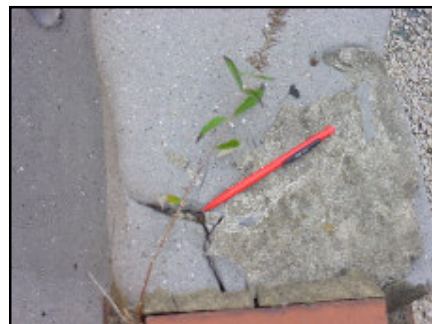
Asphalt splitting.

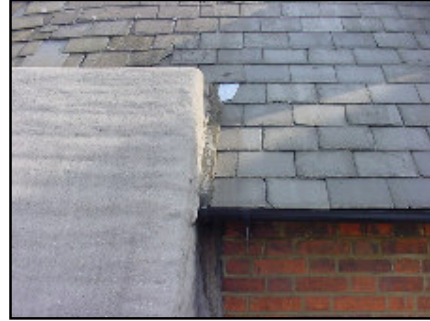
This asphalt parapet wall then carries on and becomes the roof of next door's stairway (assumed). Where the asphalt meets the slate roof there looks to have been bitumen repairs indicating leaks in this area. These are likely however to be going into the adjoining property.

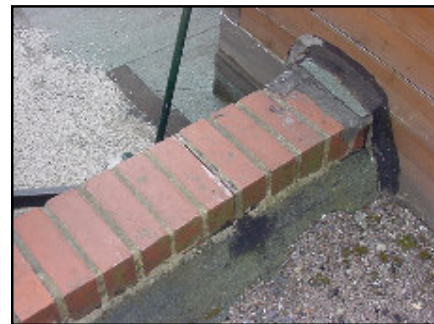
Here you can see bitumen repairs to next door's asphalt roof.

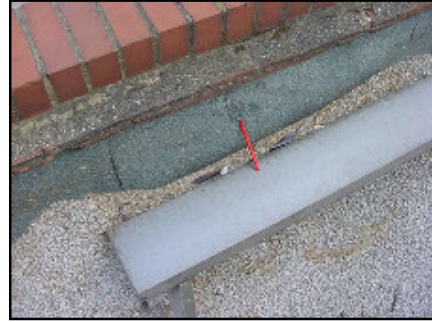
The felt flashing is blistering and has water behind it in some areas. The reason for the deterioration to this parapet wall is its condition on the adjoining owner's side.

The pencil indicates where water is behind the flashing.

ACTION REQUIRED: Replace with a lead flashing, take off the entire top course of brickwork and re-bed.

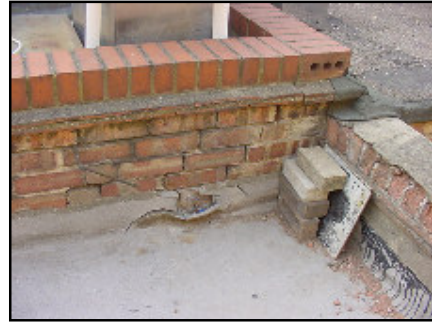
Adjoining owner's side.

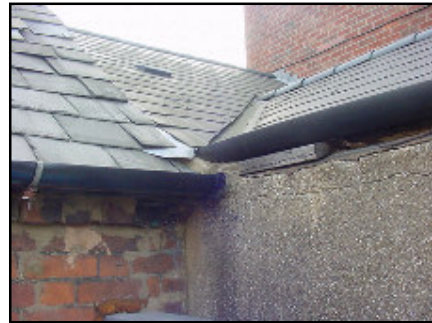
The render to the left hand wall is cracking, this we believe is due to the leaking gutter above.

ACTION REQUIRED: Once the guttering has been cleared out and re-aligned so that it falls to the downpipe and extra brackets added we suggest that the hairline cracks are filled. We are not certain whether this is your responsibility or the adjoining properties responsibility.

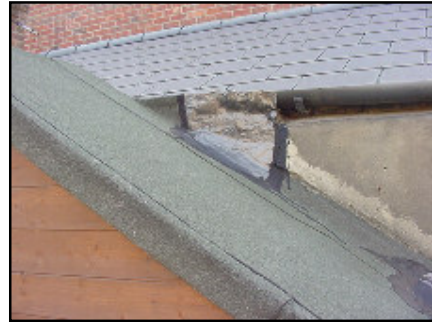
Past repair work can be seen to have been carried out to the roof over the stairway, which has a mineral felt finish that has been patched in several areas.

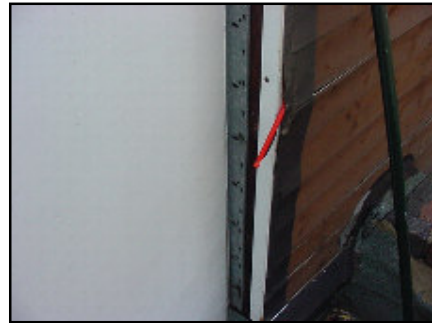
The external wall to the staircase is shiplap boarded. Here a product known as Flashband has been used to stop the water getting in.

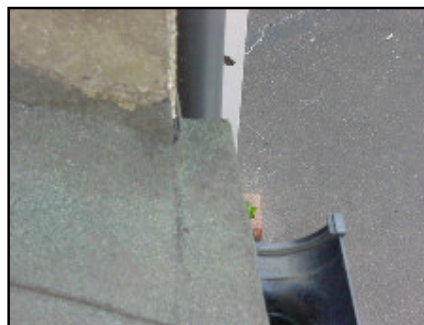
The rainwater goods are plastic and generally need cleaning, re-aligning and the joints checking. There are also various repairs needed, such as end caps to be put on and additional brackets added.

ACTION REQUIRED: General overhaul of the guttering and repair and replacement. Regular cleaning is necessary.

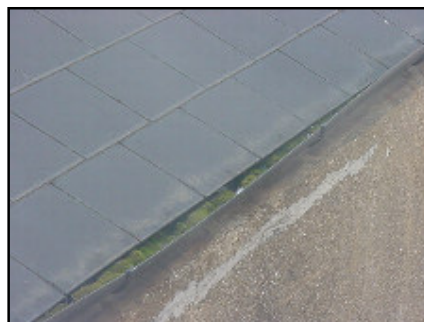
The end cap to the rear of the guttering is missing.

There is a rainwater gutter to the rear left hand side of the property, we are unsure if this guttering belongs to this property or not, but we feel we should mention it as it is leaking.

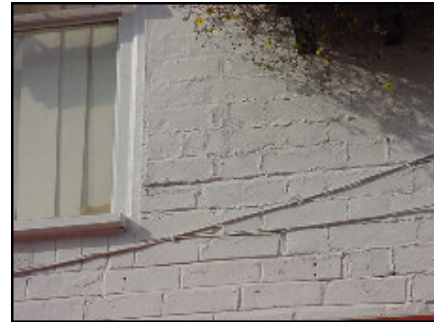
The brickwork is painted and mainly in a Flemish bond construction. It is generally in reasonable condition, although some making good has taken place. An example of the making good is shown in the photograph.

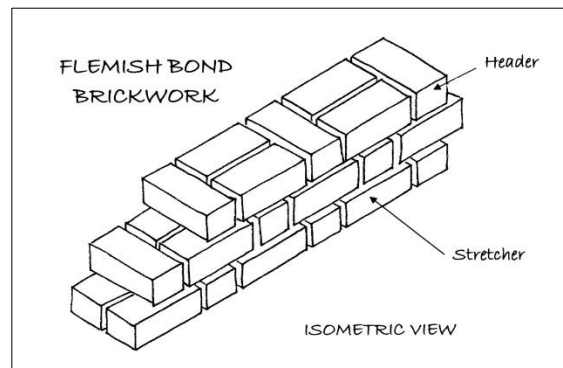
To the right hand side of the front window the brick bond changes from Flemish bond in some instances as in this example below the window.

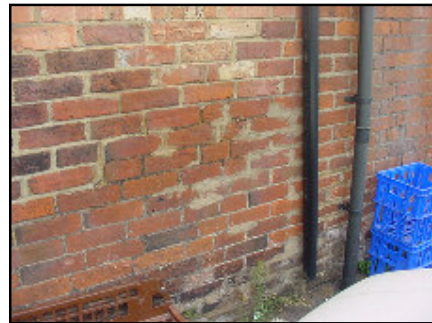
There is a mishmash of brickwork to the rear of the property with various brick bonds. It is very obvious where the brickwork has been made good over the years and re-pointing has been carried out. This is possibly due to a leaking rear gutter and it presently looks damp.

Note that the downpipe discharges directly onto the rear wall rather than into a soak away, this is likely to cause dampness within the property. We could not check this due to the units within the property.

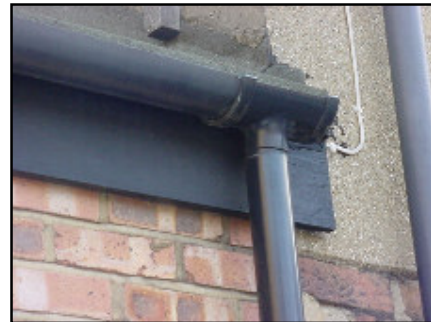
A painted fascia with some minor flaking.

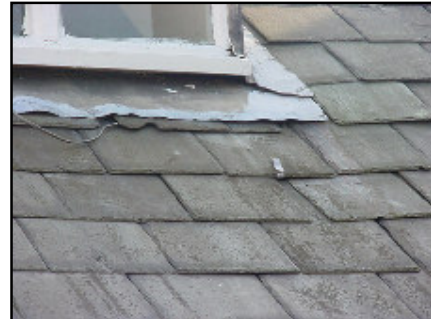
What looks to be a newly painted timber dormer window. This could be hiding latent defects.

The newly painted dormer window could be hiding latent defects. We were pleased to see a lead detail around the base of the window.

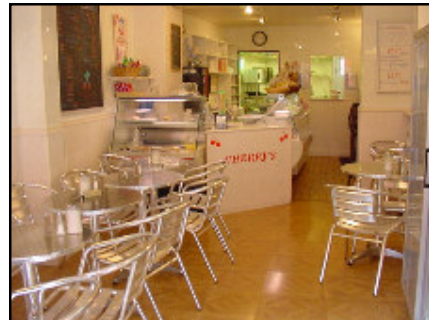
Timber boarding to the front of the property and general minor scuffing, there is also a mat well to the door on the right hand side. To the rear there is a brick quarry tile and the grout has ingrained dirt. General view of the front of house area.

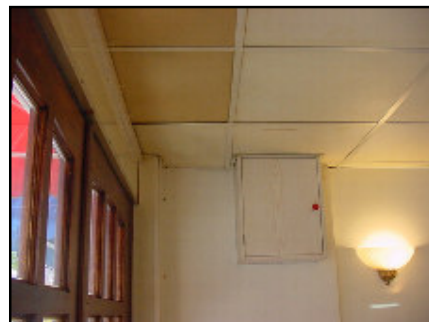
Some staining and marks to the suspended ceiling.

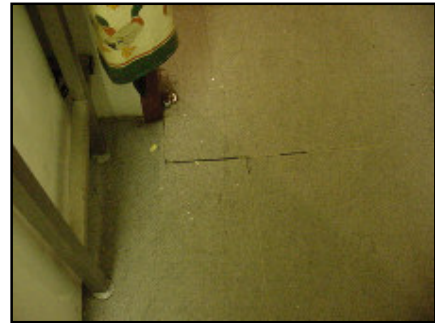
Altro-style flooring, slightly worn with ingrained dirt and some of the joints are defective and need re-sealing to meet Health and Safety standards.

An example of the defective flooring.

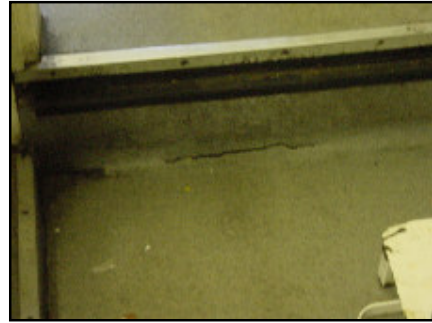
Altro-style flooring with ingrained dirt, particularly to the edge. There is a crack to the floor covering next to the step and also some of the joints have come apart.

A photo of the defective flooring at the step into the preparation area.

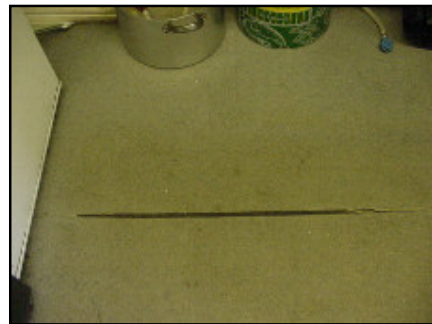
Altro-style finish, again with ingrained dirt, particularly to the edge.

Worn flooring to the preparation area.

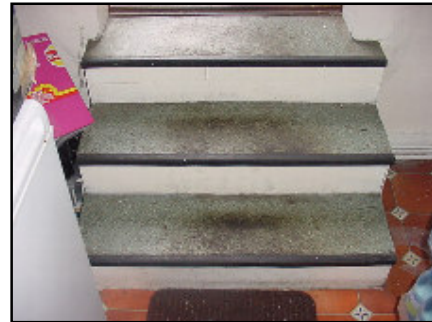
Stairs into first floor store area - worn

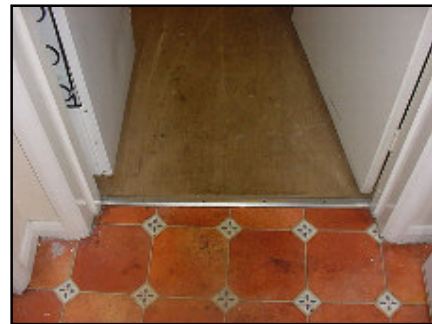
Vinyl into the toilet area - worn
