SCHEDULE OF CONDITION

PREPARED IN XXXXXXXXXX
OF
A club under a block of flats

Firstly, may we thank you for your instructions of ?????????; we have now undertaken a Commercial Building Survey (formerly known as a Structural Survey) of the aforementioned property. This Survey was carried out on ??????

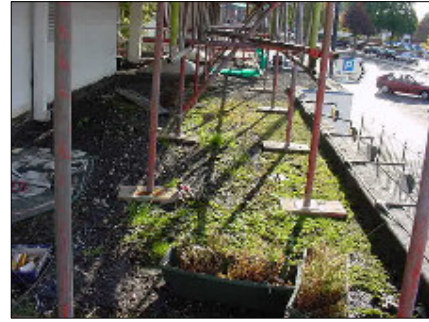
Grass and moss growing generally and the scaffolding

Action required: The management company should be contacted by your legal advisor to confirm anticipated future costs for this item and any other items of plan maintenance together with typical costs of reactive maintenance.

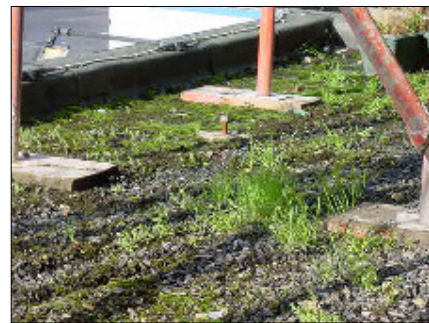
Close up of grass and moss

This is a flat roof, which does not have the recommended fall. For this reason the felt with loose chipping finish has moss growing in many areas and water sitting on the roof, particularly to the front elevation and near the down pipes and the perimeter parapet walls. Grass is growing in many areas.

Action required: Roof should be completely cleared of the grass that is present, which will also mean the chippings should be checked for any areas of deterioration and repaired as necessary and re-laid with insulation cut to falls (as we do not see any other way of producing a fall to this roof).

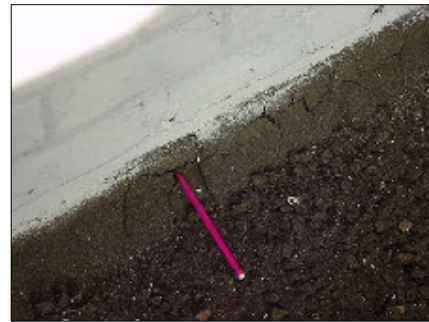
Crocodiling; deterioration to the felt is occurring which is likely to leak in the future

Crocodiling and general deterioration was noted to the felt flashing.

Action required: Replace felt flashing with a lead flashing.

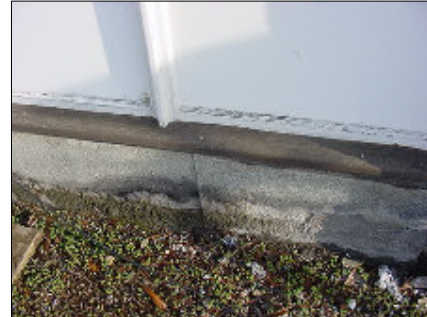
Felt flashing below window is brittle and has lost its adhesion

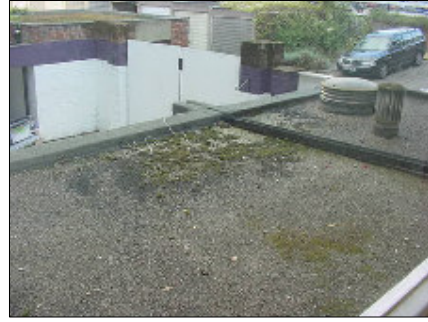
This roof is also flat and water is sitting on it. Again we recommend insulation to falls.

Ponding is occurring on this roof and there is also moss present

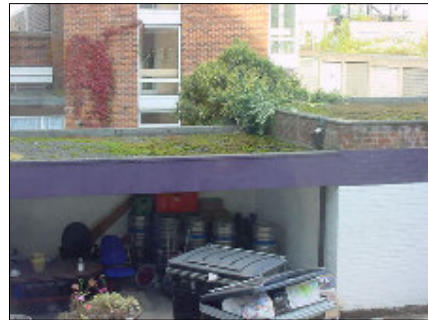
Roof over external store covered with moss indicating it is flat

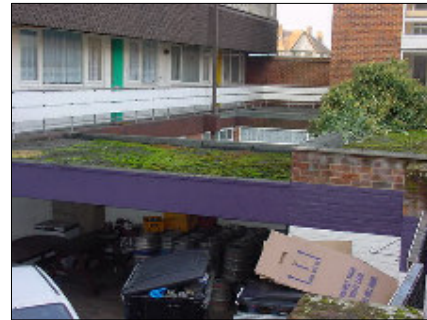
Roof 3 - Above private living accommodation kitchen

Extensive plant growth.

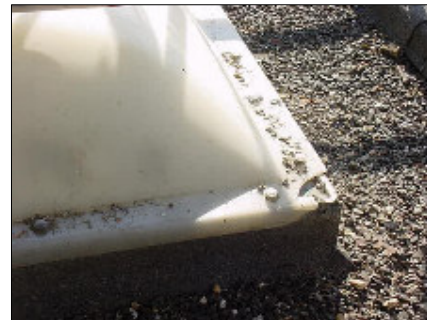
Some of the barrelled roof lights are damaged and most have the caps missing to the roof light fittings, these have had asphalt placed over the top of the fittings, so we can only assume that these have leaked in the past.

Action required: To make the roof lights watertight they will require either replacing where damaged or new fixings and cappings where they are missing.

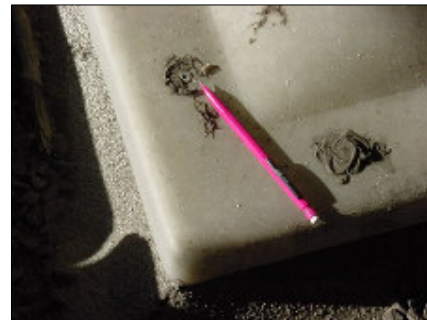
Damage to the edge of the roof light

Pencil indicates where the fixing caps have come away and asphalt has been used to seal them

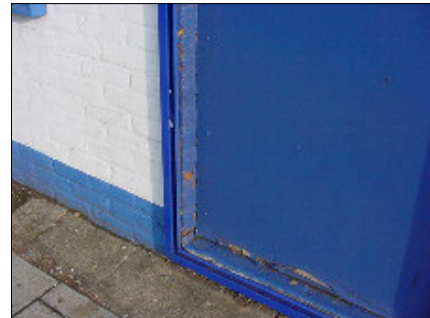
These have been clad with a metal sheet and the paintwork around these is starting to flake.

Doors marked

Action required: Clean and paint areas of flaking paintwork.

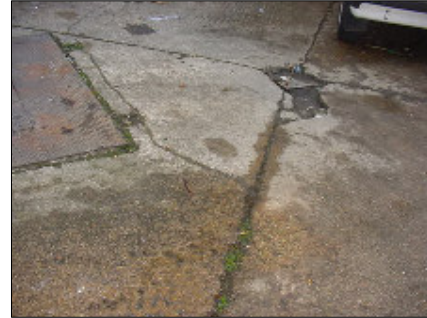
Concrete marked and impact damage from barrel delivery. Central gully blocked. Cellar flaps have dropped and need re-aligning.

Central gully blocked

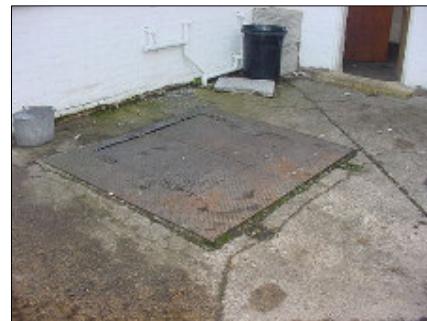
Cellar flaps need re-aligning

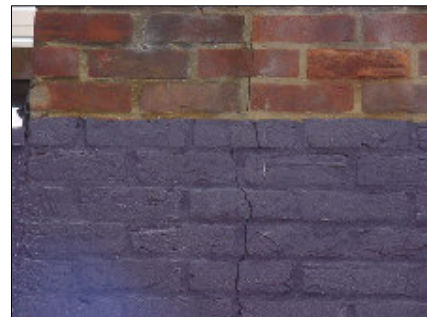
There are two areas of vertical cracking to brickwork, one to the left hand side of the double entrance doors into the courtyard and the other to the right hand side. These cracks run the full height of the walls.

The hairline cracking is to the centre of this photograph

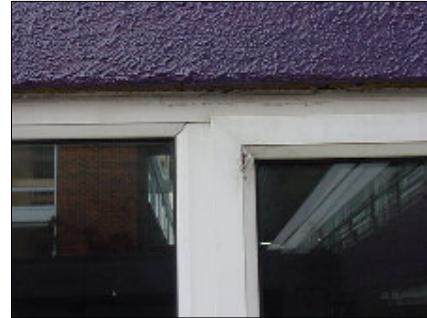
Plastic kitchen window damaged which appears to be from an attempted entrance into the property.

Window damaged

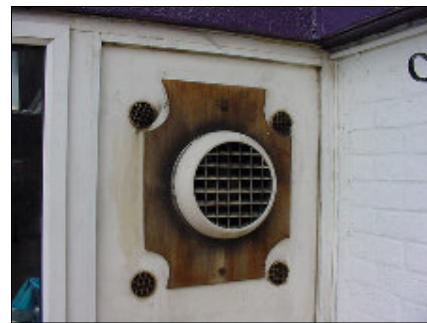
Extractor fan from kitchen discharging grease

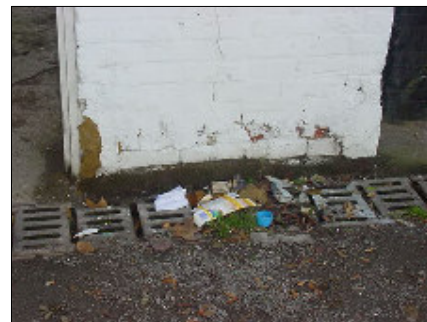
There is a running gully at the entrance to the courtyard area, which is blocked.

Blocked gully

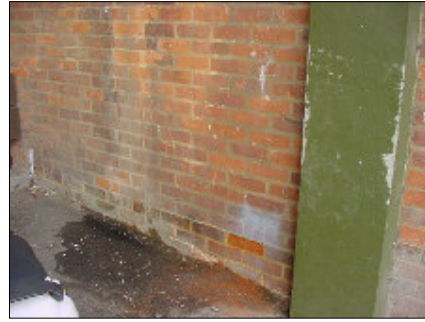
This consists of concrete columns with brick in-fill panels.

The columns are generally marked with the paint coming off and the brickwork is stained

Action Required: Repair and redecorate the columns and clean the brickwork.

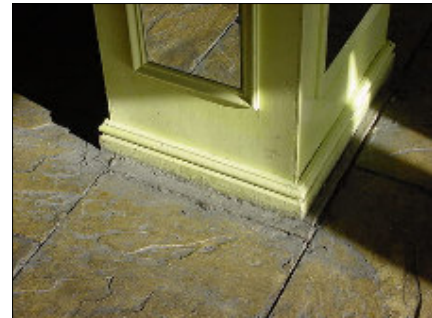
Paintwork looks to have had a coat of paint in some areas recently; unfortunately they appear to have painted directly over the dirt and grime on the wall.

Ingrained dirt

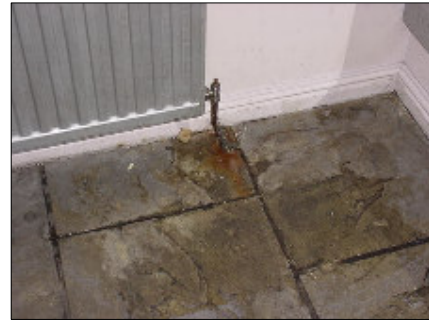
The central flagstones have ingrained dirt and the vinyl flooring to the front of the bar has various cigarette burns, chewing gum and is generally marked and the joints are starting to open up.

The radiators are leaking, causing staining in some areas.

Leaking radiator and ingrained dirt to flagstones

Action Required: Deep clean the floors and repair the radiators.

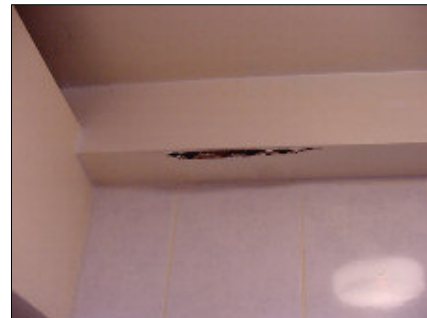
Damage to ductwork

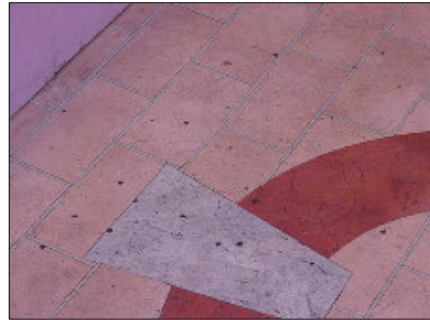
Cigarette burns to floor

Required: Redecorate, thoroughly clean and replace sink and any products that have burn marks.

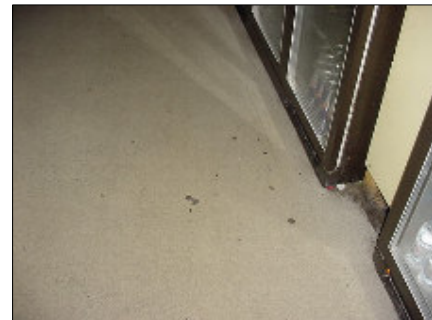
Vinyl marked with chewing gum and cigarette burns. There should also be a skirting for hygiene purposes, this is presently open.

Marked vinyl flooring

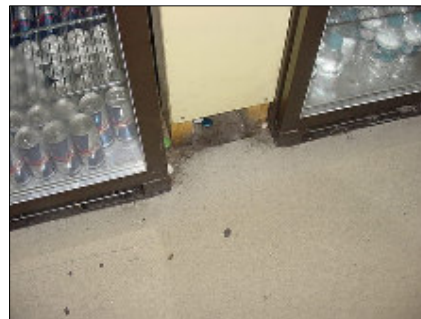
No skirting

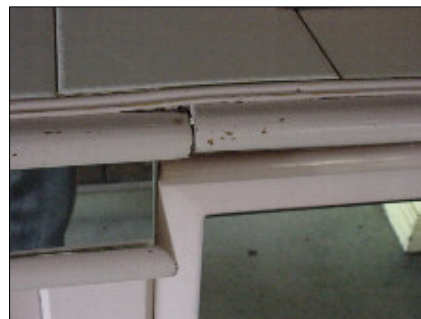
Marks to front of bar

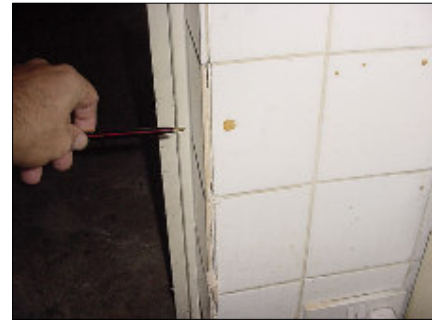
Tiles coming away in some areas, for example, in the behind bar entrance to the kitchen, and in other areas they are blown.

Tiles coming away in the behind bar entrance to kitchen

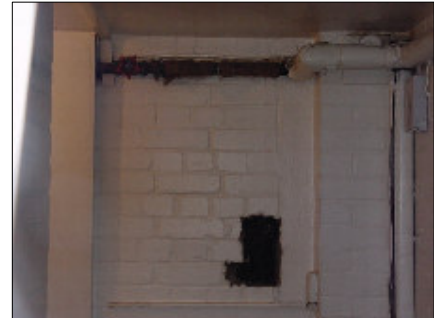
Hole within wall and covering missing from insulation

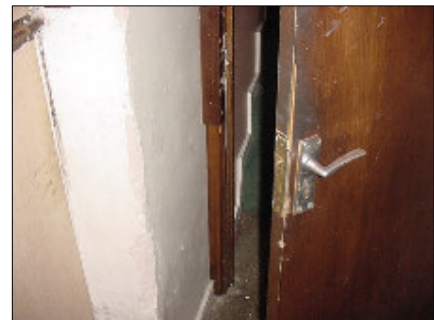
Door to Rear Courtyard – Plaster damage to corner and door requires decoration.

Damage to door

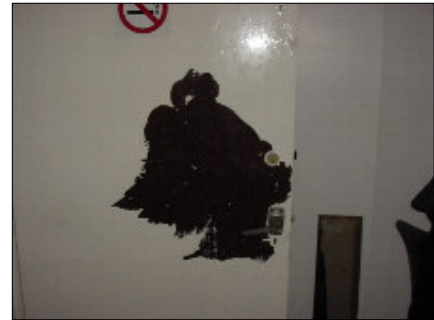
Marking to hatch and door damaged.

Damage to door

Action required: Redecorate and repair any damage.

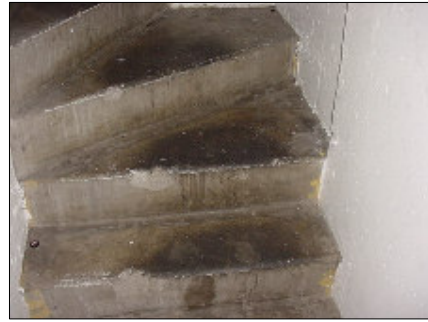
Generally stained and some areas of cracking.

Staining to stairs

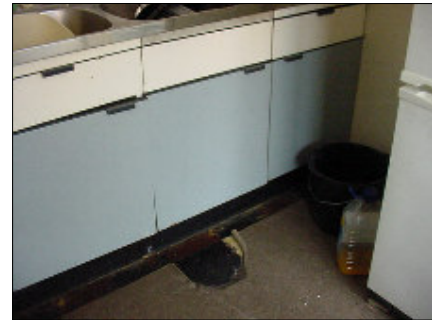
Floor worn through and kitchen unit doors fit poorly

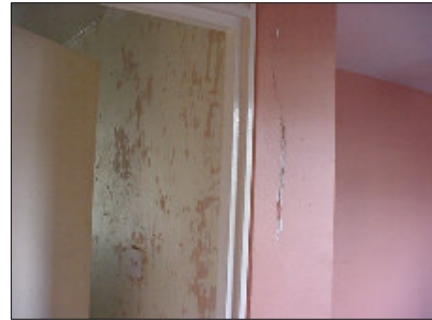
Paint literally coming off the walls.

Paint coming off the walls

Action required: Redecorate and repair as necessary.

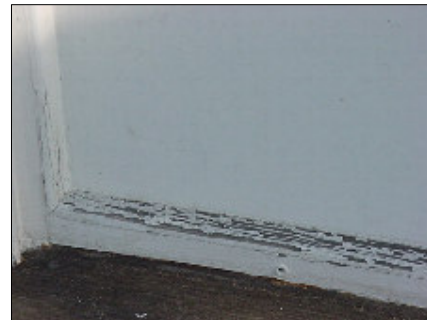
Windows require redecoration, paint flaking away

Action required: Redecorate.

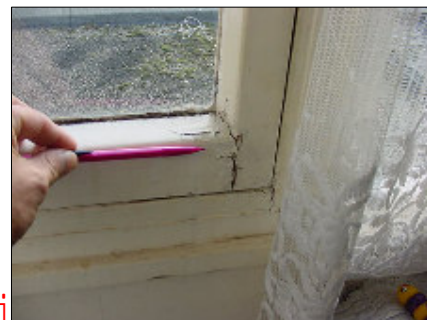
Condensation throughout

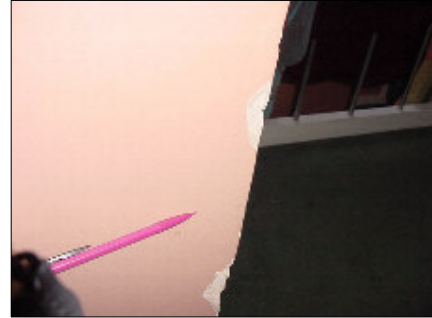
Impact damage to walls throughout

Action Required:
Redecorate.

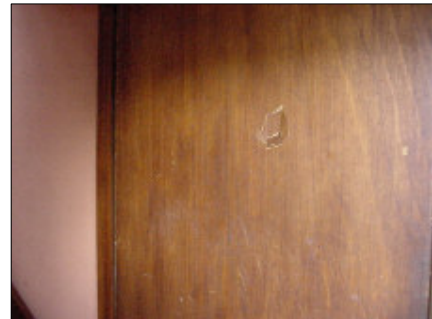
Entrance door has impact damage

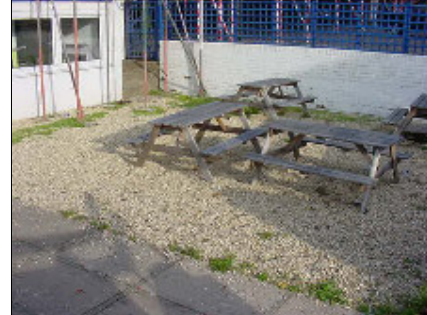
The paving slabs are uneven. We would recommend that they are re-bedded and levelled and general weeding is carried out.

Weeding required to shingle part of patio area
