**RESIDENTIAL BUILDING SURVEY**  
**OF**  
**The Square, London**

**FOR**  
**MR T**

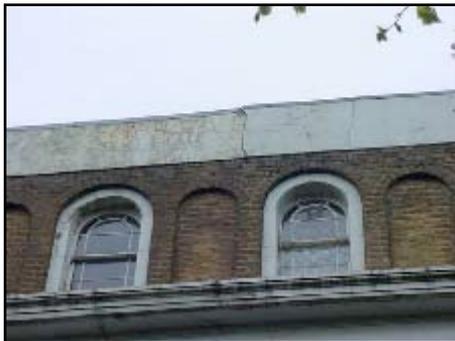
As you can see the roof is not visible, but you can see from the parapet walls the differing conditions they are in, which in turn indicates work may have taken place behind them.

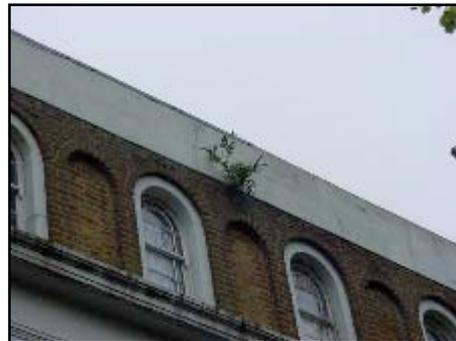
Indeed in one part of the parapet wall there is plant life growing out of it, although not, I am pleased to say, anywhere near your property.

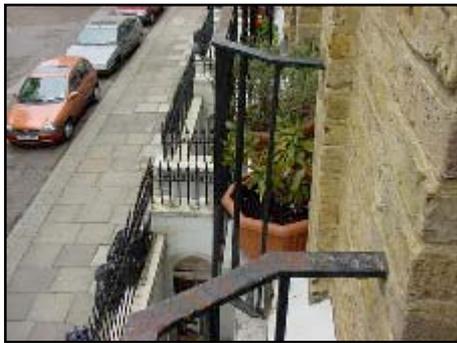
Some minor rusting was occurring to the wrought iron.

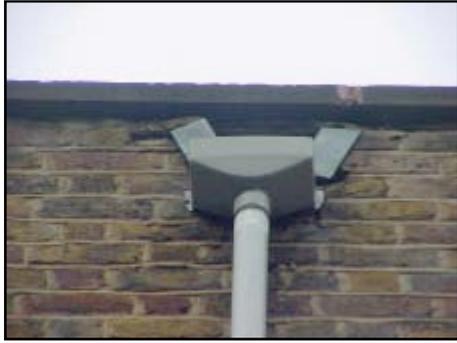
It is quite common with this type of rainwater goods arrangement for the hopper heads to overflow during periods of heavy rainfall, but this is only likely to affect the top apartment.

A close up of the hopper head, you can just see the lead around it which helps prevent damp.

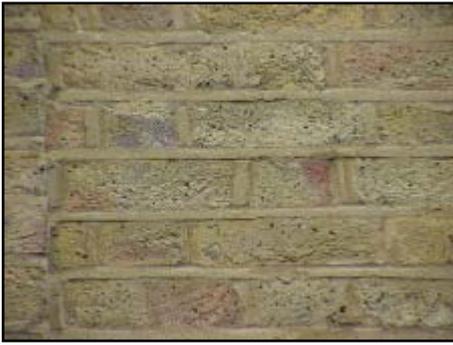
Unfortunately the re-pointing, whilst well meaning, is not appropriate for this type of construction. A cement mortar has been used rather than a lime based mortar. We recommend that you use a lime-based mortar in any future repairs regardless of what the builders say! They will often not recommend the use of lime mortar because they are not skilled enough to actually utilise this particular material. Using lime mortar, however, will limit damage to the brickwork which is almost impossible to repair successfully.

Re-pointing in a cement mortar.

**ACTION REQUIRED:** Future repairs to be carried out in a lime mortar.

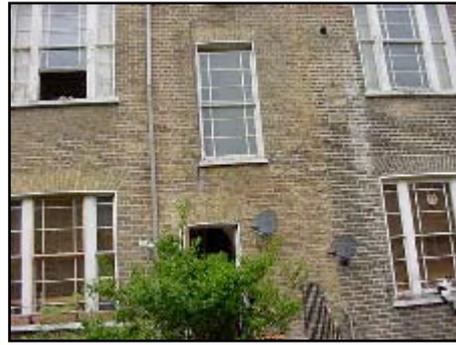
The wall to your property would appear to have been cleaned.

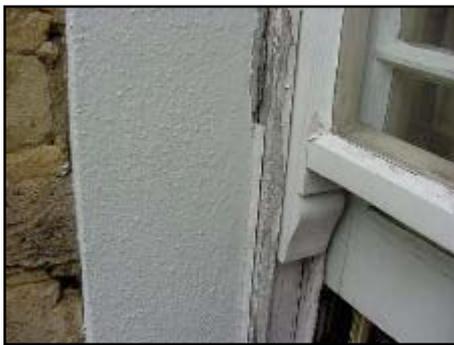
The close up of the sash windows indicates that some repair work may be necessary as well.

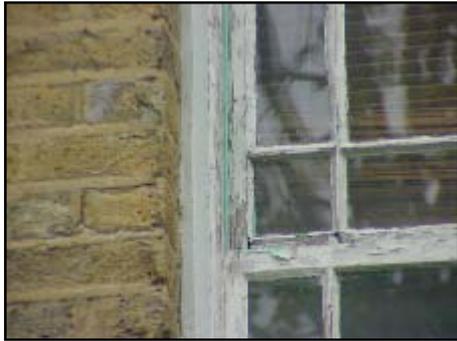
We were able to open the windows in the lounge and found these both to be replacement windows but, nevertheless, in need of redecoration. We were also able to open the window in the bedroom; again this is in need of redecoration.

The windows are in need of redecoration

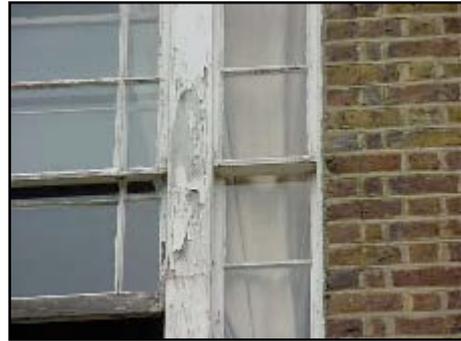
The window in the kitchen needs a general overhaul as the sash cord is missing and we feel this is an area that should be vented.

The rear window was particularly bad

**ACTION REQUIRED:** Overhaul sliding sash window. Likely cost £100 - £200.

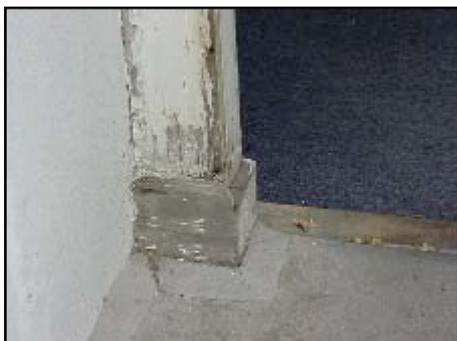
We note that the frame has been repaired and the paintwork is now flaking. The way the framework has been repaired has been to place timber over the top of what we suspect is rotten timber. Although not a big job, the difficulty in these types of properties is who should pay for it?

The base of the door frame is in need of re-decoration. See our comments within the report.

**ACTION REQUIRED:** Again your solicitor needs to confirm who is responsible for what.

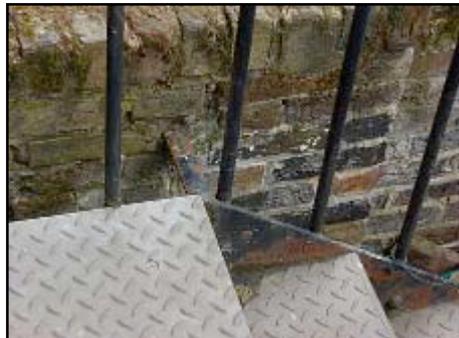
Minor rusting to the rear metal Fire Escape.

**ACTION REQUIRED:** Your Legal Advisor should check the lease to establish responsibility and any associated costs.

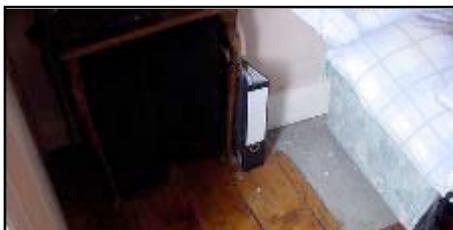
This shows part of the floor and also the old concrete surround.

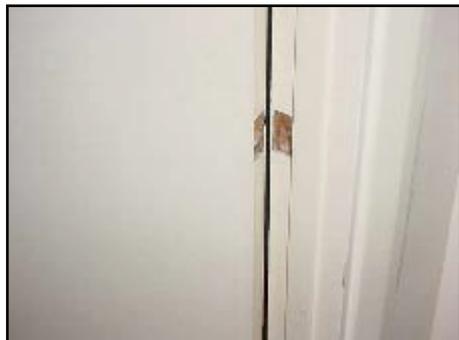
Whilst we appreciate that it can be a problem with the doors constantly shutting, we believe it is outweighed by the benefit of door closers stopping the spread of fire. We would suggest they are added.

Door closers missing

**ACTION REQUIRED:** Re-instate door closers.

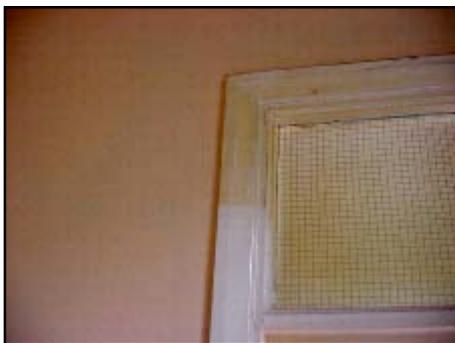
Whoever was painting appears to have lost interest in the painting just above head height!

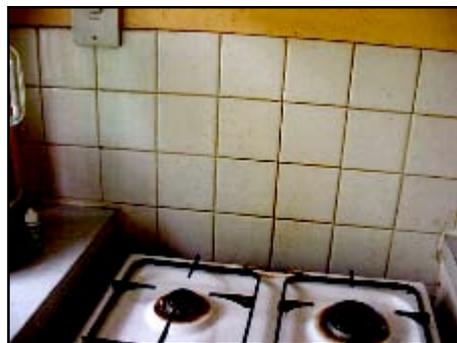
You will have some ingrained grease to deal with.

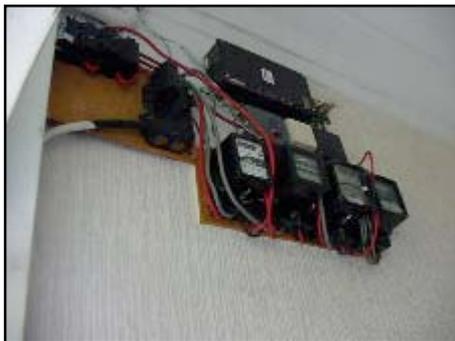
We did note that the property tended to have single sockets. You may wish to increase these to double.

Exposed fuse and circuit boards.

**ACTION REQUIRED:** An electrical test, if one has not been undertaken within the last five years, and possibly increasing the single power point units to double.

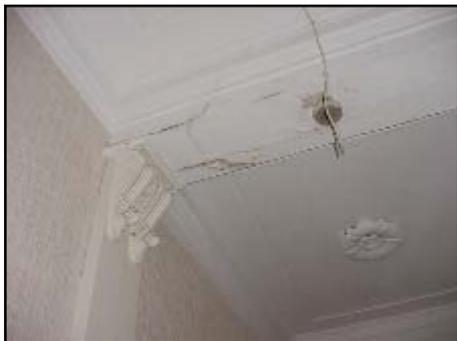
However, we did note that a leak appears to have occurred to the ceiling in the entrance hall, which looks to be coming from the bathroom above.

Ceiling in entrance hall showing leak mark.

**ACTION REQUIRED:** Your Legal Advisor should confirm that this leak has now been repaired.
