JOB REF: J1063/RBS/2

**RESIDENTIAL BUILDING SURVEY**  
**OF**  
**The Crescent**

**FOR**  
**Mr D**

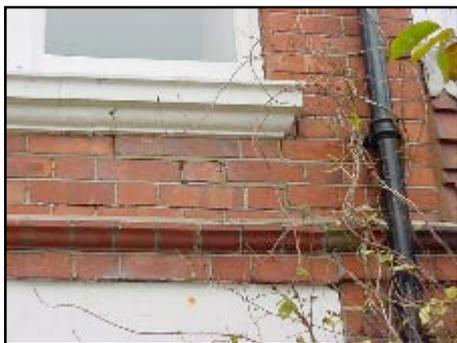
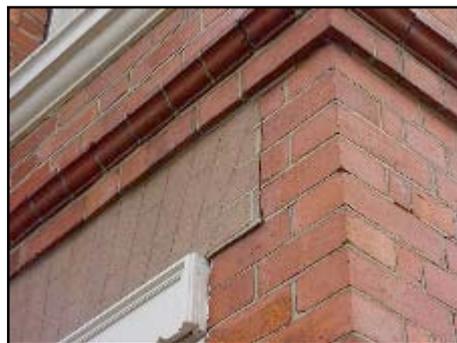
A diagonal crack running from the corner of the right hand lintel up to the window above.

There has also been some sideways movement.

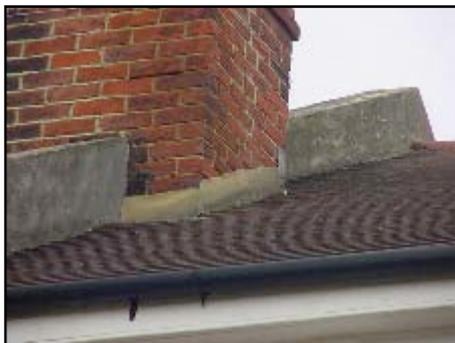
The flashing to the chimneys are poor quality and a cheap substitute for the real thing, for want of a better term. Originally the chimneys would had a lead flashing. We recommend the present tile on edge flashing and cement flashing be replaced in due course with lead.

The cement mortar to the base of the chimney rather than the flashing. Also note the pointing is starting to weather.

**ACTION REQUIRED:** When general high level work is carried out, which we anticipate will be in the next two to three years, at the latest five years, we recommend that the flashings are renewed.

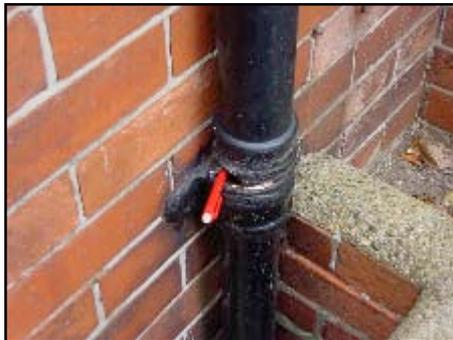
It has to be said that when the original cast iron rainwater goods have been replaced we feel it was probably on an ad hoc basis as the replacement work has not been that good. This has led to the interesting situation where you have part cast iron and part plastic rainwater goods. Repairs are definitely needed to the front left hand side where the pipe is completely broken (we advised the owners of this). There are also various other issues, which we think will come to light when you live in the property.

The broken joint between the plastic and cast iron pipe.

**ACTION REQUIRED:** Repair the down pipe to the left hand side of the property. This is causing damp within the front room.

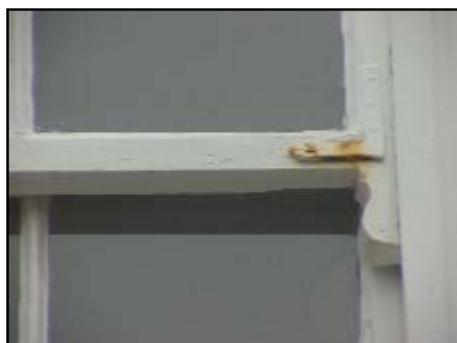
The windows to the bottom of the property appeared in reasonable condition (considering their age), however we did note to the first floor that one of the windows had a rusting metal bracket on it, these are normally put on where the windows have failed, it is fairly typical to see them on the first floor as people do not tend to paint them or pay as much attention to first floor and roof joinery. We therefore suggest that you re-decorate these and carry out any associated repairs in the summer of 2004.

The rusting ‘L’ bracket

**ACTION REQUIRED:** Although we dislike using the term ‘overhaul’ it is probably the best term to use for your windows. It may not be important to you that they all open, however we do feel that the first floor level windows should be looked at as we feel the ‘new’ paintwork may be hiding some latent defects.

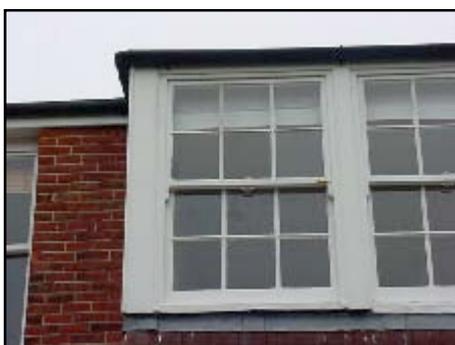
Not only does the window have the bracket to make it good, it also has a lead covered cill. This may be because water is discharging directly from the flat roof above, down the face of the window which has caused the deterioration in the window itself and also on the cill

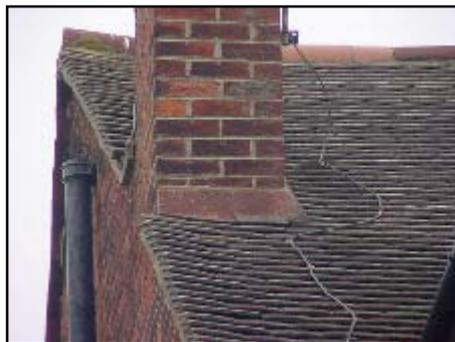
This chimney is brick built with clay chimney pots and is in reasonable to slightly poor condition and will need some re-pointing work in the not too distant future. Probably the main issue in my mind is the tile on edge that surrounds it that has been used as a flashing. This is what we would term a 'cheap and cheerful' flashing; it would be far better replaced by lead. We also note that there is an aerial strapped around the chimney; these can cause damage as they produce pressure points on the chimney so this should also be checked.

In the summary we have showed the rear chimney, this is the front chimney. The tile detail is slightly better than the cement detail that is to the rear chimney, but not much.

**ACTION REQUIRED:** Replace flashings with a lead flashing, re-point, check the flashings, which we were unable to see, and that the pots are bedded correctly. We suggest that this is carried out within the next five years, they could possibly last longer, but as you will see later on in this report there is a fair amount of high level work that could be grouped together and carried out all in one go.

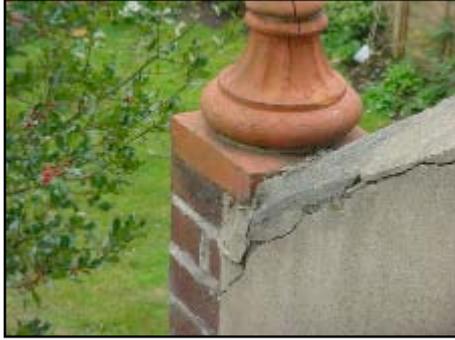
The render from this photo looks to be cement, therefore it will be fairly brittle and will crack. Note also the pot on the end is cracked nearly from top to bottom.

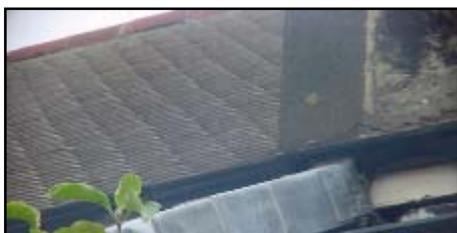
This is your neighbour's side of the parapet wall as it was hidden by a tree on your side. This needs to be checked when the roof is being checked.

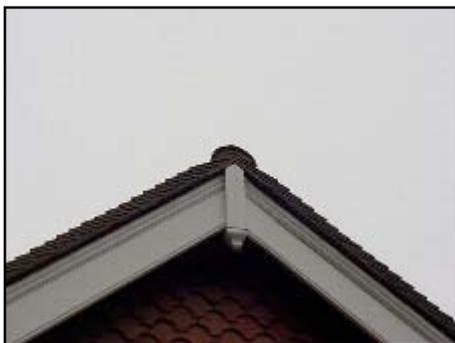
The removed finial. Also note the vertical tiling with the fish scale pattern, this is a typical feature of Edwardian properties

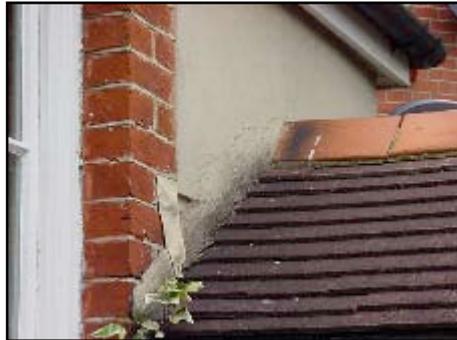
A very messy flashing detail. It also looks like the ridge tiles could do with some re-bedding, which involves lifting them, placing cement mortar on the ridge and re-bedding them.

**ACTION REQUIRED:** We suggest these are replaced when the high level work to the roof is carried out.

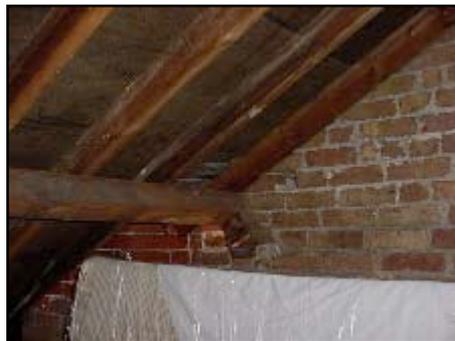
A general view of the roof. You can see the sarking felt, which is the black between the timber. You can also see some slight sign of condensation on the timbers. But what interested us most of all was the way that the purlin (the horizontal timber) has been supported on a metal bracket. We would guess that this has been added after.

**ACTION REQUIRED:** We recommend that some vents are added, although we would suggest you avoid the rather ugly plastic mushroom-type vent as there are now vents available that sit underneath the tile and could be carried out at the same time as the high level work is being done.

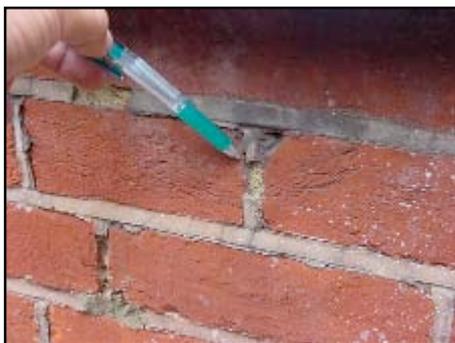
Here you can see the cement mortar pointing that is starting to come away to reveal the original lime mortar below

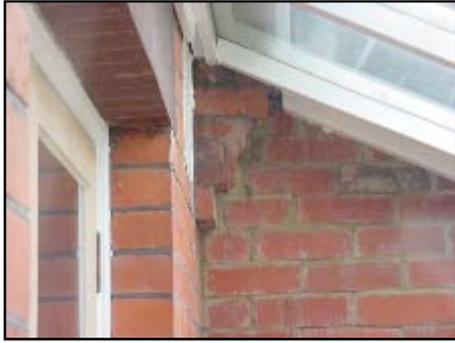
Some fairly awful repair work has been carried out within the veranda. The efflorescence (salts) is still coming through indicating this area must have been wet for quite a long time from a leaking roof, or it may still be getting wet from your adjoining neighbour. If you look in the Neighbourhood Section you will see that the upper storey of next door is very poorly maintained.

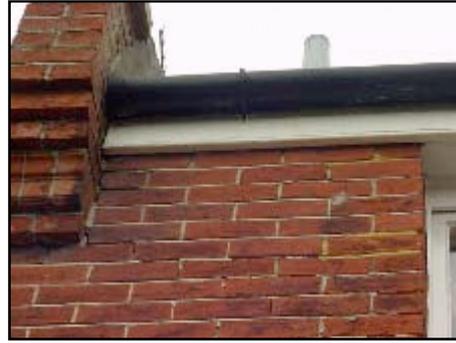
This shows a variety of re-pointing that has occurred and also generally the weathered joints.

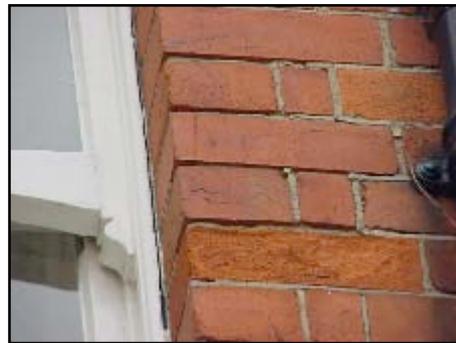
You can see the spalling brickwork at the base of this photograph, this is the effect of using cement mortar.

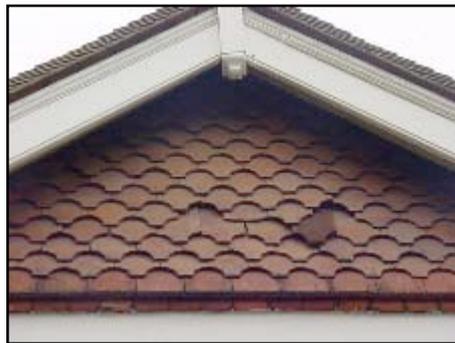
Here you can see that the tiles have slipped. It will be fairly difficult to get replacements for these.

**ACTION REQUIRED:** Re-position slipped tiles.

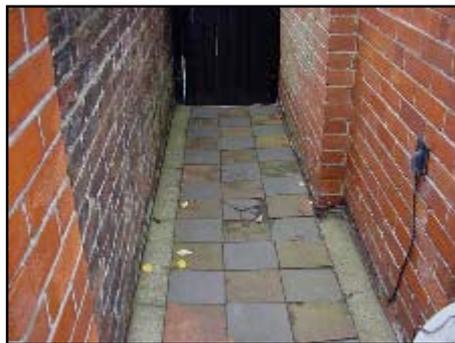
Our only slight cause for concern is the drains that run down the left hand side where we could see a dip in the pathway that indicates there has been some settlement in this area, possibly from a slight leak to the drains.

The slightly hollow shape of the path.

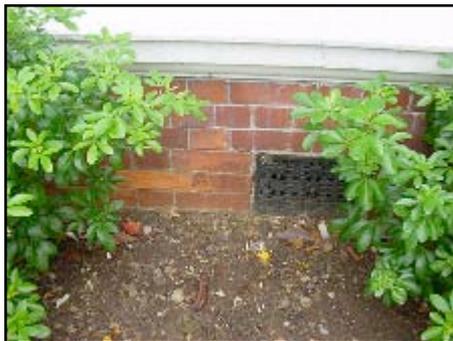
You do not have many of these and you probably require more now that the patio has been added to the rear.

**ACTION REQUIRED:** We suggest you have a closer look to see if there are any airbricks to the rear of the property that have been hidden and have been carried out by a thoughtful builder when, for example, he did the patio alteration. If you cannot find anything we suggest you give us a call and we will re-visit the property and have one final check before we recommend putting in airbricks, as it would be a shame to add a modern airbrick as it would not be in keeping with this property.

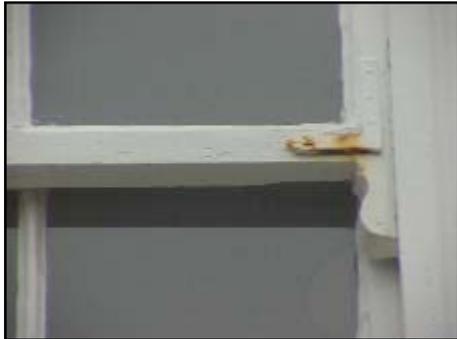
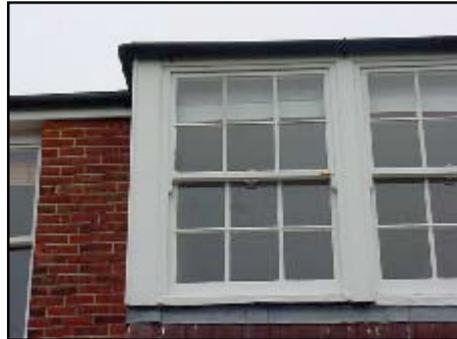
The rusting angle bracket

**ACTION REQUIRED:** The upper windows to be checked when the high level work is being carried out.

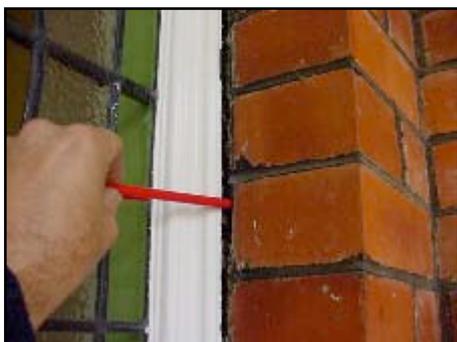
We have already stated the following in the Summary Upon Reflection:  
There seemed to be general problems to the windows in this area, not only does the window have the bracket to make it good, it also has a lead covered cill. This may be because water is discharging directly from the flat roof above and down the face of the window, which has caused the deterioration in the window itself and also on the cill.

we were intrigued by the movement to this window. The only thing we could think of was that the brickwork had perhaps got damp when the veranda above it was deteriorating and there has been differential movement between the brickwork and the window. We would suggest it is filled to stop any dampness getting in.

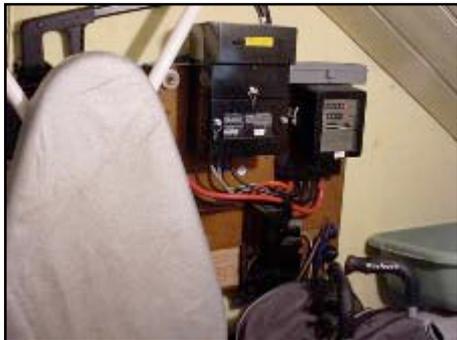
Not the red and black wiring; this has been superseded for many years. From what we could see this is an old electrical installation

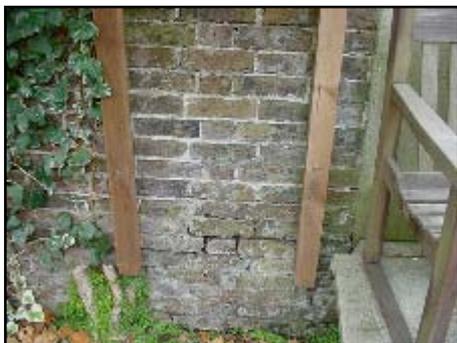
Some re-pointing required to this boundary wall.

**ACTION REQUIRED:** General re-pointing and re-rendering.

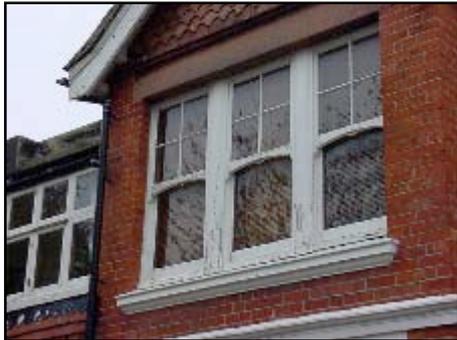
If you look closely you can see the peeling paintwork to the window.
