RESIDENTIAL BUILDING SURVEY

OF
1940s Detached Chalet Bungalow

Mr H

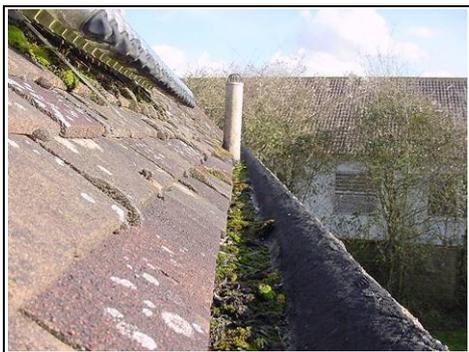
Looking into the Finlock guttering

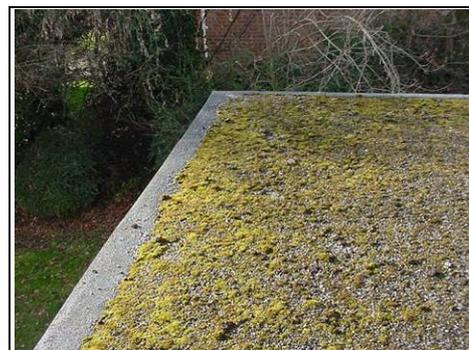
Right hand flat roof

We also noted that the flashing needs to be replaced in lead and there are also some repairs to the nearby pitched roof.

ACTION REQUIRED: We recommend complete replacement of the roof, and to ensure that there is a fall on it we would recommend adding cellular insulation, cut to falls, with a high performance felt on top.

Finally, we would recommend that the tree is cut back to allow some sunlight onto the roof, which should reduce the moss.

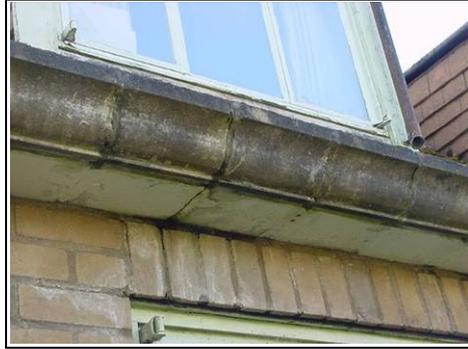
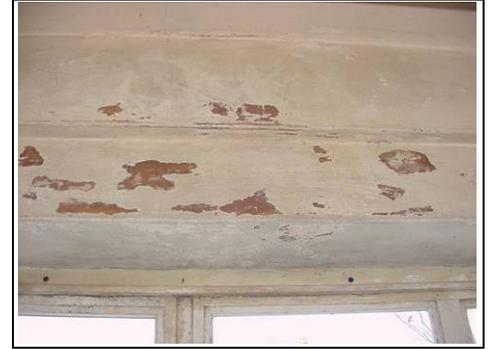
Dampness coming in from Finlock gutters

Even once this work has been carried out the walls will take many months, in our experience, to dry out. It is only after these many months that you will know whether you have managed to stop all leaks (and they will tend to return from time to time if the guttering becomes defective again).

ACTION REQUIRED: The gutter needs to be made watertight. Typically, this is with a bitumen paint, which could be a DIY type job, particularly as great care needs to be taken over it to ensure that it is done properly. The bitumen coating will need regular repair to ensure it stays watertight. An alternative may be to line the gutters with lead, providing sufficient fall can still be obtained on them.

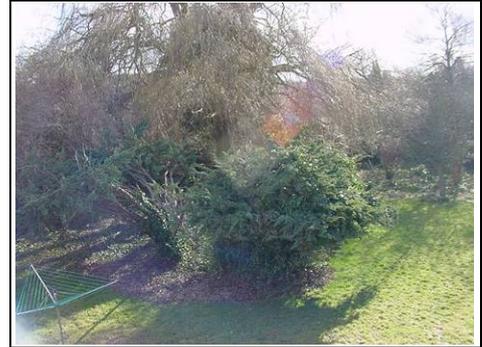
There is a large willow tree in the garden, which, whilst being a beautiful tree, also does indicate that there is a reasonable amount of water in the ground below as, if you recall, typically willow trees are next to rivers and therefore like water.

ACTION REQUIRED: We would recommend an arboriculturalist be called (not a tree surgeon) to advise on how to maintain the trees.

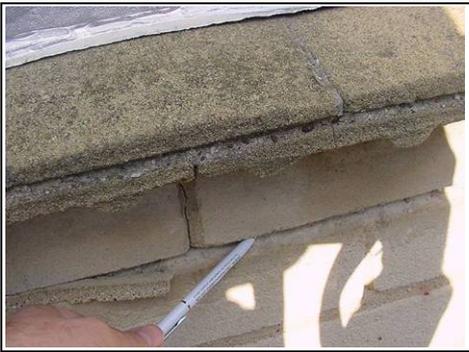
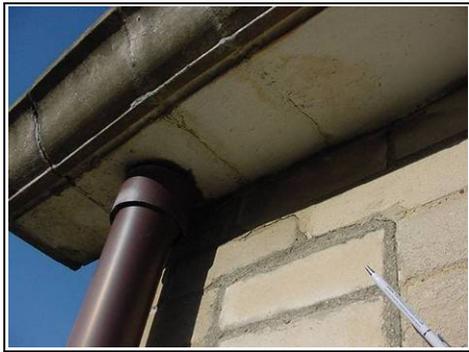
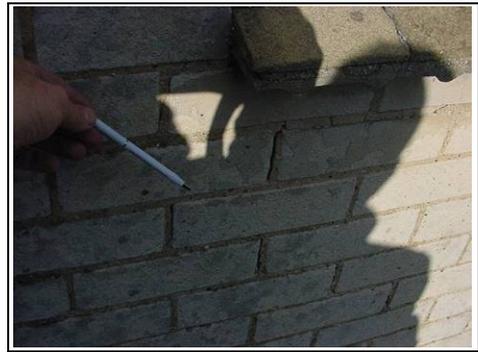
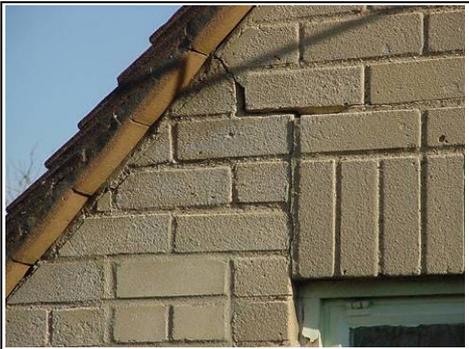
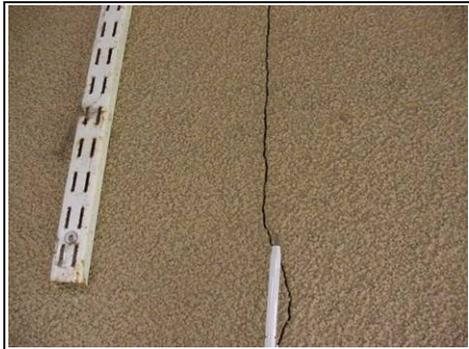
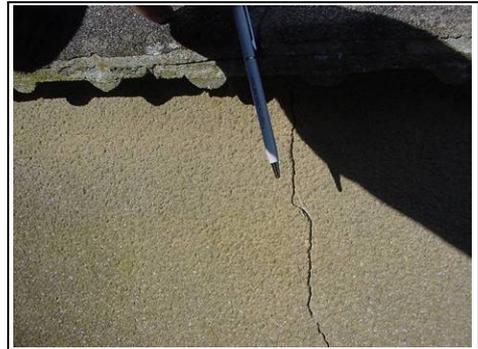
There are various vertical cracks around the windows and there is one crack running from the top to the bottom of the structure on the right hand gable.

There are various cracks to the front and rear.

Examples of cracking,
repointing needed

ACTION REQUIRED: All cracks need filling with a lime based mortar that matches the dry mortar to the house. The matching of the mortar is very difficult to do. If you are not careful the building will be repointed in a different colour mortar and will look to have “scars”.

ANTICIPATED COST: This ranges from a DIY style job to a few hundred pounds, as a yearly event, with a full style bricklayer that knows how to use lime mortar, spending a few days at the property with a soft brush, removing any loose pointing and repointing as necessary. We would add that we noted some pointing had come loose. This will need repointing in a lime based mortar, as opposed to a sealant being used.

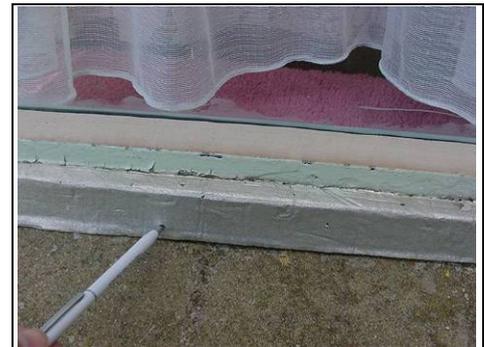
Metal timber frame

You have a number of metal windows. These tend to promote condensation, depending of course on how you use the property, whether you regularly air it and/or the number of baths you have, for example, or the type of cooking that you carry out.

ACTION REQUIRED: We therefore recommend replacing some windows to rooms that you utilise most (but there is no rush, remember the SPAB (Society for Protection of Ancient Buildings) philosophy of the first thing you should do when you get a new property is do the gardening and think about what you are going to do to the house). We would also recommend a visit to Solopark, near Duxford in Cambridgeshire, and one of the largest building reclaimers yards in the country, where you may find some inspiration and nice windows!

ANTICIPATED COST: This depends on the quality of the double glazed windows, if you choose to replace with double glazed windows. We would always recommend trickle vents. We have recently put six new double glazed windows and two new doors in a rental property for £3,200 including VAT.

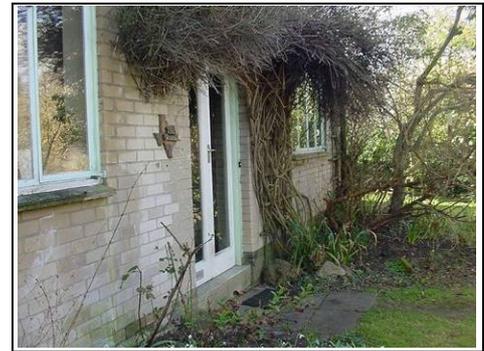
There is some rising damp at the base of wall, which is being caused by the high ground level.

ACTION RQEUURED: We therefore recommend a French gully be added.

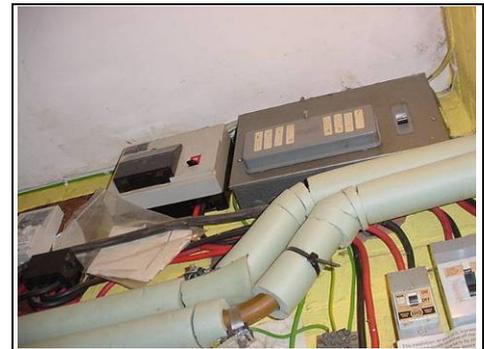
Dated electrics

ACTION REQUIRED: We would recommend that the fuseboard is replaced with a good one that works more efficiently and also recommend an NICEIC inspection and test and their recommendations. We would also take the opportunity to add extra power points, as these seem to be minimal!

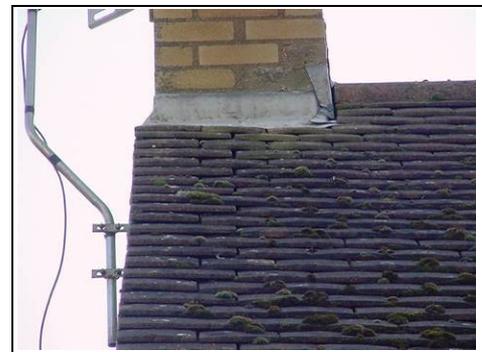
Displaced roof tiles,
front left hand side of property

In this case, dampness seems to have got through the tiles and the underlayer beneath. This may be due to the mass of moss on the roof, so we recommend that this be cleared, and it may be due to slight opening up of the roof, due to movement in the structure.

ACTION REQUIRED: We recommend that all moss is removed from the roof and a roofer spends half a day to a day on the roof, generally tidying up and closing up the joints.

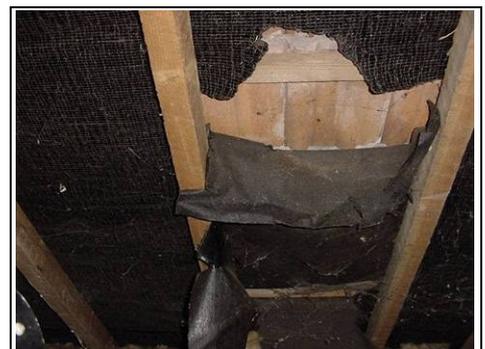
Low Level Roofs

There is also a low level pitched roof, where the felt unfortunately has been damaged by the ladder as you get into the roof. We recommend you replace it and then put a sheet of timber between the joists to stop the ladder from causing further damage.

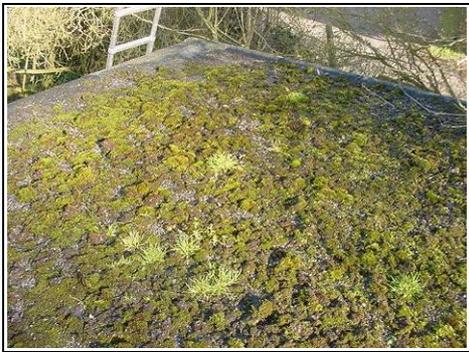
Mass of moss on left hand flat roof

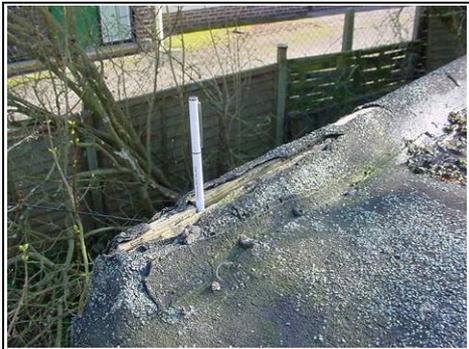
Damage visible to left hand flat roof

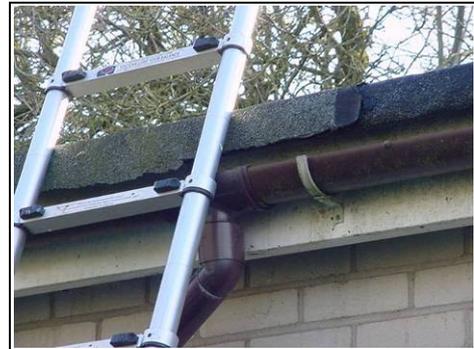
Repairs and replacement of the mineral felt visible

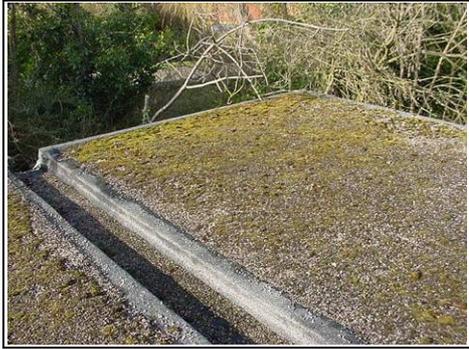
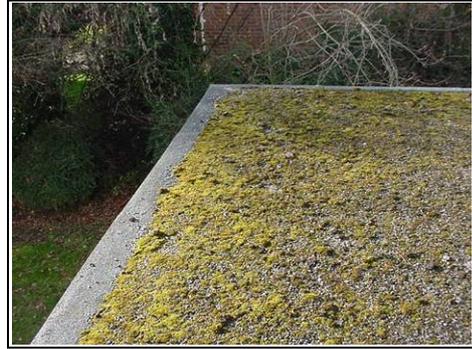
Mass of moss on
Right hand flat roof

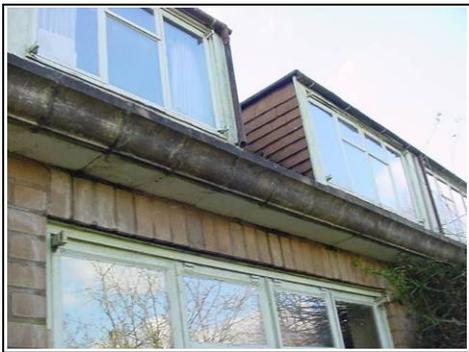
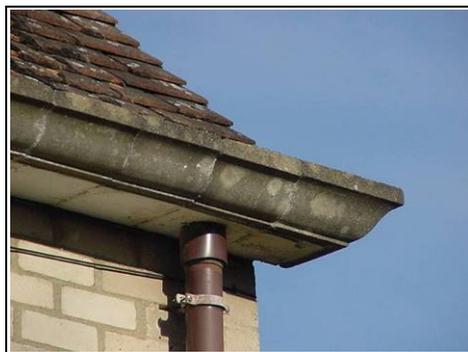
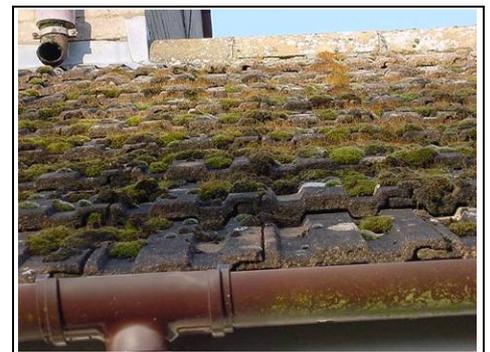
A mixture of Finlock and plastic gutters

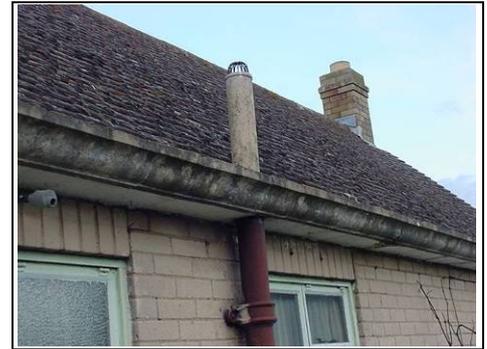
The property has a cast iron soil and vent pipe. It is in need of redecoration. At the same time you should check to see if there are any cracks, particularly to the rear at high level. As discussed, the top of it does look to be in a different material.

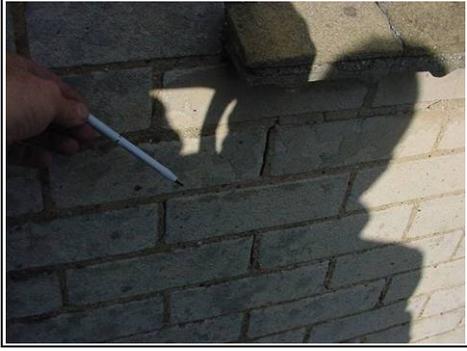
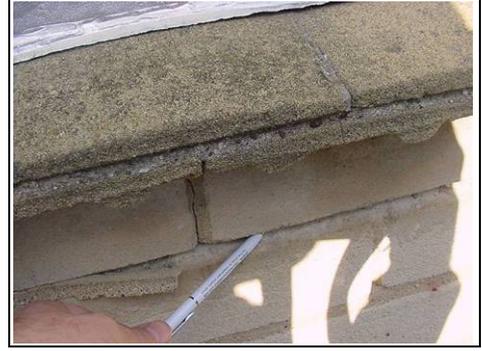
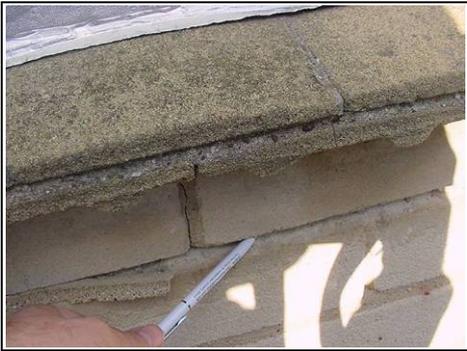
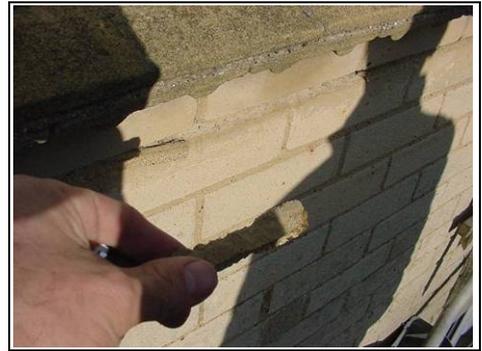
Examples of cracking in walls

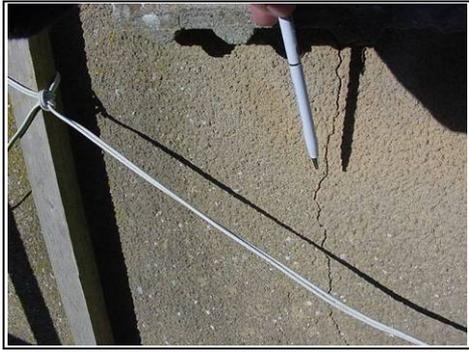
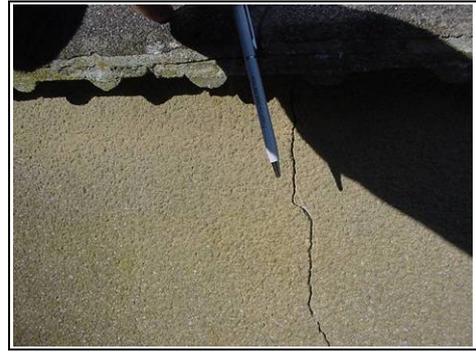
The property has vertical cracks, these are between the windows, which are reasonable common as this is the weakest area.

Cracks to the render on the rear
of the right hand side

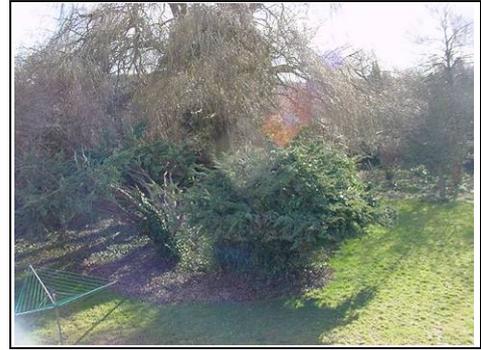
The amazing willow tree in the garden.

The willow tree is relatively close to the property and you need to get advice specifically on this tree. Interestingly, it is generally considered that, where there is a willow tree there is usually water.

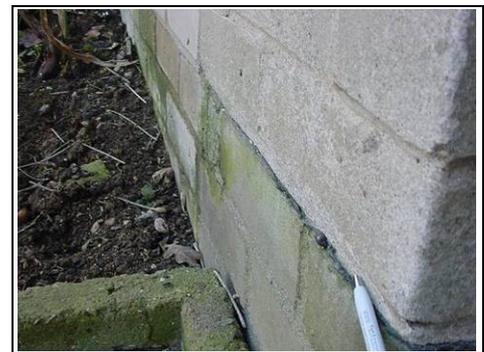
Unfortunately, the ground level is high in some areas and you will need to lower this. This may be sufficient, however we have recommended adding a French drain, as a belt and braces measure.

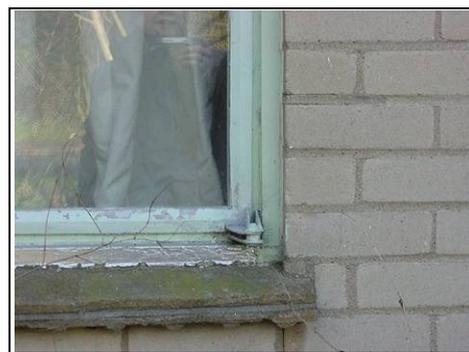
Many of the metal windows are remaining. These can lead to condensation and generally rust and are draughty.

Metal window

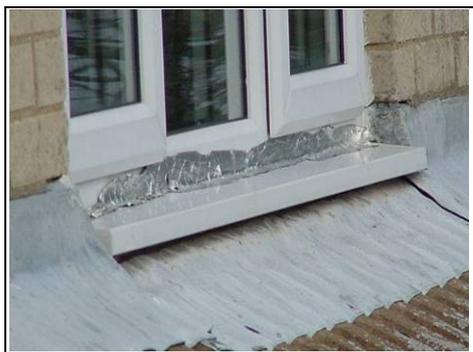
Plastic windows with foil at the bottom

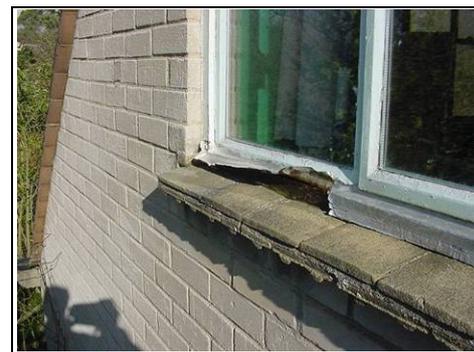
Lifting the aluminium revealed rot and rust to the windows. This is very unusual

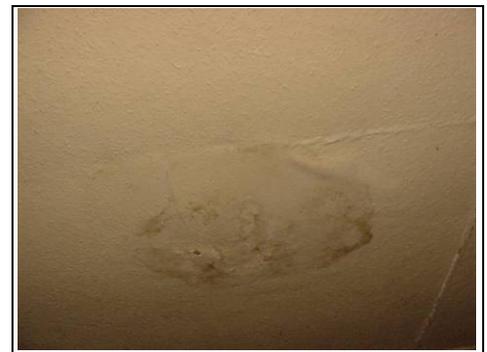
Leak in the rear ground floor bedroom

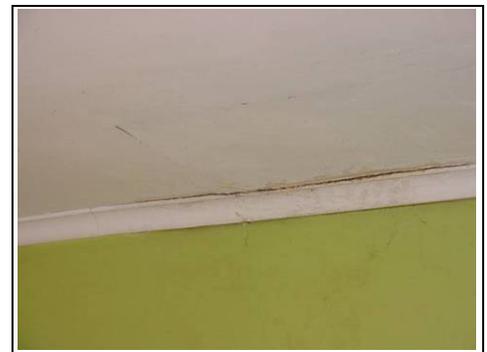
Main left hand bedroom, looks to have been damaged by water

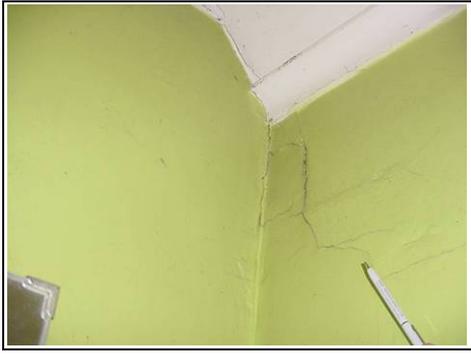
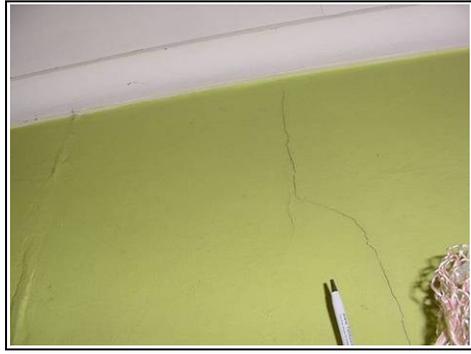
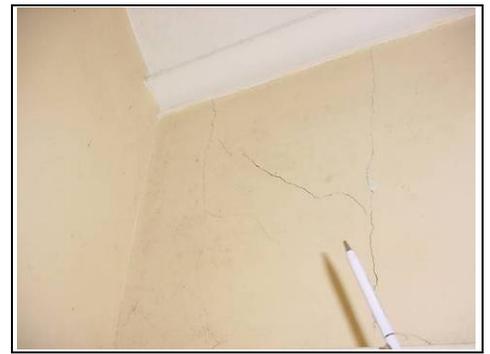
Internally there are many cracks to the walls. These cracks are caused by a combination of the materials used in the construction and dampness getting into the property for a long period of time.

Cracks to internal walls

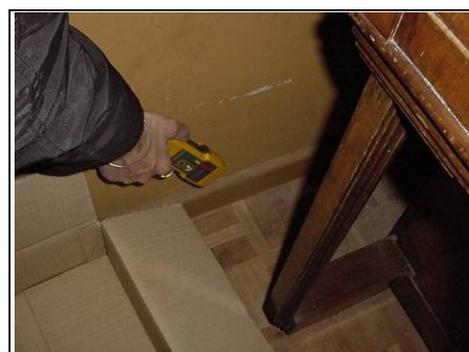
The ground floor of the property is below the outside ground level this leads to dampness.

ACTION REQUIRED: Lower the ground level and add a French gully. Please see our comments in the Executive Summary.

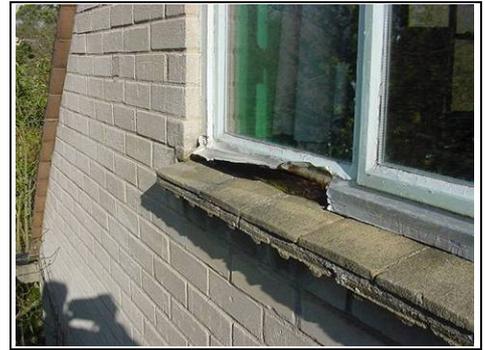
We believe foil has been added to the base of the windows as a misguided solution to the condensation that is occurring, thinking that the dampness is coming from the outside when it is likely the condensation is occurring inside and is causing the bottom of the window frame to rot beneath.

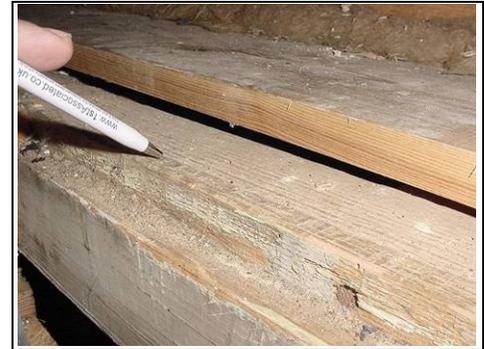
A small amount of woodworm, found around the hatch as you enter the room
