High Street Example Commercial Building Survey

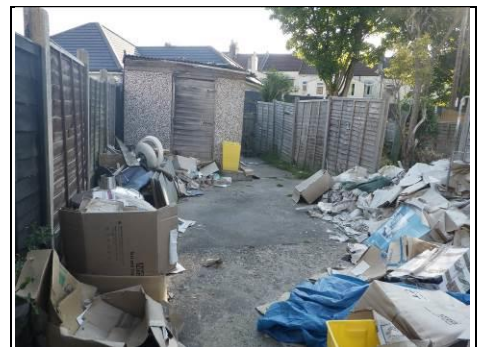
Rear garden and shed.
The area was full of stored/
waste items

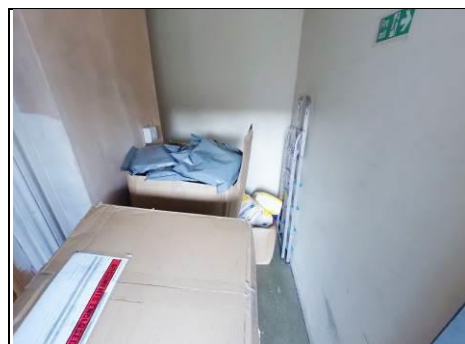
Rear left exit/fire exit.
Blocked at time of survey

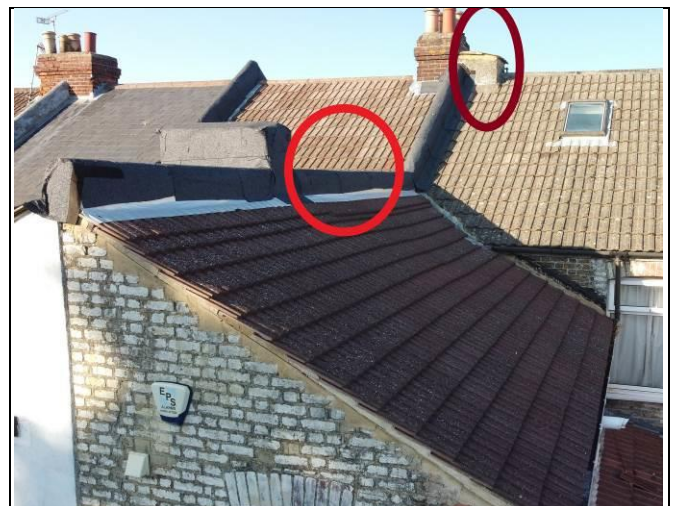
When this property was originally built the rooms would have been heated by real fires and as such would have chimneys. From what we can see, the chimneys have been removed, either partially or completely, and as such there should have been structural supports added, Building Regulations Approvals obtained, together with Party Wall agreement with the neighbour, which your legal adviser needs to check and confirm.

Front and rear chimney removed/partially removed

We discuss later in within this report the structural integrity of the property, as we feel these chimneys have been removed/partially removed incorrectly, which has affected the structural integrity of the property.

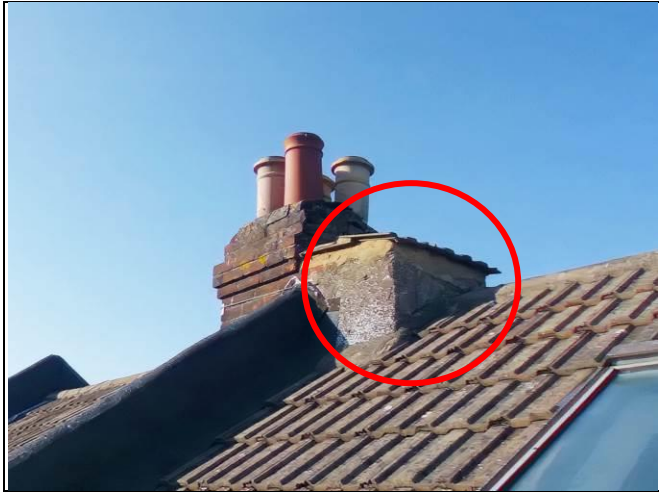
Close up front chimney
~ Aerial View - 360 Photo ~

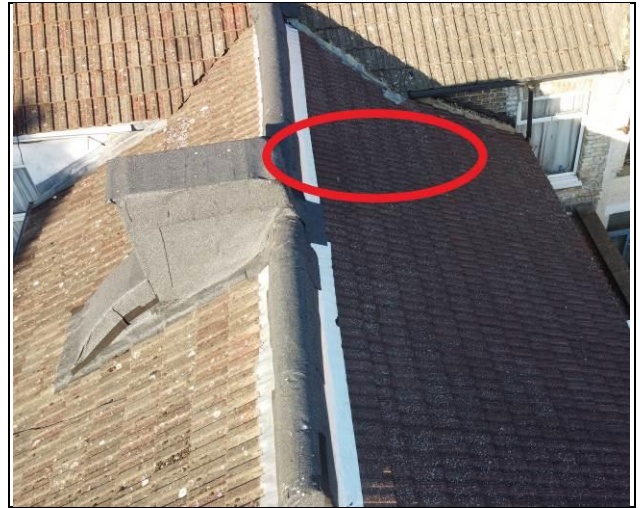
Close up rear chimney
~ Aerial View - 360 Photo ~

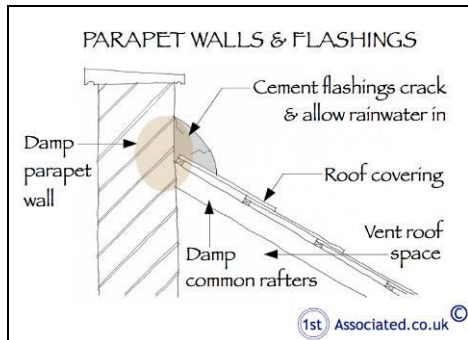
Plant wall problems with cement flashings

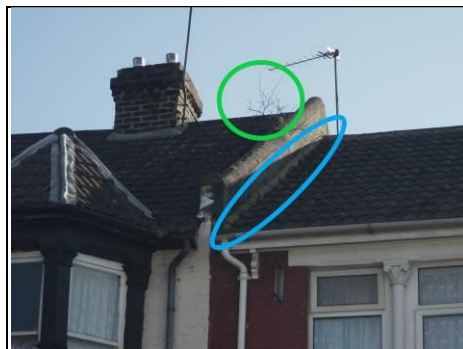
Plant growing out of front left parapet and cement flashing – we much prefer to see a lead flashing

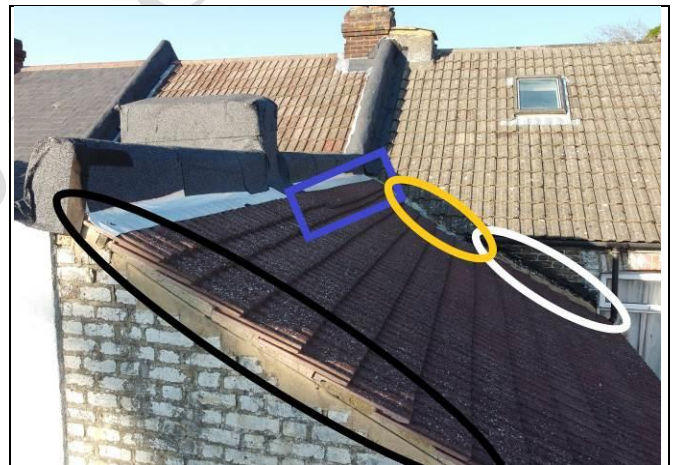
To the rear roof the concrete tiles we can see that some of the tiles have slipped. We can also see poor quality detailing to the parapet walls, which we have already talked about, also where the roof adjoins the other roof and the surrounding wall.

Problems with rear roof

Purple box: slipped/out of alignment concrete tiles

White oval: cement and bitumen repaired flashing.

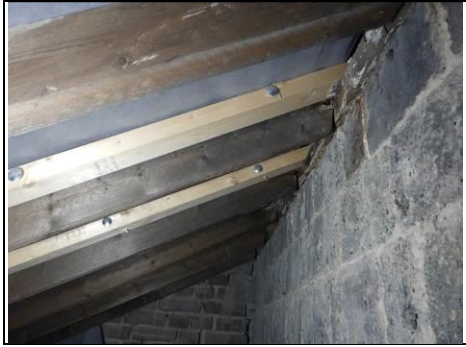
We have not had access into the front of the main roof to see the structure. What we can see in the rear roof is that some of the timbers are deteriorating and rather than replacing these they have been strengthened by adding additional timbers to them, what we term as back to backing.

Back to backing of timbers in rear of main roof

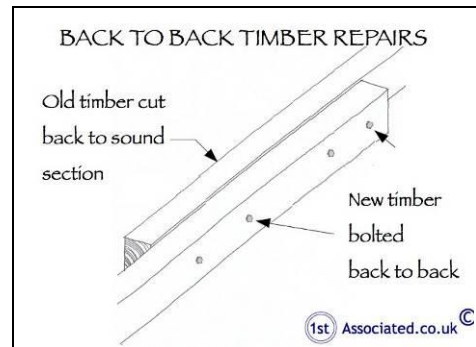
Back to backing

Our concern is the overall quality of the work to the roof, it is what we would term as DIY type work.

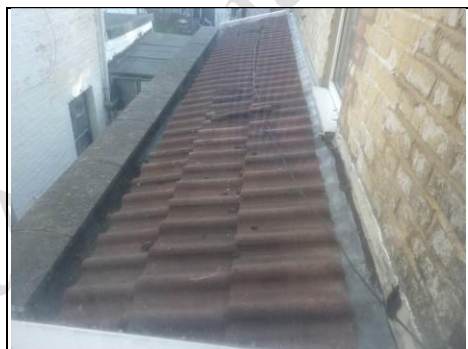
It has an internal gutter, we are not keen on these as they tend to leak sooner or later, either because the roof is so shallow or because of the internal gutter.

We can see there looks to have been water damage and deterioration already from the condition of the left hand wall and the coping stones look like water is leaking through. We think in the long term this will cause damage, deterioration and dampness.

Close up single pitched roof

ACTION REQUIRED: The internal gutter needs to be checked and cleared to ensure it is watertight and you need to re-bed/repair the boundary wall and associated coping stones.

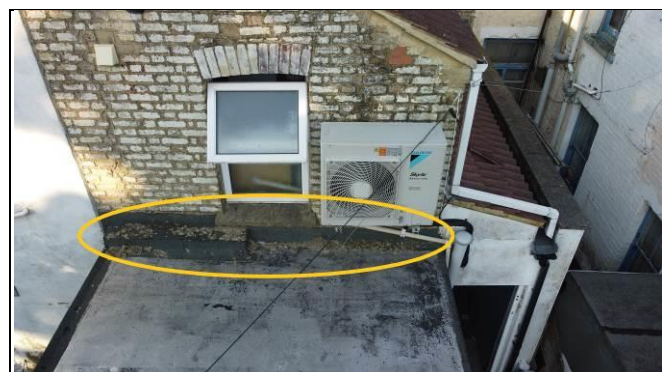
1. First of all it is a flat, flat roof, meaning there is no good fall on it. However, even if it did have a fall there is no gutter to catch the water, so presently because there are no upstands around the flat roof (marked with black ovals on sketch) we think that water will be discharging down the external walls.
2. We also noticed that the felt work has not been carried out very well and bricks are visible to the front of the wall.
3. Also, we would add that we think the flashing is poorly carried out and we would prefer it to be replaced with lead.

Felt flashing

ACTION REQUIRED: We recommend a new roof, with insulation cut to falls, and the adding of guttering and downpipe. The downpipe needs to discharge into a soak-away.

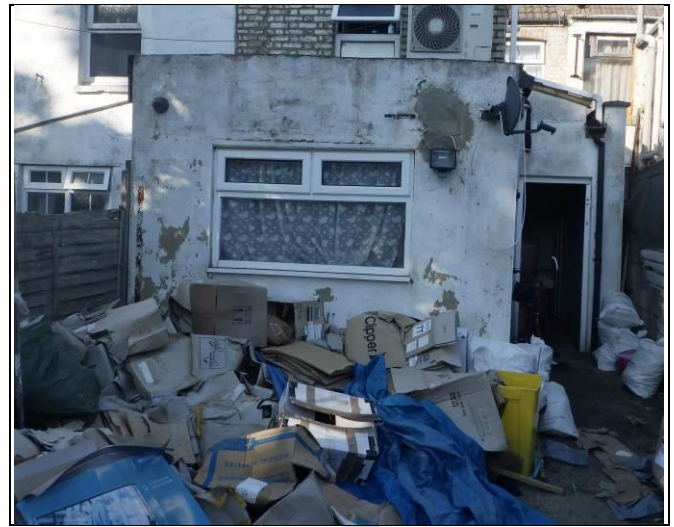
Mass of stored items in front of rear rendered wall
~ Aerial View - 360 Photo ~

We would also suggest you then phone our office to book a re-visit so we can look at the property when it has been cleared of stored items so the walls are more visible to the rear of the property.

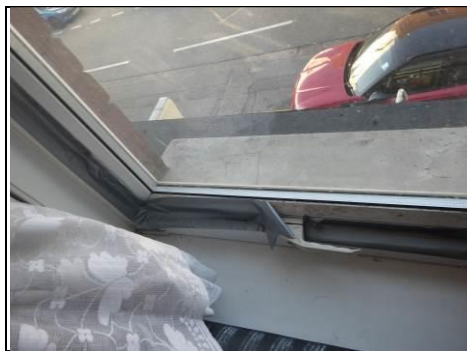
Some of the windows are misting over and many are not openable and sealed.

Problems with front bedroom window

ACTION REQUIRED: We would recommend replacing all the windows with double glazed windows with trickle vents.

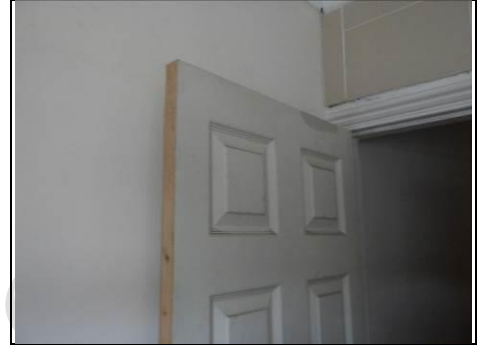
Kitchen door is a fire door and is falling off its hinges

ACTION REQUIRED: We recommend you get professional advice via a Fire Officer with regard to what fire safety systems would be good for you.

We recommend fire doors with door closers;

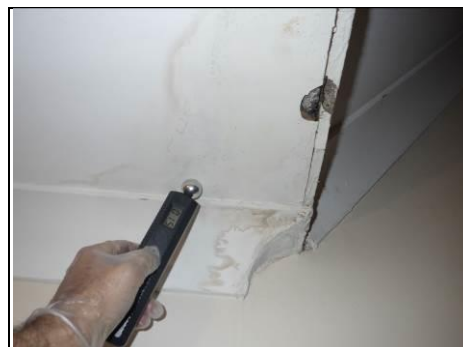
We noted that the surrounding properties have render to their walls, which indicated to us that there may be problems with lateral dampness in these properties, even once you have carried out the roofing work we have mentioned in our earlier comments.

Testing for lateral damp to staining by stairs to room in roof

ACTION REQUIRED: It may ultimately be better for you to re-render/render the front and rear of the property to make it watertight. However, we would try out the other areas of maintenance of work we have mentioned throughout this report first. We do need to make you aware of this.

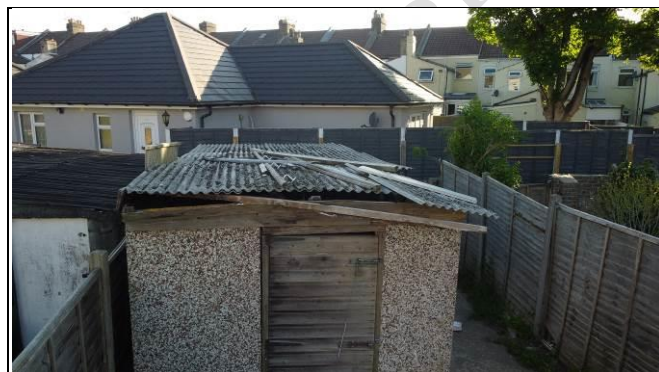
In his case we believe the shed to the rear of the garden has an asbestos roof.

Shed in rear garden
~ Aerial View - 360 Photo ~

ACTION REQUIRED: You need to obtain an asbestos report from the existing owners or have one carried out yourself.

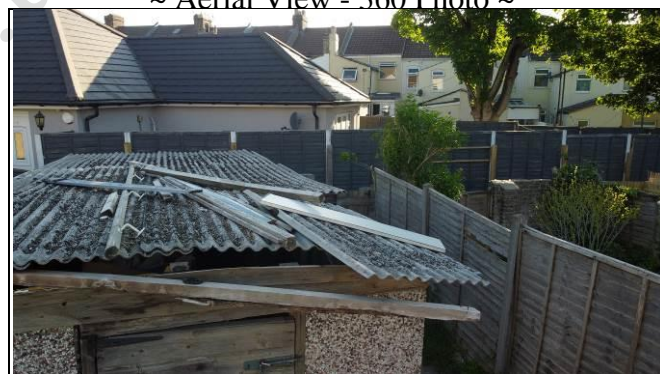
Asbestos roof
~ Aerial View - 360 Photo ~

We always recommend all asbestos is removed.

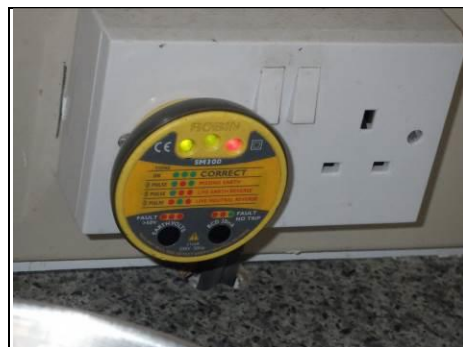
The electrics failed our earth test twice during the course of the survey. There should be three green lights, we had two red lights the first time, which indicate the live neutral has been wrongly installed. The second time we carried out the test is failed with one red light, which means an unknown fault.

Second earth test failed

ACTION REQUIRED: We recommend immediate work is carried out to make the kitchen safe and also a general upgrade of all the electrics. We reiterate, this work needs to be carried out immediately.

We recommend a new fuse board in a metal fire resistant casing.

We also recommend an Institution of Engineering and Technology (IET) test and report to be carried out by an NICEIC registered and approved electrical contractor or equivalent.

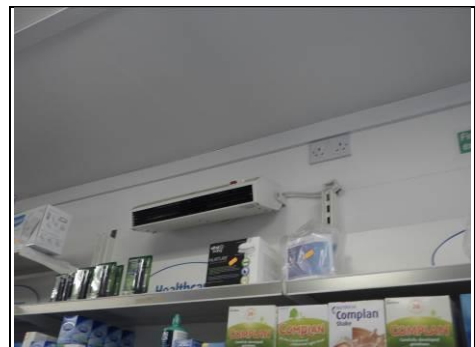
There are some electric heaters in the property in the front of house shop area, which also need checking.

Electric heaters

ACTION REQUIRED: We recommend the electric heaters are checked at the same time as the electrical work is being carried out.

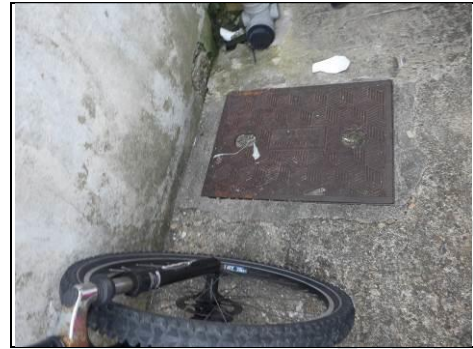
We understand you have had problems with the drains. We could see what we would term as an awkward layout and we understand macerators are being used, which can be problematic.

Rear manhole – not opened up

We would recommend a closed circuit TV camera report of the drains and clearing as necessary.

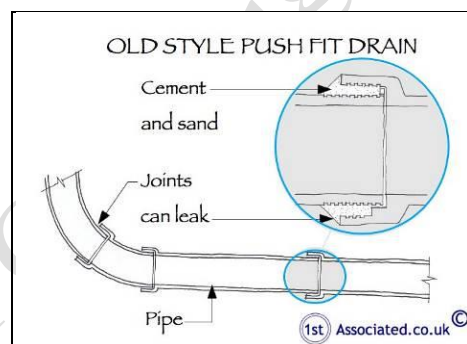
In older properties, such as this, drainage was often push fitted together rather than bonded together.

Push fit drains

ACTION REQUIRED: The only true way to find out the condition of the drains is to have a closed circuit TV camera report to establish the condition of the drains. In this age of property there have often been leaks over the years.

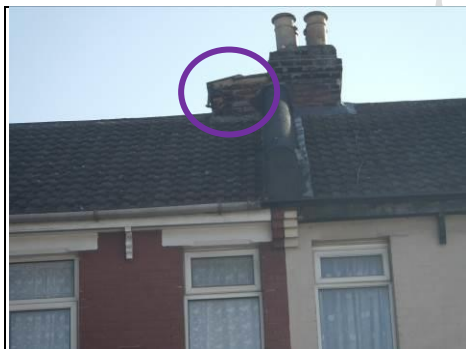
This chimney is brick finished with a cement flashing. It has been dropped and capped using tiles. We can only see the very top of it and are not sure whether it is supported underneath.

Front right chimney –reduced in size and capped

ACTION REQUIRED: Please see our comments in the Executive Summary.

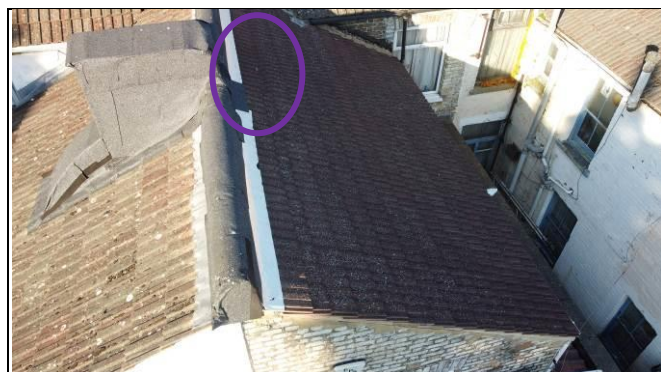
This chimney has completely been removed. The neighbour's side has lowered the chimney and capped it with felt.

Our concern is the chimney remains in part and is not being supported, or it may be affecting next door's chimney.

Chimney removed, with neighbour's chimney
felted over
~ Aerial View - 360 Photo ~

ACTION REQUIRED: Please see our comments in the Executive Summary.

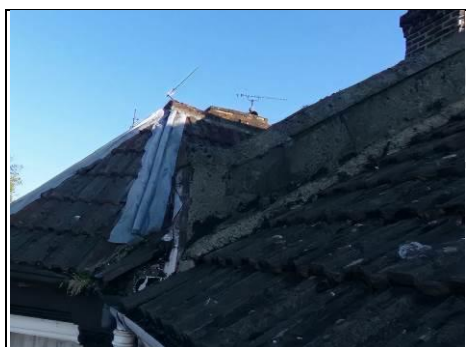
Close up front left parapet

These are in poor condition, with cement flashings. There is a tree growing from the front left parapet.

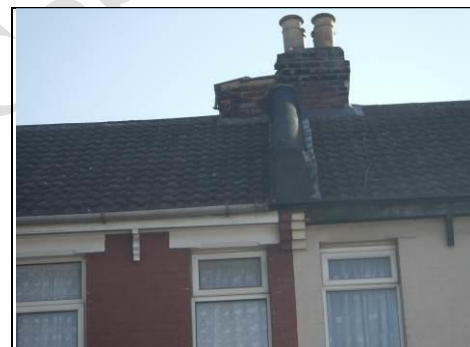
Front right parapet – felted over

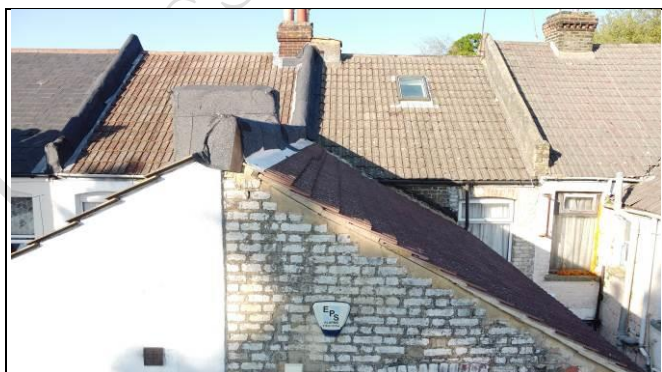
These have been felted over and we can see Flashband flashing has been used, which we consider a temporary material.

Felt over rear parapet wall
~ Aerial View - 360 Photo ~

Overall, we think the parapet walls are leaking. They have been repaired using a felt flashing in some areas, which is a poor quality repair with Flashband, and we can see repairs on the repairs.

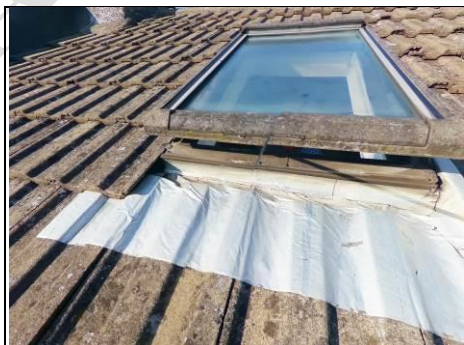
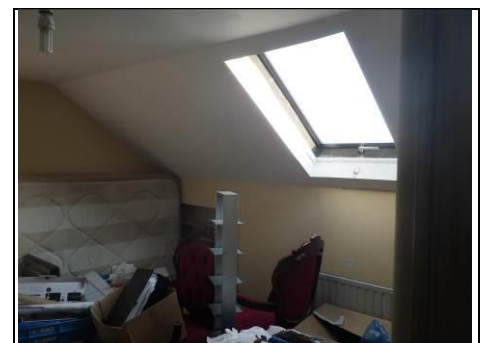
There are signs it has been repaired, as we can see Flashband around it. When we tried to open it internally it would not stay open.

Roof window

Roof window in room in roof

ACTION REQUIRED: We recommend you repair and redecorate or it may be more economical to fit a new roof window.

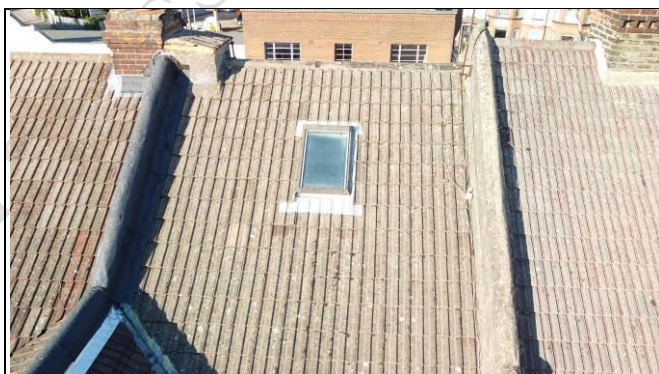
In this case we have not been able to view the front roof, in the rear roof we can see the timbers have been strengthened by back to backing of timber.

Rear concrete tiles
~ Aerial View - 360 Photo ~

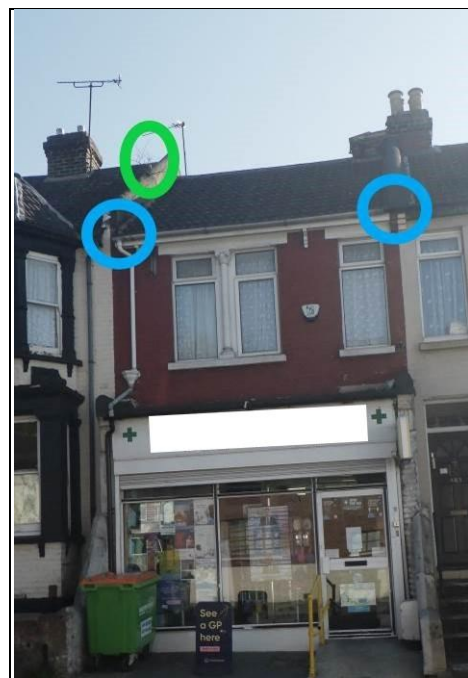
Front roof problems

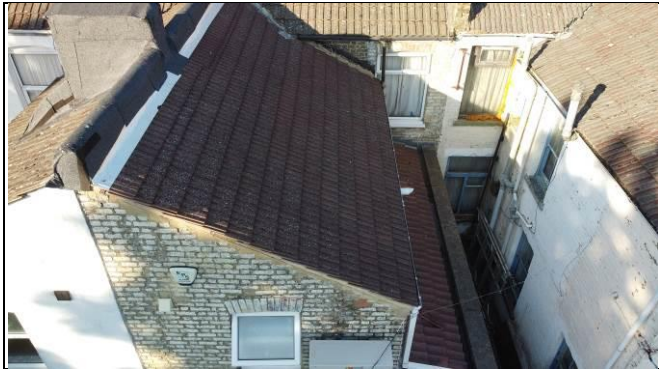
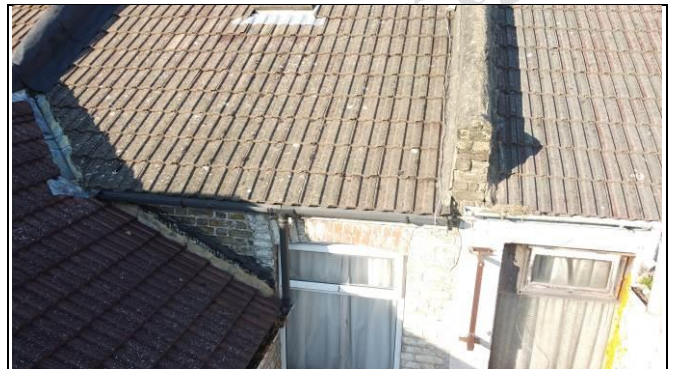
This is pitched, clad with concrete tiles. There are lots of problems with this roof.

Rear double pitched roof,
with left side lower roof side below
~ Aerial View - 360 Photo ~

Cement fillet flashing and poor valley gutter detail
~ Aerial View - 360 Photo ~

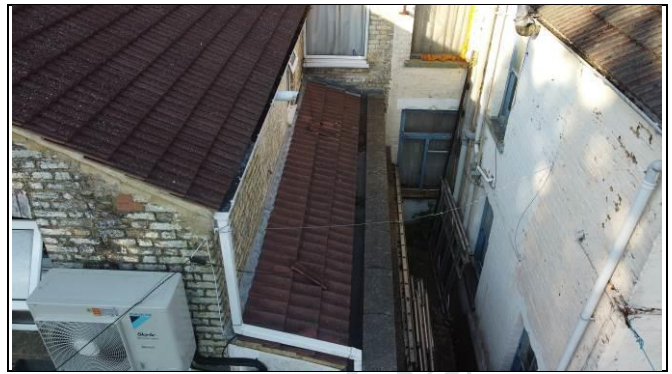
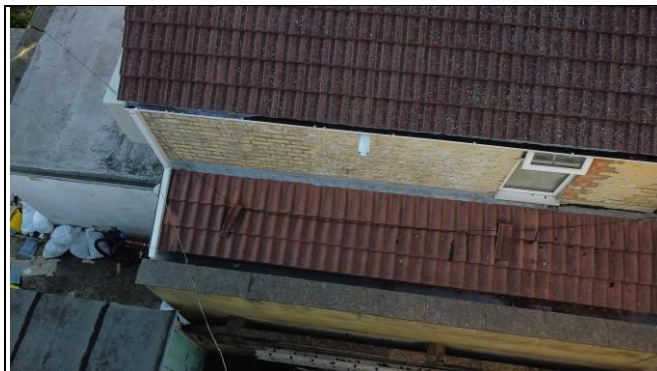
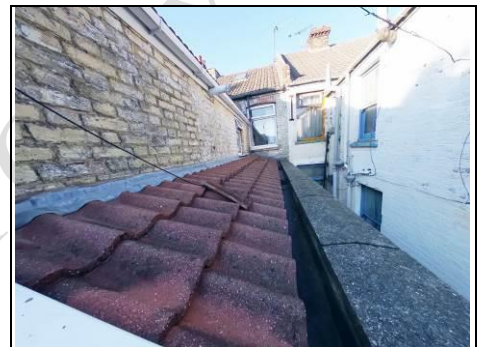
This is shallow pitched, clad with concrete tiles and an internal gutter. It is built right up to the boundary wall.

Left side single pitched roof next to boundary wall
~ Aerial View - 360 Photo ~

Rear left side
~ Aerial View - 360 Photo ~

Close up

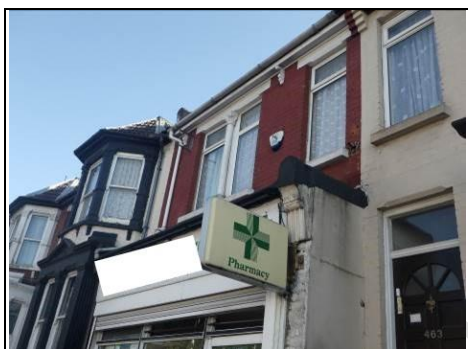
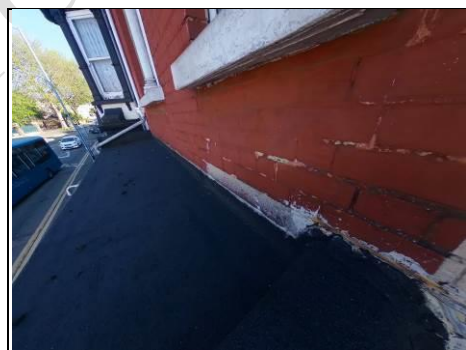
The front single storey flat roof and is covered with felt. It has a felt flashing, also parapet walls to either side look to be felted over, which we are not keen on.

Front flat roof, with parapet walls to either side

Close up front flat roof

ACTION REQUIRED: We recommend the roof is re-done and the felt removed from the parapet walls to either side and these are repaired properly, and a lead flashing is added.

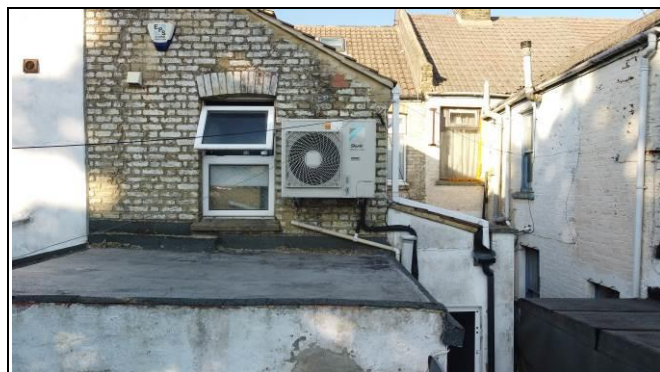
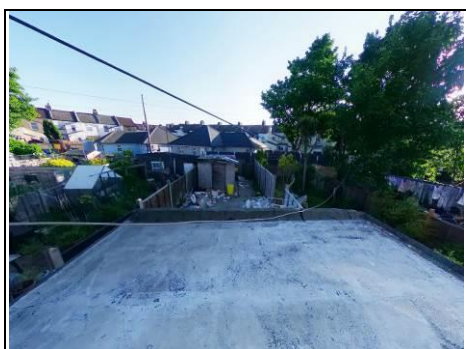
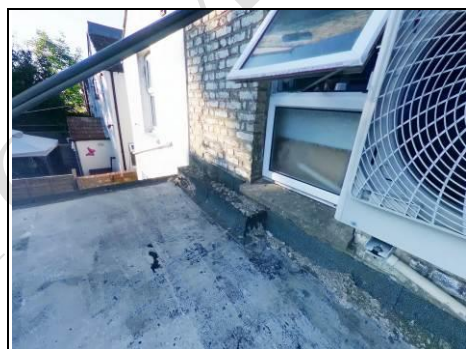
Rear single storey flat roof
~ Aerial View - 360 Photo ~

Rear flat roof

Close up flashing

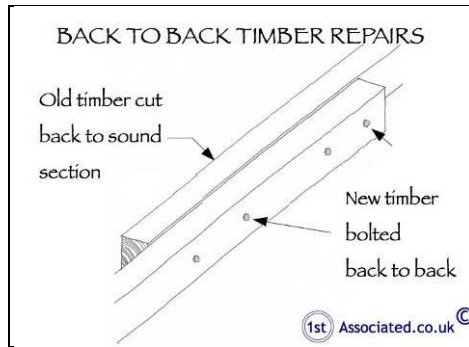
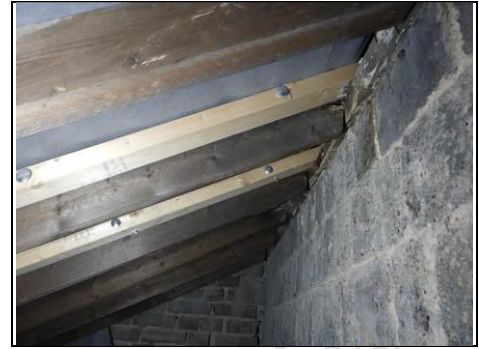
Our examination was limited by the general configuration of the roof. It is in below average condition for its age, type and style. There is back to backing timbers. We can see that dampness is getting in and we can also see cracking to the rear gable end wall.

Back to backing

Back to backing of timbers

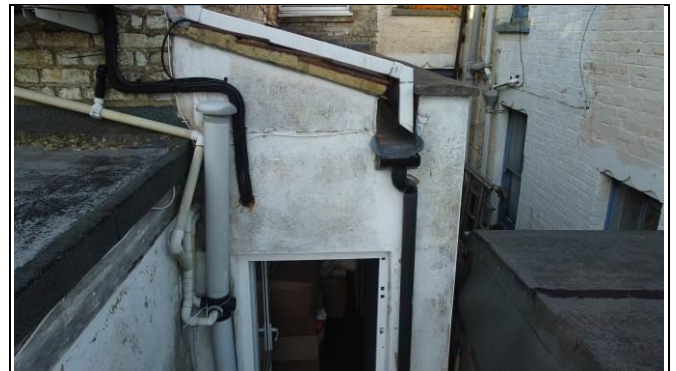
The rear hopper head is quite small and likely to be overflowing, discharging water down the wall.

Hopper head to rear likely to be overflowing
~ Aerial View - 360 Photo ~

ACTION REQUIRED: Replace rear hopper head with a larger hopper head, also improving the lead detailing, as well as of course putting in a gutter to the rear flat roof.

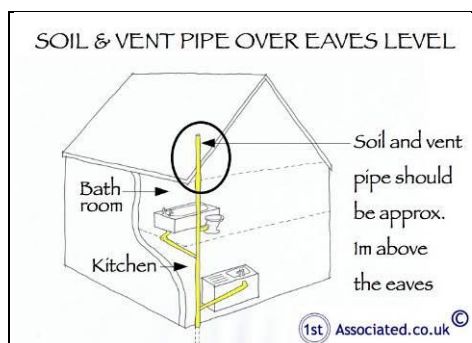
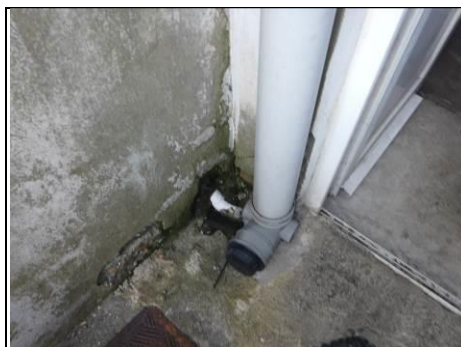
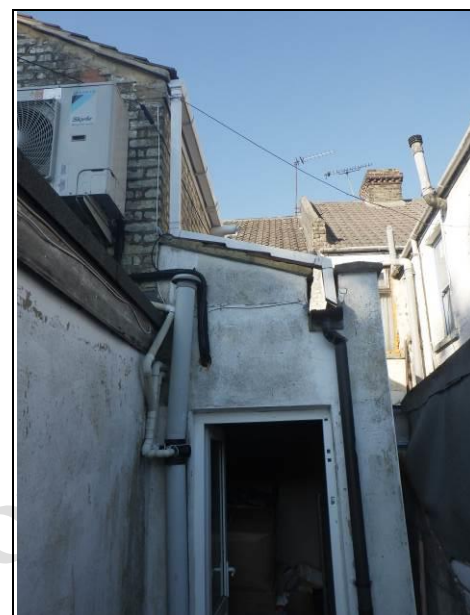
It has a number of different fixtures going into it incorrectly and we believe it to be an illegal fitting.

Soil and vent pipe should be above eaves of roof

Base of soil and vent pipe - does not look to be legally fitted

Rear soil and vent pipe, with different fixtures going through it

Also, as mentioned, it is below roof level and we recommend it is increased in height above the eaves of the roof, which will be an awkward detail given its position.

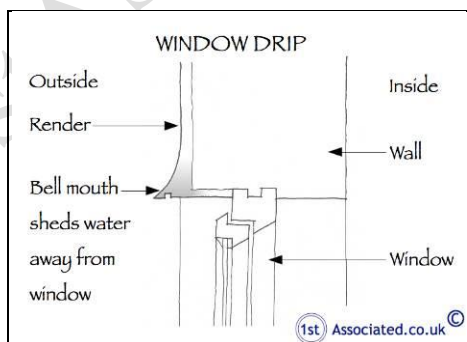
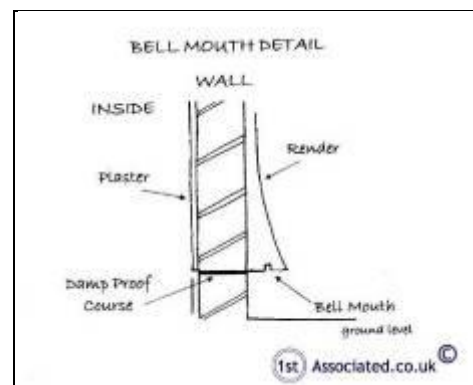
In this case we would comment that there was no drip detail nor bell mouth detail to the base of the wall.

Window drip

Bell mouth detail

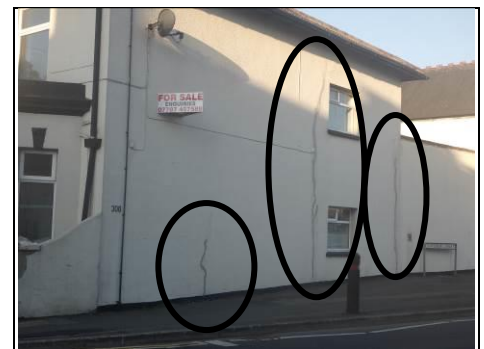
It should be noted that we think this area sits on clay, as we also noted movement in a nearby property.

Movement in nearby property

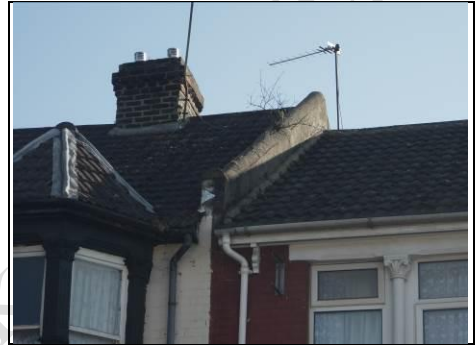
The fascias and soffits are timber. They are painted and we would comment they are in weathered condition for their age, type and style.

Fascias and soffits

ACTION REQUIRED: Make sure gutters and downpipes are watertight before carrying out any work on fascias and soffits.

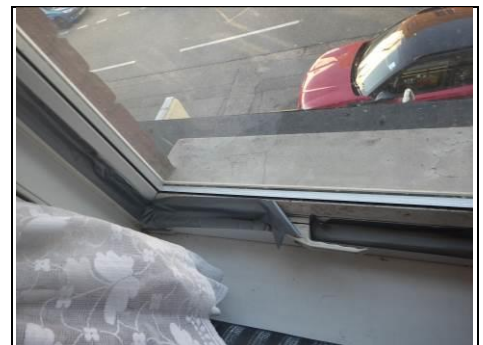
The windows are metal double glazed windows without trickle vents. They are in below average condition for their age, type and style.

Front bedroom window taped up

We recommend new windows are installed.

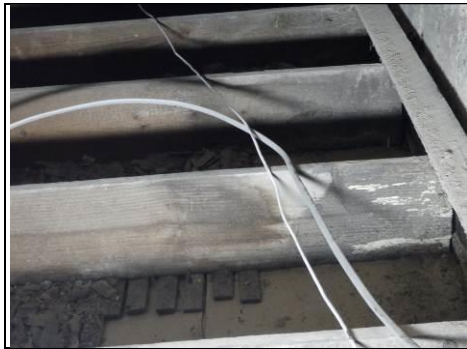
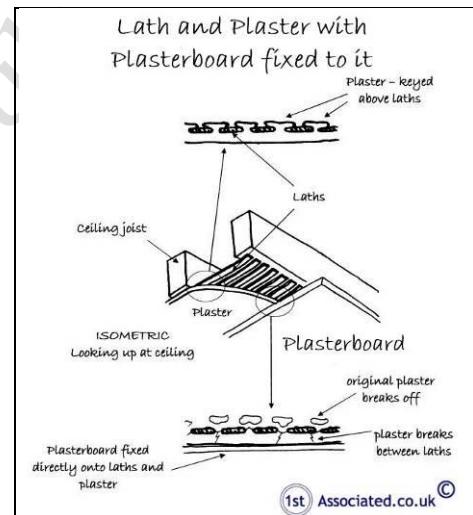
Where we could see the ceilings from the rear roof space we could see that originally they were lath and plaster, some of which remains. We can also see plasterboard or proprietary boarding has been replaced the lath and plaster. Sometimes it is also over-clad and looks to be the case in this instance.

Old laths above
plasterboard/proprietary boarding

Lath and plaster with plasterboard
or proprietary boarding tacked on

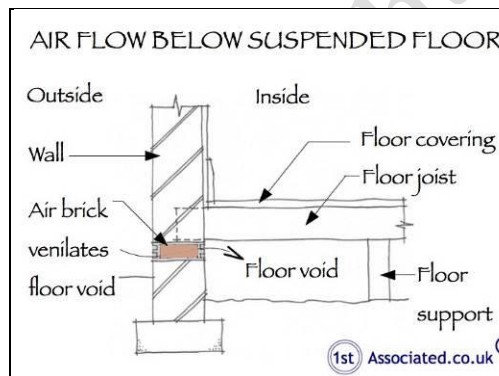
The floors have been covered so this is difficult to ascertain if this is still the case, although we do think it is likely.

Suspended timber floor

ACTION REQUIRED: Please see our earlier comments relating to the flooring in the Airbricks Section of this report.

We recommend the floors are opened up in three areas before you legally commit to purchase the property.

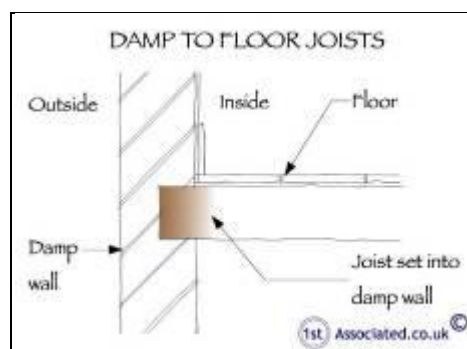
We have assumed that the first floor construction is joist and floorboards with embedded timbers, as this is typical in this age of property.

Embedded timbers

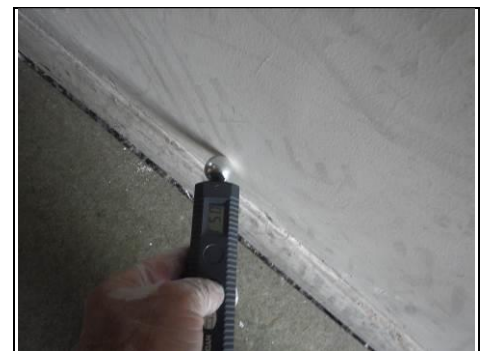
A visual inspection and tests with a moisture meter have been taken to the perimeter walls. In this particular case we have found some areas of dampness.

We suspect we would have found more dampness if we had had access to the walls. As mentioned, there were a lot of stored items/shelving, also items of waste.

Checking for rising damp

ACTION REQUIRED: Please see the Executive Summary.

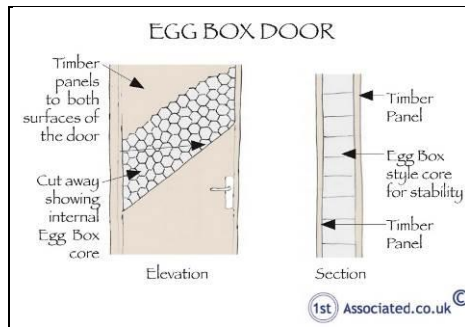
The doors are hollow core doors, often known as egg box doors.

Hollow core door/egg box door

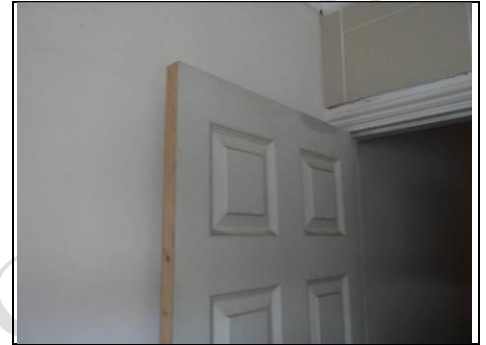
Hollow core door/egg box door in kitchen, which was literally coming off its hinges at time of survey

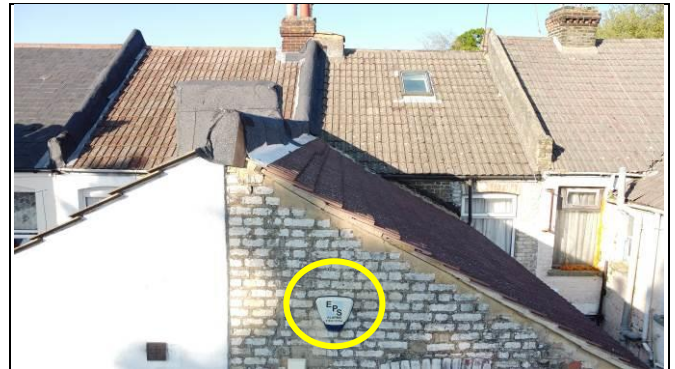
We noted an alarm box to the rear. A good alarm system should not only help reduce break-ins but also help reduce your insurance. We are not experts in this field and therefore cannot comment further.

Felt alarm box
~ Aerial View - 360 Photo ~

ACTION REQUIRED: Further information should be obtained from the vendor and the installer.

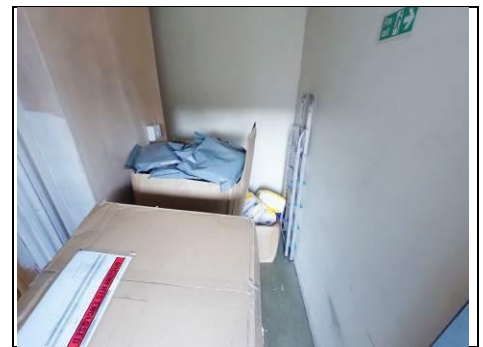
At the time of our inspection the only fire escape we could see from the upstairs area was blocked by stored items, which should be avoided at all cost.

Fire exit sign not illuminated. Rear door was blocked by stored items at time of survey

Also there are no illuminated fire exit signs.

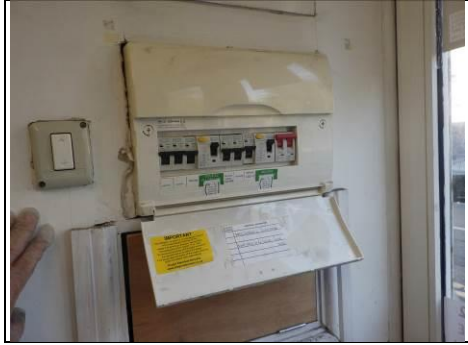
The electrics are dated and tripped twice when we carried out our earth test. They electrics in the kitchen should not be used until immediate work is undertaken.

Dated fuse board

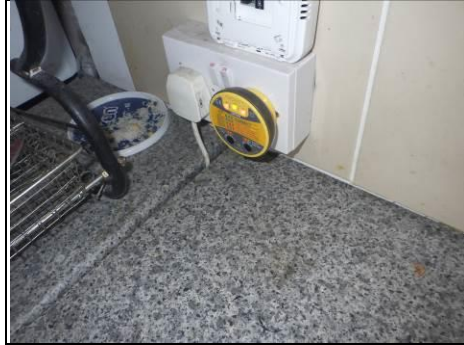
First earth test failed, with two red lights showing

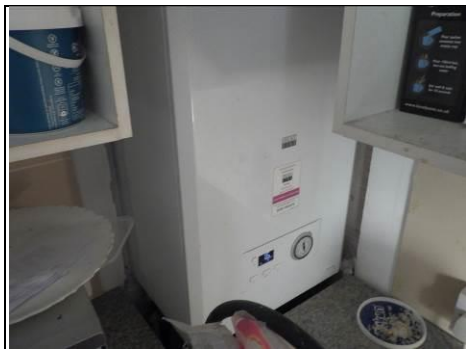
The property has a Heatline boiler heating system and some electric heaters.

Heatline boiler

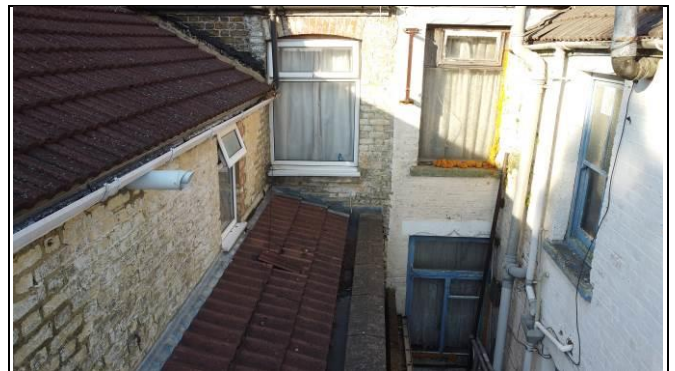
Boiler flue to rear
~ Aerial View - 360 Photo ~

ACTION REQUIRED: Please see our comments in the Executive Summary.

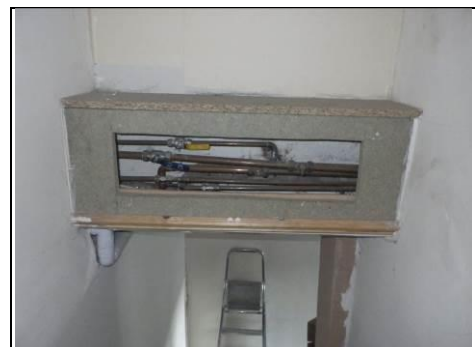
There is copper piping where we noted it.

Plumbing opened up

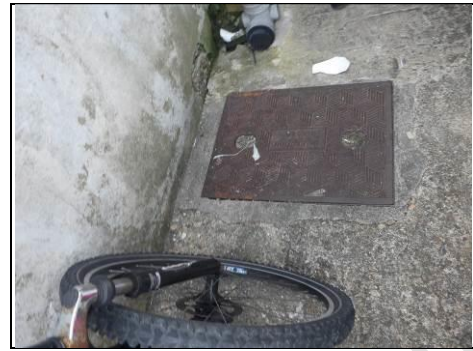
We have not carried out a drainage test. We would recommend that a closed circuit TV camera report is carried out.

Rear manhole

ACTION REQUIRED: Please see our comments in the Executive Summary.

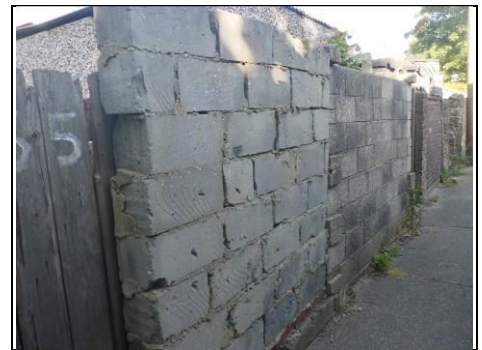
Poor quality blockwork to rear wall

ACTION REQUIRED: The garden should be cleared as soon as possible. We consider it a health hazard as it presently is.

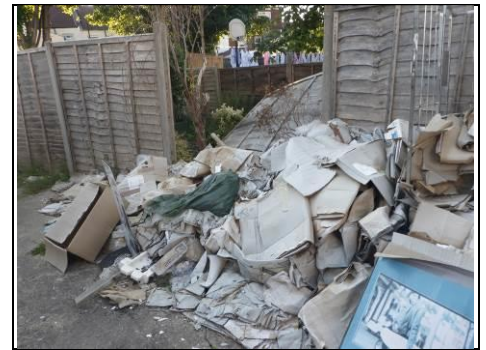
Rear right fence panel down
