Victorian Example Residential Building Survey

GENERAL INTRODUCTION

Firstly, may we thank you for your instructions of XXX we have now undertaken an independent Building Survey (formerly known as a Structural Survey) of the aforementioned property. This Survey was carried out on XXX.

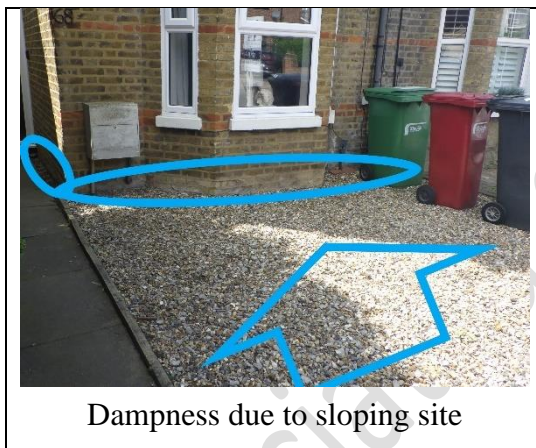
Dampness due to sloping site

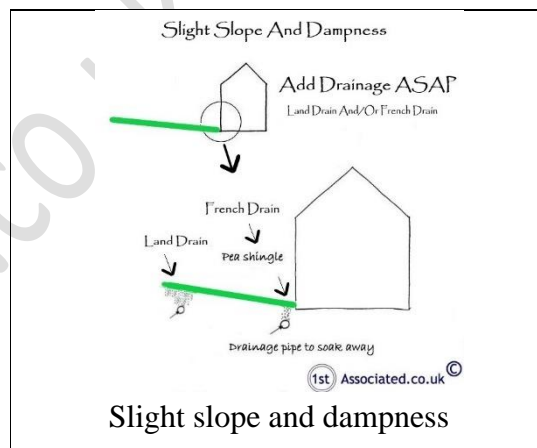
Slight slope and dampness

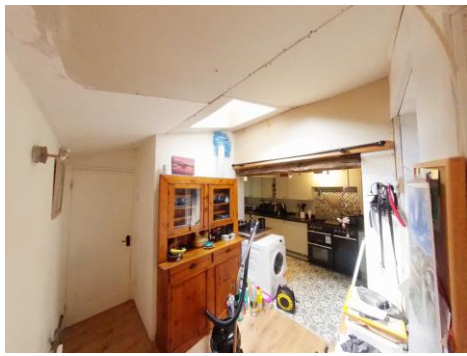
Unfinished area

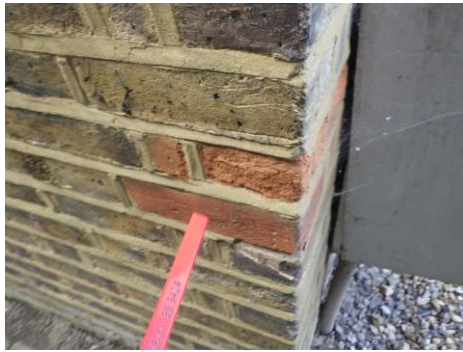
Cement mortar re-pointing has been carried out on the exterior of the property that we feel is not appropriate to this building. Originally, it would have been built with a lime-based mortar which allows the building to breathe. Cement repointing causes deterioration to brickwork and does lead to the face of the bricks deteriorating known as spalling and also leads to dampness and cracking.

Cement repointing

ACTION REQUIRED: Re-pointing is required in a lime based mortar and this is what should be used for any re-pointing in the future as this allows the property to 'breathe' and dissipate dampness. Find the oldest/most experienced bricklayer/mason you can who is skilled in using lime mortar and ask them to work on your property ideally during warmer days. A programme of work then needs to be carried out on replacing cement re-pointing with lime. This building needs to be able to breathe again.

ANTICIPATED COSTS: Initial work we would expect to cost in the region of £2,500 £5,000, this would be ad-hoc repointing and repointing to the base of the property. The good thing about cement mortar is that it tends to fall out over time, we would try and remove it with a stiff brush and ad-hoc repoint, possibly this will take a few years. Please obtain quotations before legally committing to purchase the property.

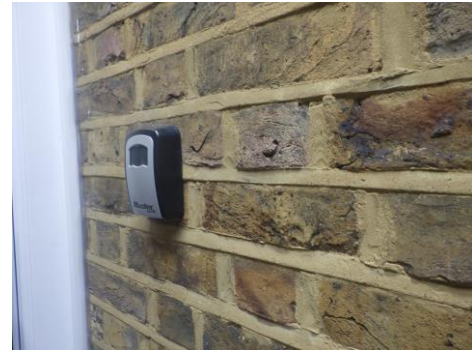
Proud pointing to the brickwork in cement

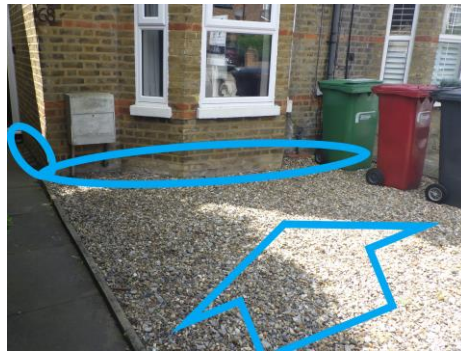
The sloping site is tipping water towards the front of the building where we could see green moss on the brickwork.

Dampness due to sloping site

ACTION REQUIRED: We recommend a French drain and/or land drain is added to the front and side of the property to divert the water all the way around the property and is discharged into a soakaway which the owner advised is located to the rear of the property.

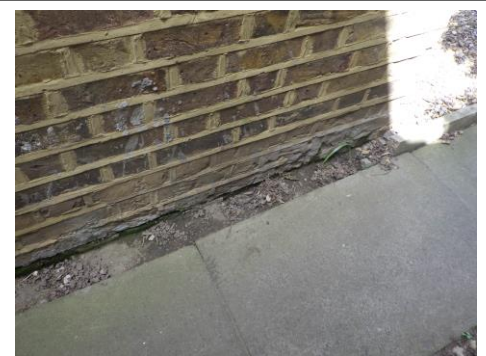
French drain required to left

ANTICIPATED COST: In the region of £5,000 – £10,000; please obtain quotations before legally committing to purchase the property.

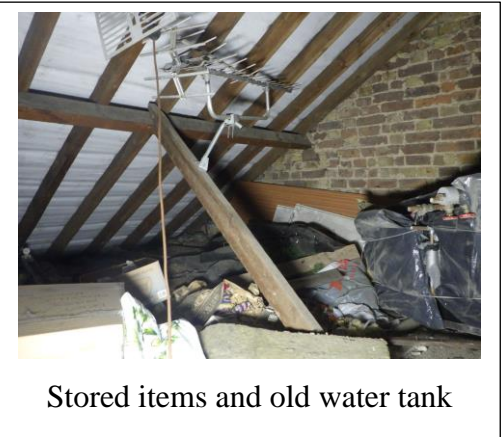
The roof space has an above average level of stored items including the old water tank, doors and other stored items.

ACTION REQUIRED: We would recommend checking that the roof space is being cleared by the vendor and then we would add boarding with an insulation beneath.

ANTICIPATED COST: £1,000 - £2,000 if you are required to clear the roof and then board out, we would add good lighting and an access ladder as this would then make this area a much safer and usable space. Please obtain quotations before you legally commit to purchase the property.

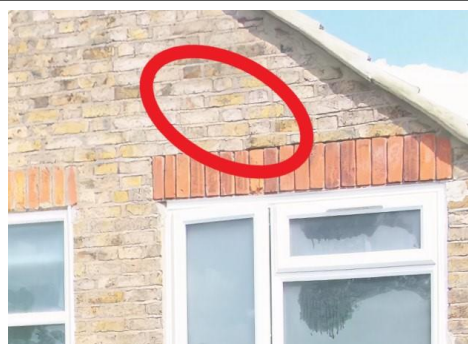
We noted what looked to be some movement over the rear bathroom window. This could relate to the windows that we understand were installed relatively recently in XXX. It may be that the timber lintel behind the soldier course of bricks (the red bricks) has failed and deteriorated, it certainly looks in poor condition with the soldier brickwork needing repointing to stop dampness getting in and also to strengthen the area.

Close up of crack above rear window?

ACTION REQUIRED: If you wish to be one hundred percent certain that there isn't any risk we would recommend the existing owners take out an insurance claim, advising that the cracking has been noted by a structural surveyor (this should cost them nothing other than time to write the letter/email). This usually means that the insurance company will carry out a monitoring exercise (the Building Research Establishment recommend monitoring any cracks for a minimum of one year) to establish if there is any progressive movement. Your future liability should be limited to the cost of the excess on the insurance providing the insurance company is happy for you to take over the insurance claim.

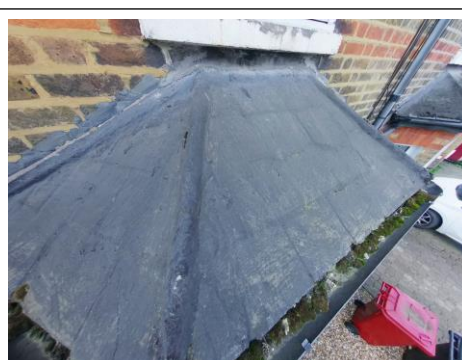
We believe the front bay roof was once slate as we think the whole of the property once had a slate roof. This has then been turnerised which is a tar that is put over roofs that are leaking.

Front bay roof tarred

ACTION REQUIRED: Ideally remove the tar and replace the slates to the front bay. As far as we can see this is not required immediately as we could not see any water getting in but is something we believe will be required in due course.

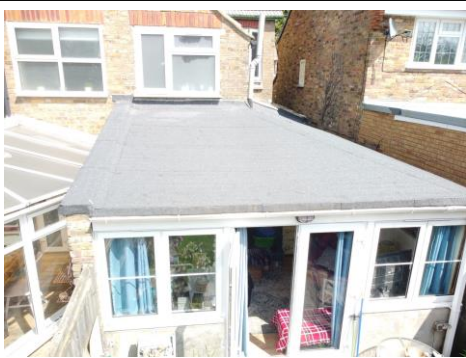
There are some fairly basic constructed shallow pitched roofs with a felt finish to the side and rear of the property, in fact we would say the whole of the rear single storey construction is lightweight.

Rear shallow pitched roof

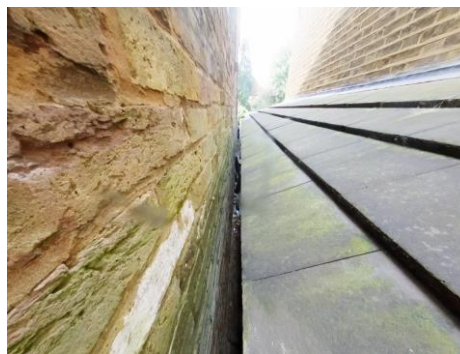
There is a gap to the left side of the property (all directions given as you face the front of the property). This is an awkward gap and we think it is where dampness could be being held. It is so small in some areas that it is not possible to get down. We noted there is a lot of rubbish and stored items to the rear left.

No gap between extension and neighbour's property

ACTION REQUIRED: You need to ensure the owner clears the area or get a discount of £1,000 to £2,000 off the purchase price of the house to clear the area and lower the ground level. Also, we would suggest a drain going to the soakaway which the owners say has been added to the rear of the property. Please see our comments on the dampness in the property.

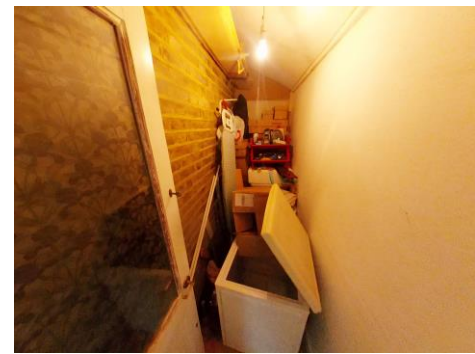
Limited view of left side due to stored items

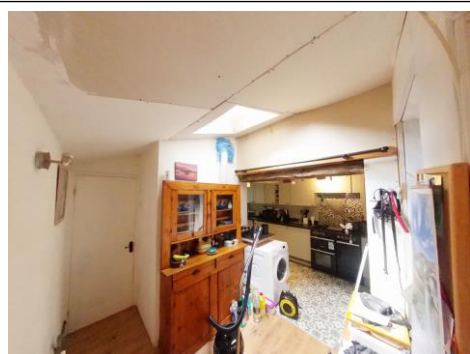
We have already discussed the roof on these extensions. We feel they are fairly basic construction and we would term as lightweight. The area adjacent to the kitchen and the corridor style cupboard are unfinished.

Unfinished area

ACTION REQUIRED: We would recommend you finish the work in these areas. As mentioned elsewhere within this report clear the gap and lower the ground level and add a drain and ideally add a guttering to the roof if it hasn't got a guttering.

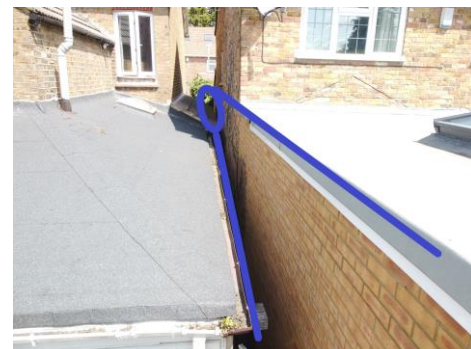
Narrow gap

Oval – tarred roof over porch area that does not have a gutter

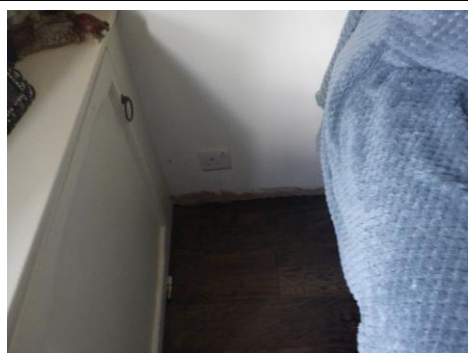
For example, (and we may be pointing out the obvious) the architraves and skirtings are missing and we can see an exposed extract system.

No skirting

ACTION REQUIRED: Fix architrave and skirtings and check the exposed elephant trunk is working and conceal it and then repair, prepare and redecorate.

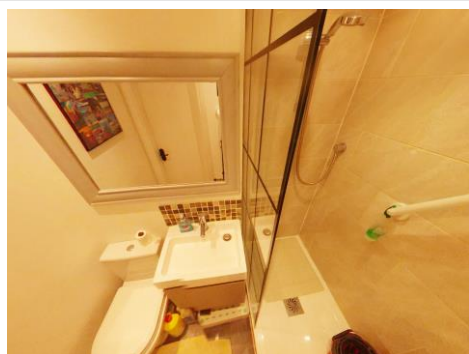
Internal shower room

The property has an internal shower room which has an extract within the light which we are not keen on.

ACTION REQUIRED: It is best to remove humidity as quickly as possible and therefore we would recommend large good quality humidity controlled extract fans are added to the kitchen, bathrooms, plus any humidity generating areas:

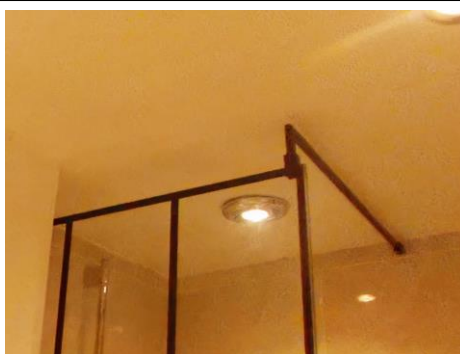
Extract within light

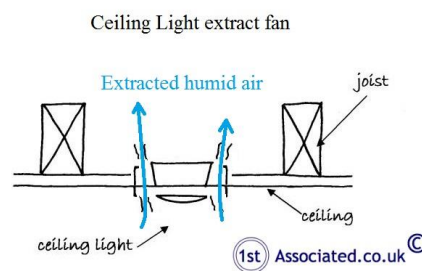
Extract fan within ceiling light

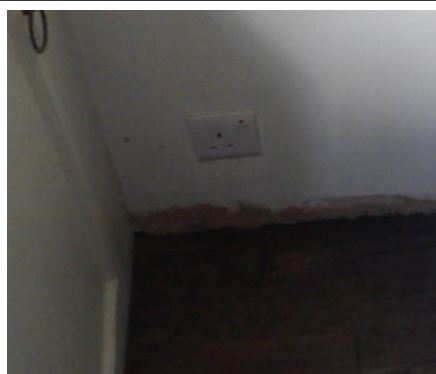
The electric fuse board is dated and better are now available. We can see some other indicators that this is an older style electric system such as the single socket points; we would recommend these are upgraded to double socket points (there are now some socket points with USB ports). We also noted a light in the bathroom has dropped out of position.

Single socket

- 1) £250 - £500 for a test and report
- 2) £250 - £500 for a new fuse board
- 3) £500 - £1,000 for additional socket points and updating
- 4) Plus any further work recommended

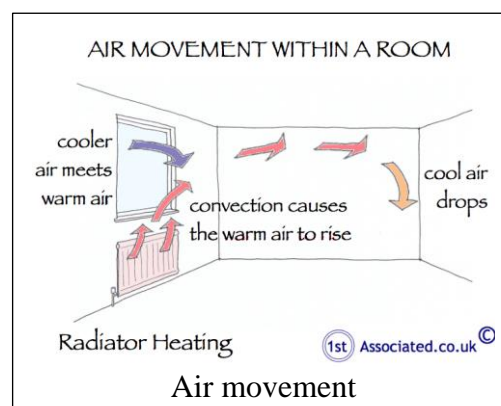
We noted the radiators in some areas are internal/not under the windows which is the usual position.

This is often carried out on cheaper central heating systems to save the labour and piping costs of positioning the radiators underneath the windows. However, it then reduces the air movement in the room which can lead to black mould.

ACTION REQUIRED: We suggest you live in the property and then if there are problems we recommend you move the radiators underneath the windows as this gives a better circulation of air and reduces the chance of condensation.

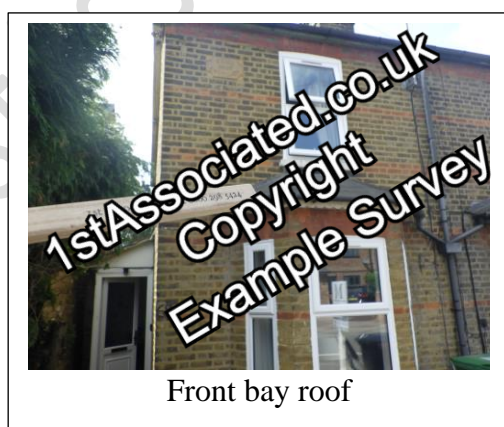
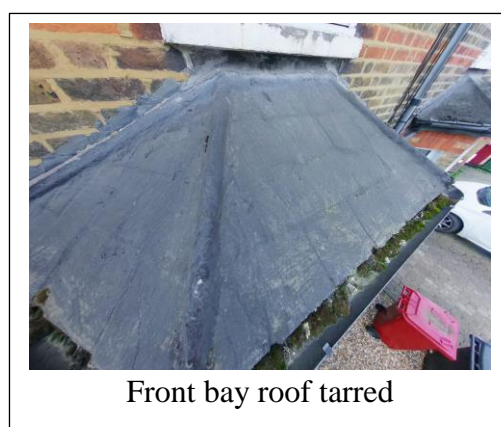
This roof is pitched and clad with mineral felt which has been tarred, often known as turnerising. We would comment it looks to be watertight, we would much prefer to see slate.

ACTION REQUIRED: Please see our comments in the Executive Summary.

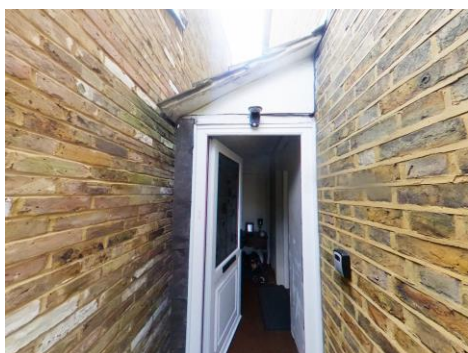
Left entrance area roof

This roof is shallow pitched and clad with slates. There is a slight gap where it meets the neighbour's property which we believe could be a trap for moisture and there is no gutter.

ACTION REQUIRED: Please see our comments in the Executive Summary.

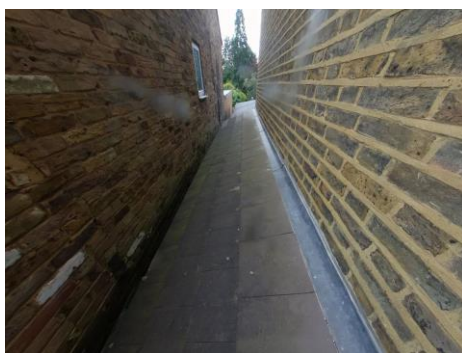
Left roof has no gutter and no gap

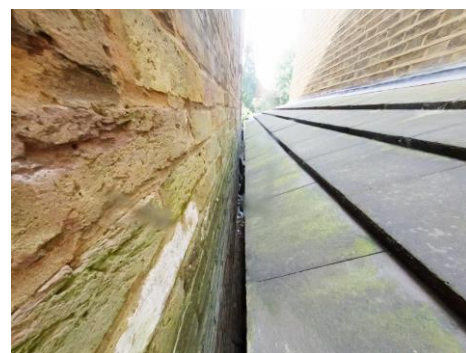
Awkward gap between extension and neighbour's property

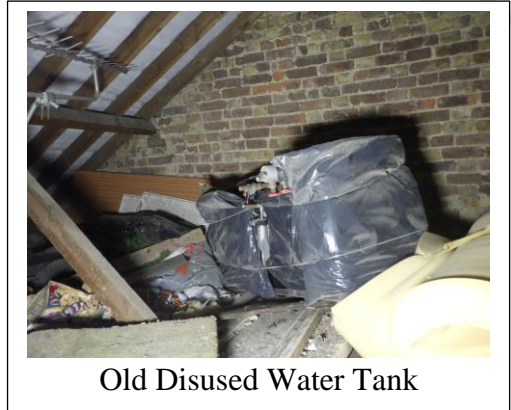
There is a disused water tank.

Old Disused Water Tank

ACTION REQUIRED: Remove.

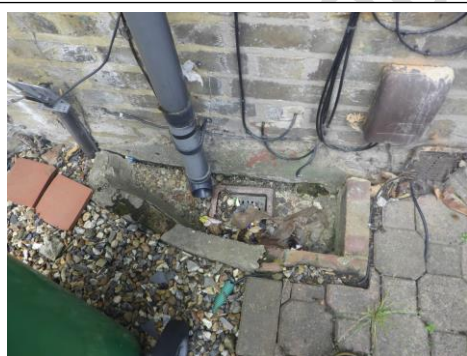
Gully to front right

The property has plastic hopperheads, gutters and downpipes. They are in below average condition for their age, type and style. We were pleased to see gullies, for example to the front right.

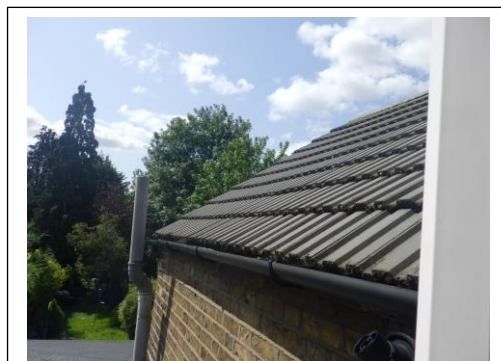
Soil and Vent Pipe to rear left

The property has a plastic soil and vent pipe which is partly internal. Internal soil and vent pipes can work well, apart from if they leak, as they are hidden from view so a leak is not normally discovered.

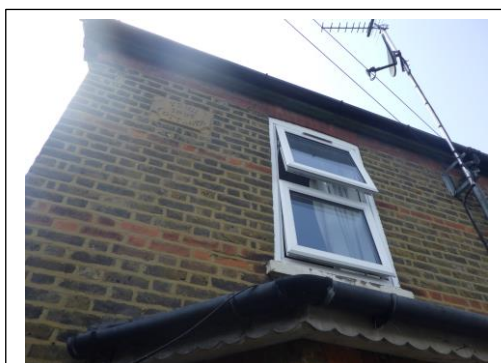
The property is finished in a brick originally in a lime mortar in what is known as Flemish bond brickwork which has now been wrongly repointed in cement mortar.

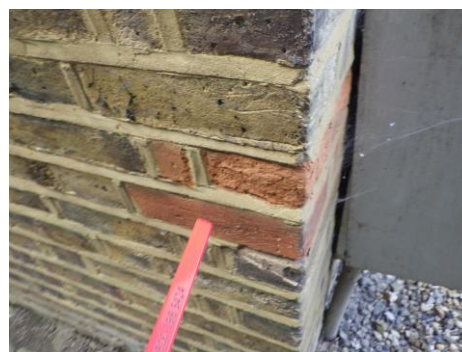
Cement repointing causing spalling bricks

The original lime mortar is a softer material which allows dampness to dissipate, whereas cement mortar is a harder material that does not allow the walls to 'breathe' and in turn causes dampness to come into the walls. The use of cement mortar causes deterioration to brickwork and does lead to the face of the bricks deteriorating, which in turn leads to dampness. This is a very important point.

ACTION REQUIRED: We would recommend replacing the cement mortar with lime mortar gradually and carefully over a long period of time, using the oldest/most experienced builder you can find who is experienced with lime work.

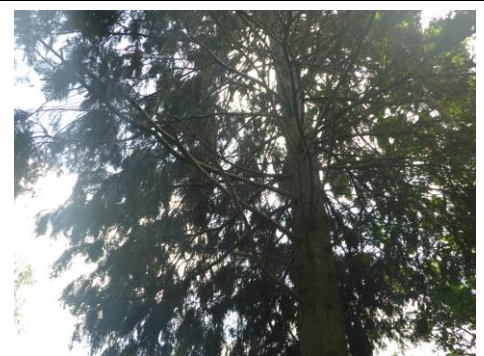
Large tree to rear

There is a large tree within the rear garden which needs to be maintained.

ACTION REQUIRED: We would recommend that all of the trees and bushes are regularly maintained.

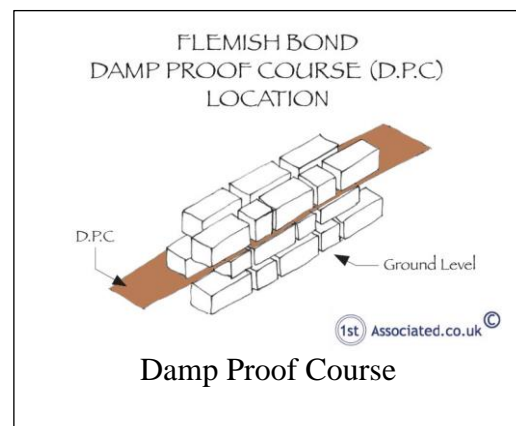
In properties of this age, it is unlikely that a damp proof course (DPC) would have been built in originally however often they have had damp proof courses added at a later date. In this case, we can see a chemical DPC has been added to the front of the property and possibly elsewhere.

ACTION REQUIRED: Your legal advisor to check and confirm if there is any information with regard to chemical damp proof courses being added.

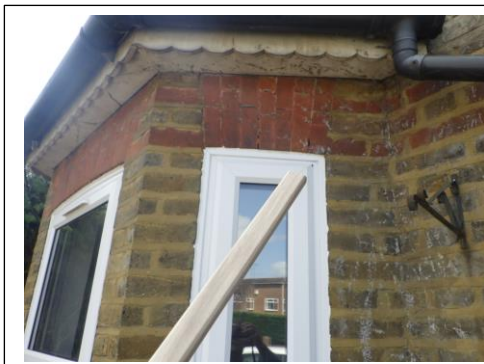
We can also see the windows have been positioned level with the brickwork; we much prefer to see them set back. Traditionally in this type of property they are set back about 100mm.

Windows level with brickwork

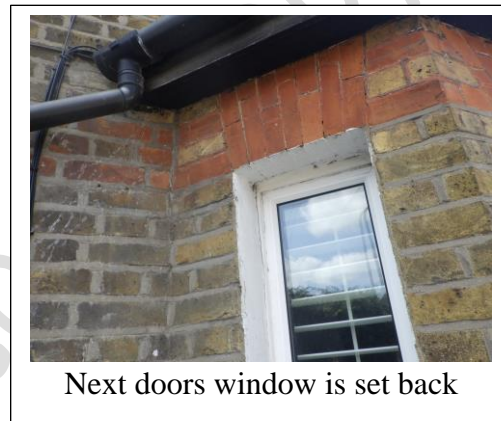
Next doors window is set back

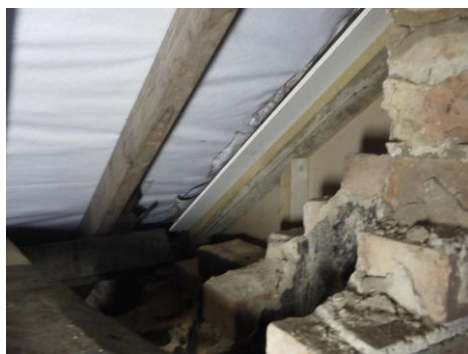
We believe that the rear chimney has been partially removed.

Rear chimney partly removed

ACTION REQUIRED: Your legal advisor needs to check and confirm if permission has been obtained to remove the chimney and if there are any structural calculations in relation to it.

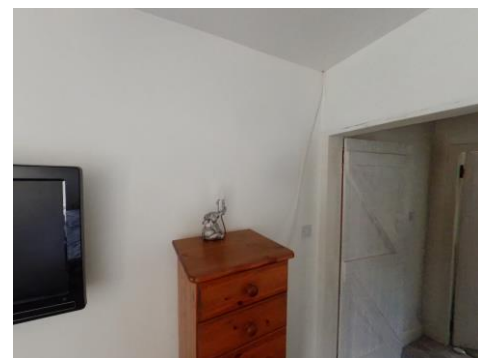
Mark to wall in rear bedroom indicating chimney removed

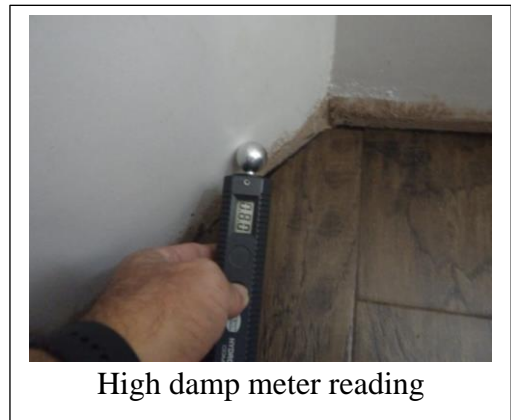
A visual inspection and tests with a moisture meter have been taken to the perimeter walls. In this particular case, we have found significant rising damp.

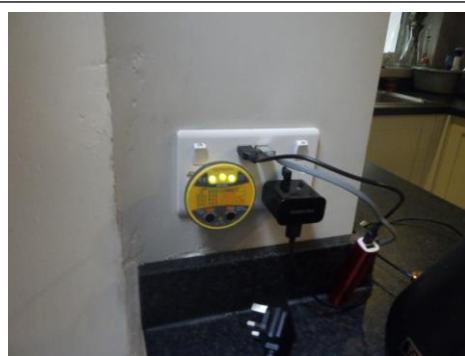
We carried out an earth test in the kitchen area to the socket point that is normally used for the kettle; this proved satisfactory.

Earth Test satisfactory

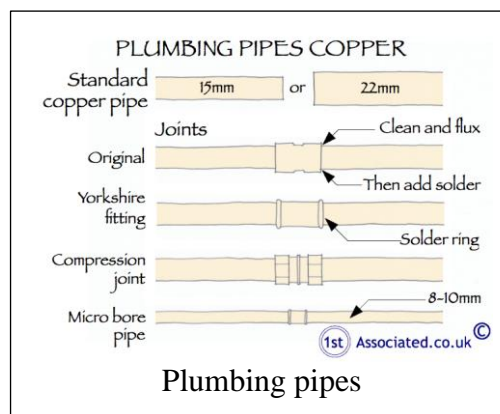
PLUMBING

The plumbing, where visible, comprises copper piping. No significant leakage was noted on the surface, although most of the pipework is concealed in floors, walls and ducts.

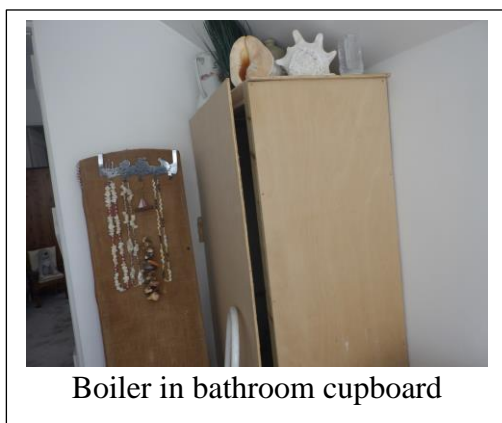
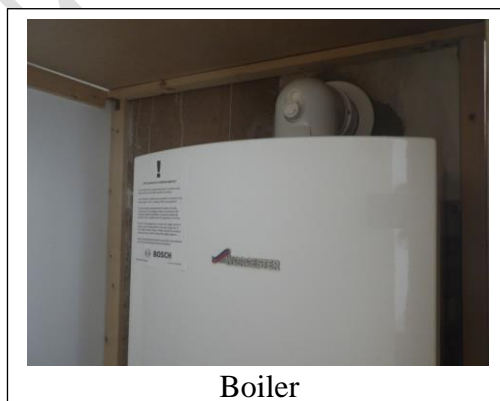
There is a Worcester boiler located in the bathroom. In our vendor questionnaire the owner advised the boiler was installed in XXX and last serviced on XXX.

Our limited inspection of the hot water and central heating system revealed no evidence to suggest any serious defects but we would nevertheless recommend that the system be tested and overhauled before exchange of contracts and that a regular maintenance contract be placed with an approved heating engineer.

ACTION REQUIRED: We recommend you return to the property with the estate agent to turn the heating on to ensure it is working.

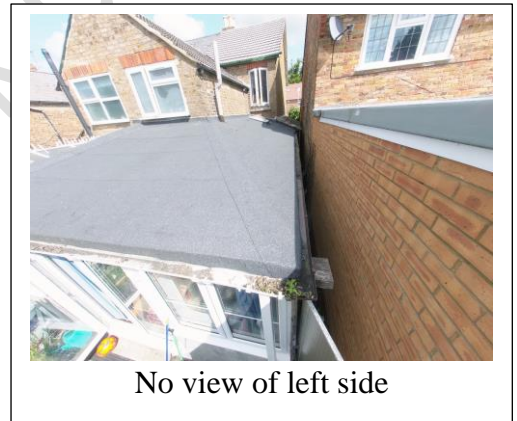
- 1) We did not have a full view of the roof due to the insulation covering the ceiling joists and general configuration of the roof. We could not see the rear right roof structure over the bathroom.
- 2) We had no view of the gap on the left side of the property due to the way the extension has been built.
