COMMERCIAL BUILDING SURVEY

Three Storey Converted Cheese Factory

Mr Businessman

GEM Associates Limited

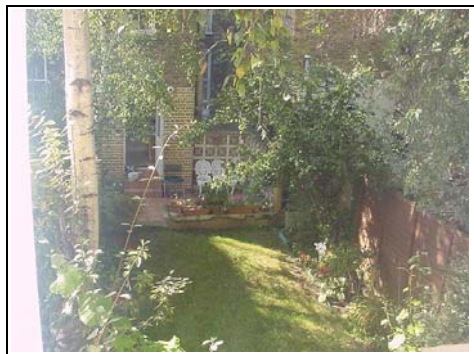
Rear view,
looking from the dry cleaners to the rear,
the grassed area being part of another
property's garden.

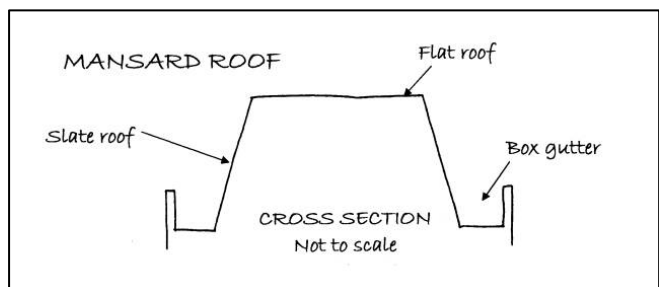
The leaves and branches will also affect the roof of the property, which will also need clearing from time to time.

Put a leaf guard over the box gutter and also regularly maintain it, probably monthly in the case of the rear box gutter.

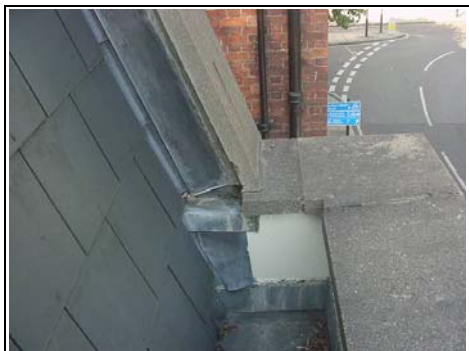
Slate roof

The slates form the pitch of the roof and are manmade. They look in reasonable condition and sit fairly true and level. The danger area with this type of roof is the box valley gutter, which we will look at in the Gutters and Downpipes Section.

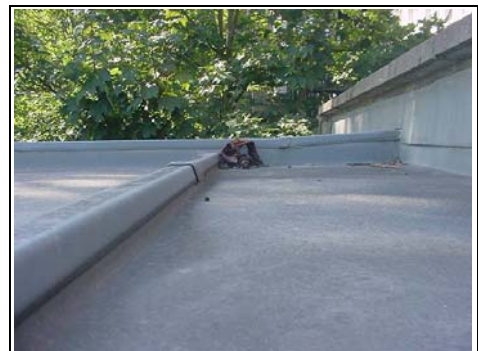
Metal roof to top

From what we could see of the top of the roof it all looks relatively clear of leaves, branches, etc, and in reasonable condition, but we would reiterate our limited view.

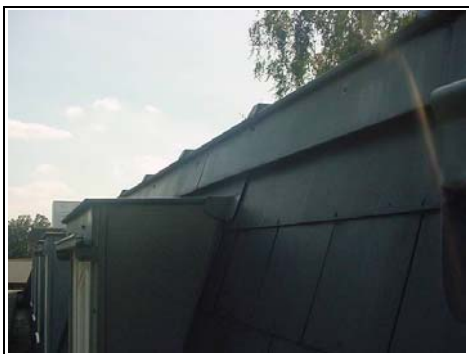
Close up of dormer

Our view was limited, but what we could see of them they were in reasonable condition.

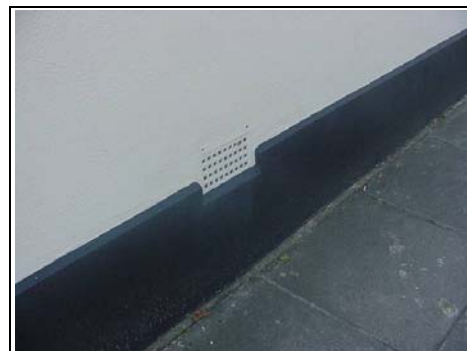
Smooth faced painted render

The walls to this property are finished in a smooth faced painted render. We have carried out a tap test to the render at low level (literally hitting the render with the back of a hammer) to try to establish if there are any hollow areas. We believe the walls to be in average condition. We have found some areas but this is typical for this age of property.

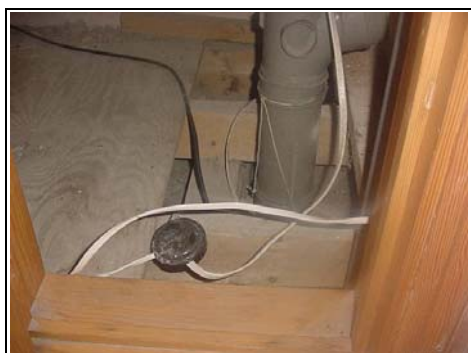
Suspended timber floor

Based on our knowledge of this age of construction we believe that, predominately, the ground floor construction is a suspended timber floor. This type of floor needs air circulation under it to reduce deterioration from wet rot and dry rot; please see our comments in these sections.

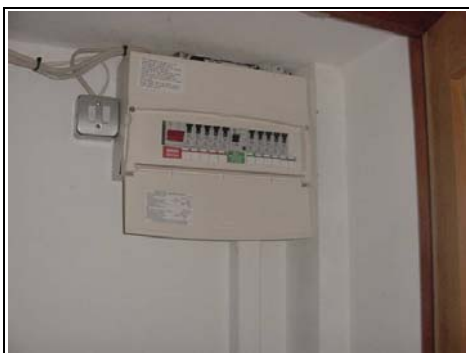
Fuseboard on first floor

There are two electric fuse boards and consumer units located on the ground floor on the right hand side and on the first floor in the central office. We would date the fuse boards as being from the 1980s and, whilst not the best now available, are reasonable.

ACTION REQUIRED: If there is no record of an electrical test having been undertaken within the last five years, it is recommended that the installation be tested by a competent electrician (NICEIC registered) and all recommendations implemented. Thereafter, the installation should be re-tested every five years.

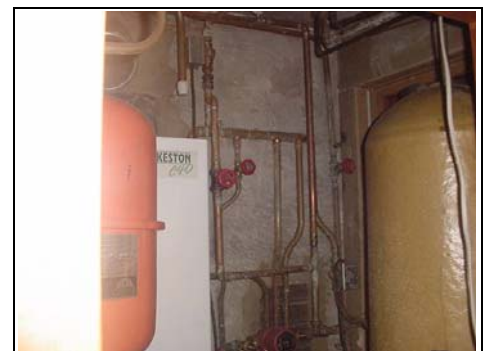
Hot Water Cylinder

The hot water cylinder is located on the first floor near the kitchen area, and in the same storage space as the boiler. It is factory lagged, therefore indicating it is relatively new (in this case we mean in the past 30 years) and will have relatively good thermal efficiency.
