COMMERCIAL BUILDING SURVEY
OF
Three Storey Office Block in the City of Westminster, London

Mr Businessman

GEM Associates Limited

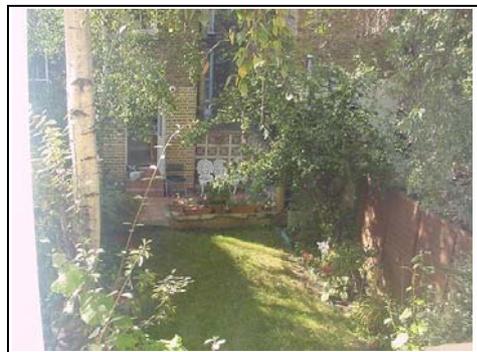
Rear view,
looking from the dry cleaners to the rear,
the grassed area being part of another
property's garden.

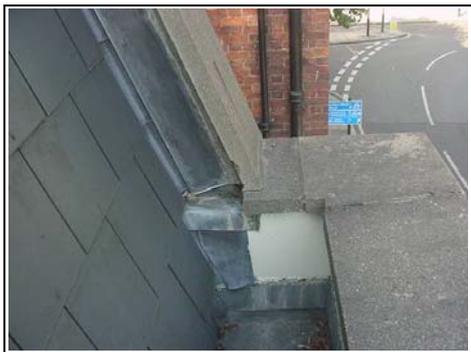
Slate roof

The slates form the pitch of the roof and are manmade. They look in reasonable condition and sit fairly true and level. The danger area with this type of roof is the box valley gutter, which we will look at in the Gutters and Downpipes Section.

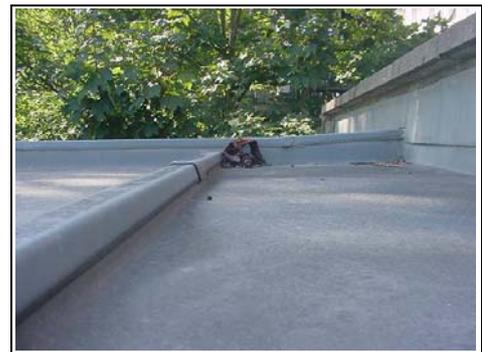
Metal roof to top

From what we could see of the top of the roof it all looks relatively clear of leaves, branches, etc, and in reasonable condition, but we would reiterate our limited view.

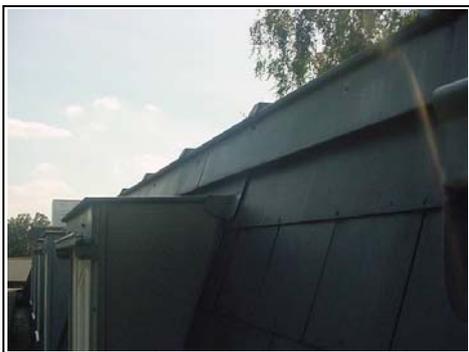
Close up of dormer

Our view was limited, but what we could see of them they were in reasonable condition.

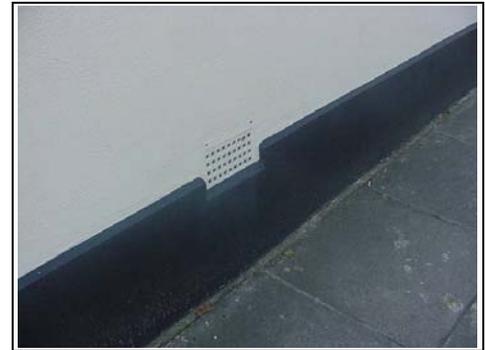
Smooth faced painted render

The walls to this property are finished in a smooth faced painted render. We have carried out a tap test to the render at low level (literally hitting the render with the back of a hammer) to try to establish if there are any hollow areas. We believe the walls to be in average condition. We have found some areas but this is typical for this age of property.

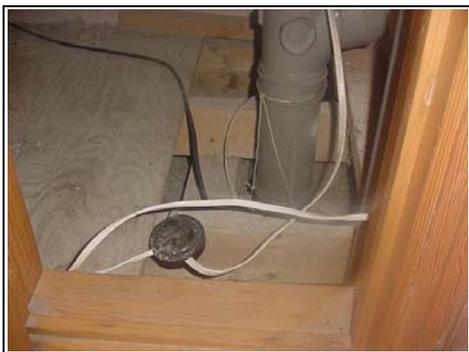
Suspended timber floor

Based on our knowledge of this age of construction we believe that, predominately, the ground floor construction is a suspended timber floor. This type of floor needs air circulation under it to reduce deterioration from wet rot and dry rot; please see our comments in these sections.

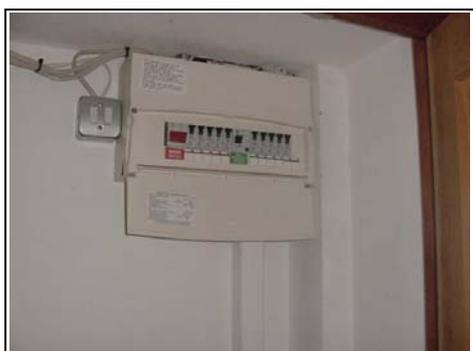
Fuseboard on first floor

There are two electric fuse boards and consumer units located on the ground floor on the right hand side and on the first floor in the central office. We would date the fuse boards as being from the 1980s and, whilst not the best now available, are reasonable.

ACTION REQUIRED: If there is no record of an electrical test having been undertaken within the last five years, it is recommended that the installation be tested by a competent electrician (NICEIC registered) and all recommendations implemented. Thereafter, the installation should be re-tested every five years.

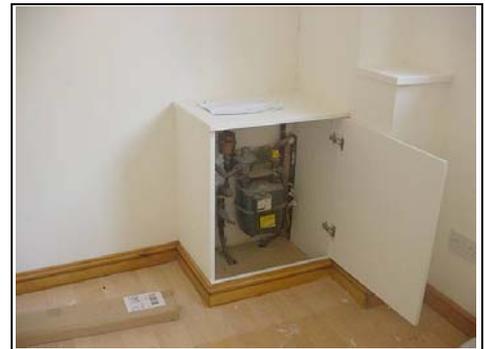
The gas meter cupboard is located in the middle office on the ground floor.

All gas appliances, pipework and flues should be the subject of an annual service by a competent engineer, i.e. a member of CORGI (the Council of Registered Gas Installers); works to gas appliances etc. by unqualified personnel is illegal. Unless evidence can be provided to confirm that there has been annual servicing we would recommend that you commission such a service prior to use to ensure safe and efficient operation.

ACTION REQUIRED: As a matter of course it is recommended that the entire gas installation is inspected and made good, as necessary, by a CORGI registered contractor. Thereafter the installation should be serviced annually.

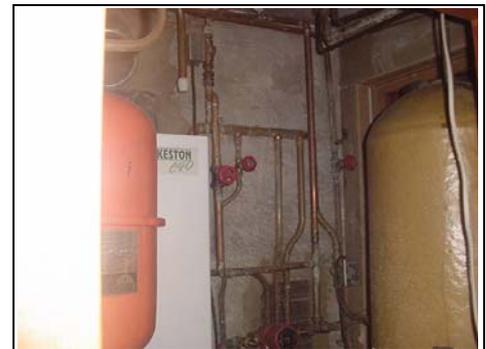
Hot Water Cylinder

The hot water cylinder is located on the first floor near the kitchen area, and in the same storage space as the boiler. It is factory lagged, therefore indicating it is relatively new (in this case we mean in the past 30 years) and will have relatively good thermal efficiency.
