**COMMERCIAL BUILDING SURVEY
OF
A Retail Unit in Kent: Two Shops, Offices and Storage**

**FOR
Mr Retail**

GEM Associates Limited

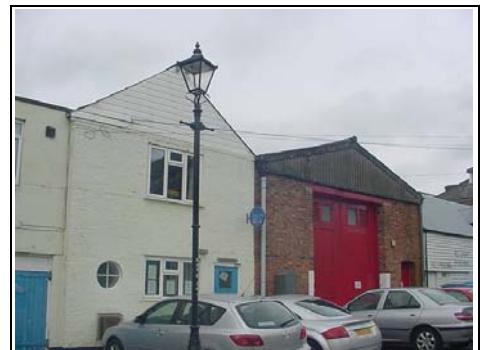
A considerable amount of water is getting into this storage facility and office area, particularly down the right hand back wall (all directions given as you face the property from the front). This is affecting both your property and the adjoining CAB (Citizens Advice Bureau).

The valley gutter and relatively small hopper head

The only long term solution is to redesign the valley gutter. We would recommend a wider valley gutter. The roof problems could in turn, we believe, have affected the roof structure. Please note we have not gained access to the high level areas within the store.

ACTION REQUIRED: We would recommend the only long term solution to the valley gutter problems that you have is to change the design of them. We would recommend a wider valley gutter, which allows access, i.e. to be a width of approximately half a metre to one metre. This, unfortunately, would involve reconfiguring part of the roof. Also, the question is do you replace the asbestos now, or encapsulate it, which of course depends how long a term your long term plans are!

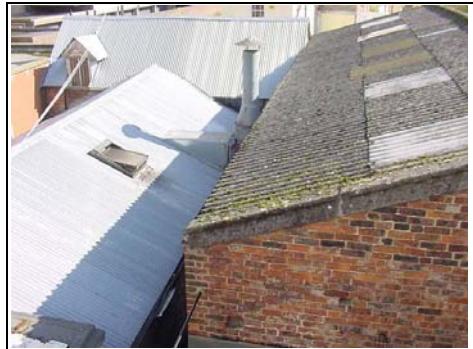
We would specifically draw your attention to the asbestos that has been used for the roofing, which in our opinion, the perception of asbestos problems do affect clients/future tenants.

Left hand view of asbestos sheet roof

ACTION REQUIRED: We believe that you should budget for repair/replacement of the asbestos roof, if you are looking at this as a long term investment, i.e. ten years plus.

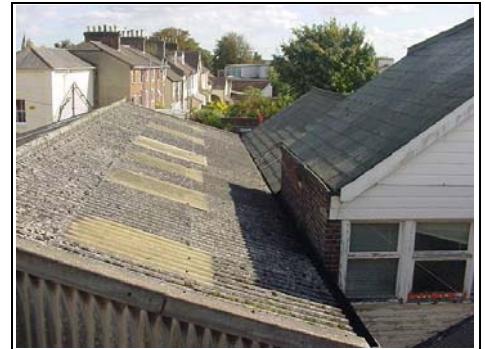
Right hand view of asbestos sheet roof

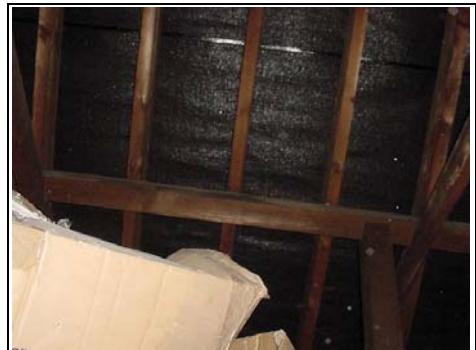
Within the main roof, over the opticians and the florists, we found a Hessian base Bitumen membrane. This type of membrane has been used since the 1960s. We generally found it to be in average condition, its damaged in a few more places than we normally find.

This photo shows the common rafters (the ones that form the pitch of the roof) and the dark area between is the underlayer.

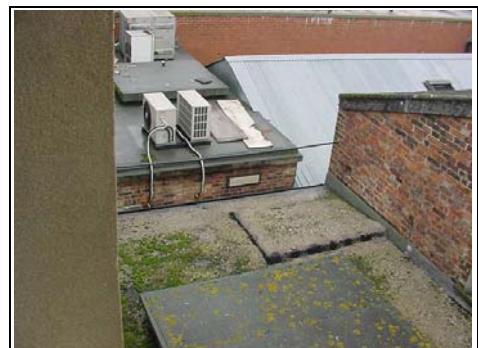
The property has a felt flat roofs, typically this type of roof has a life of between 20 and 30 years, depending upon the quality of workmanship, materials and decking, although some roof manufacturers do claim longer. We can see in this instance that the flat roof has been repaired over the years and we can also see that a lot of moss is sitting on the roof, indicating that a great deal of water also sits on the roof.

The latest Building Regulations require flat roofs to be ventilated. Building Regulations are not retrospective but the reason for the requirement is to make sure that any moisture that enters the roof construction is dispelled by way of ventilation. We would suggest that if the opportunity arises ventilation should be provided. This will stop the possibility of fungal growth above the ceiling in the flat roof area.

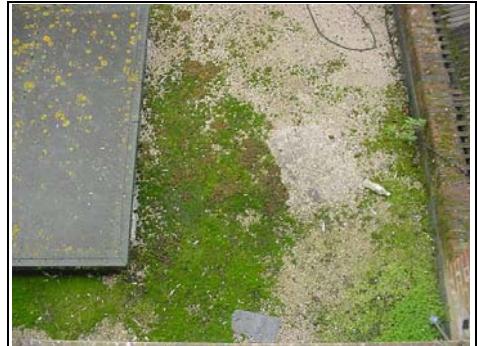
Also it could not be established if there is insulation within the roof or a vapour barrier, without the vapour barrier and combined with inadequate ventilation there will be an increase in the risk of wet or dry rot.

A lot of moss indicates sitting water

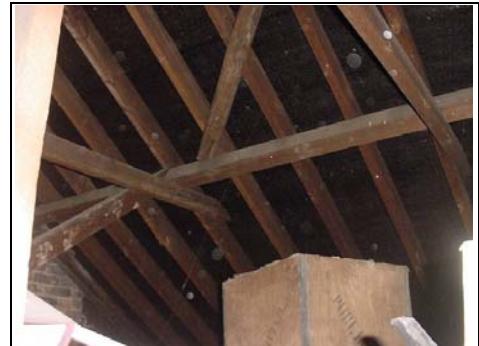
Our examination was limited by the general configuration of the roof, the insulation and stored items. What we could see was generally found to be in average condition considering their age, with the exception of the front right hand corner, where we can see a new timber has been put in place to prop part of the roof. Also, we suspect dampness is coming into this area. It is, however, feasible that there are problems in the roof that are hidden.

Note the new looking vertical timber to the right hand side of the photo.

ACTION REQUIRED: The only way to be 100 per cent certain is to have the roof cleared and checked.

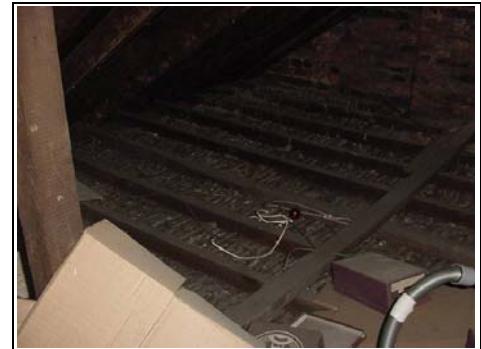
From our visual inspection of the ceilings when we were in the roof, what we could see was a lath and plaster finish. We believe some of the ceilings may have been replaced with plasterboard. Generally they are in average condition considering their age.

Dark photo, lath and plaster just about visible

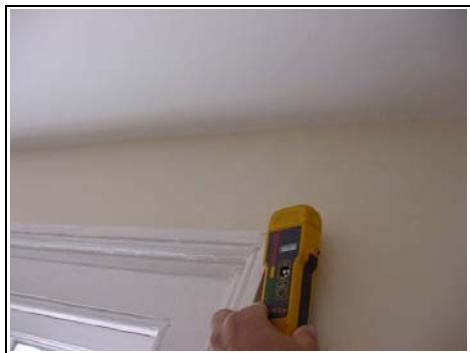
Tests were taken with a moisture meter at random points to external walls, floors and other surfaces. In the charity shop/store we get high readings of lateral dampness. The dampness is affecting next door in the CAB and also the timber ends, which we believe will need some work. Again, please see our comments in the Executive Summary.

Dampness to timber ends
