RESIDENTIAL BUILDING SURVEY
OF
A Post War 1960's Bungalow

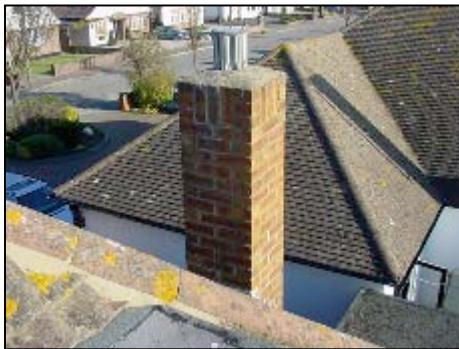
Left hand brick chimney

This chimney is brick finished with a lead flashing and has one chimney pot. It generally looks in reasonable condition with the exception of a split to the side of it. We believe this chimney is used as a flue for the boiler system.

ACTION REQUIRED: You need to occasionally check the chimney (whilst you are checking the flat roofs) and repair the split if it gets any larger. There are sometimes splits in these chimneys due to heat and condensation that occurs.

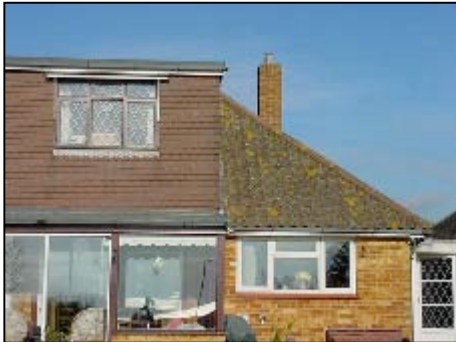
The dormer windows to this property; form the upper floor. Please see our Executive Summary for our comments on the roof. Vertical tiles have been utilised to form the walls, these all look in reasonable condition.

The dormer window

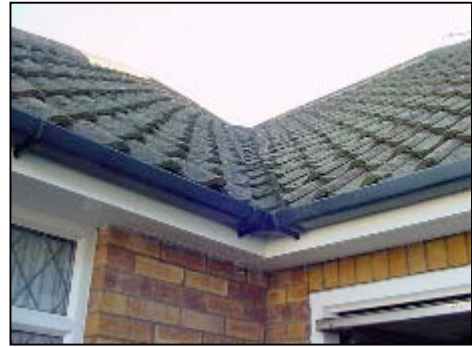
Valley gutters are weak areas often in roofs, we would much prefer to see a lead valley gutter you have a tile valley gutter which looks in reasonable condition.

A view up looking at one of the valleys

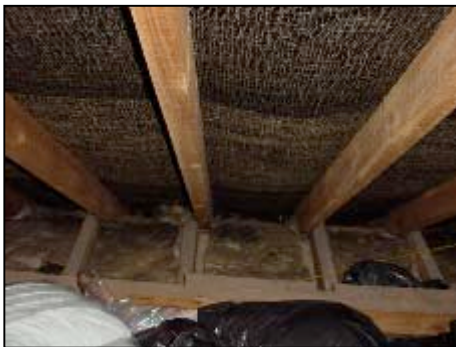
When we inspected the loft we found a Hessian base Bitumen membrane. This type of membrane has been used since the 1960s. We generally found it to be in average condition, it is damaged in a few places but this is not unusual considering its age.

A general view of the layers (in black) between the common rafters, which form the pitch of the roof

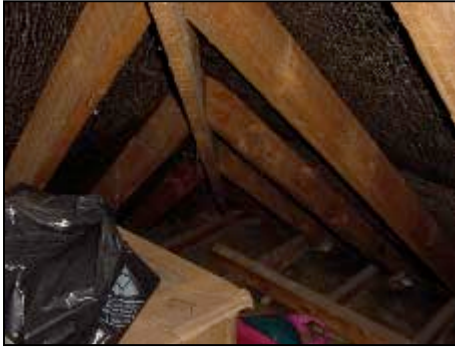
A view of the corner of the roof, which is an area where hipped roofs normally slip, as you can see in this instance there is no problems.

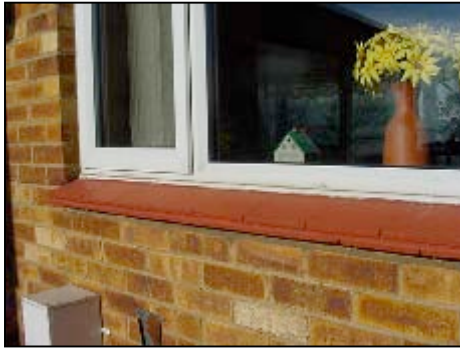
The double glazed plastic windows to this property are not of the best of quality. The windows are part of your protection against the strong winds in the winter. We noted that some were wooden on the first floor and some are secondary glazing.

Double-glazed plastic window

ACTION REQUIRED: Replace all of these windows with a better quality double glazed window.

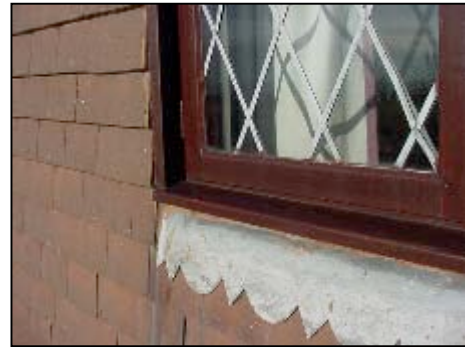
First floor timber window

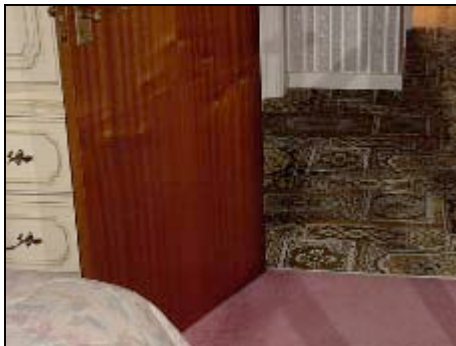
The property has veneered hollow core doors also known as egg box doors as this is what they look like if they are opened up.

Veneered door.

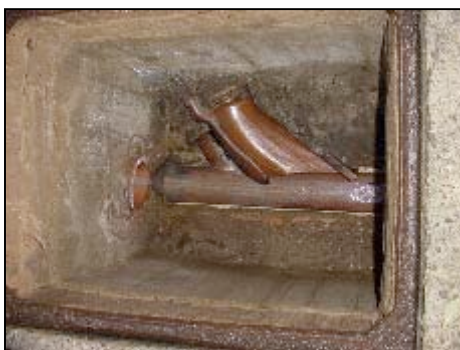
We have identified two manholes were located both on the left hand side of the property, one within the brick paved parking area and could not be lifted, the other was close to the house and was lifted and was found to be free flowing and clear and finished in concrete.

Manhole finished in concrete.
