RESIDENTIAL BUILDING SURVEY
OF
The Hayloft

FOR
Mr N
PREPARED BY

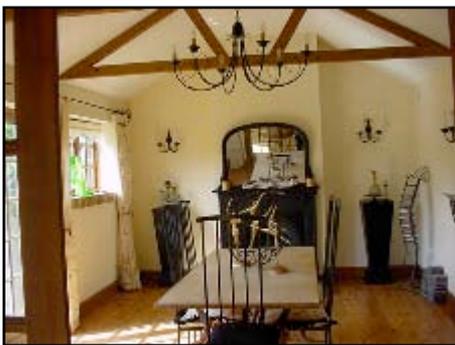
The Fireplace

This room has some nice features, such as the fireplace.

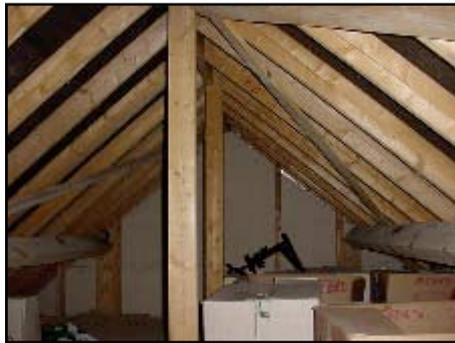
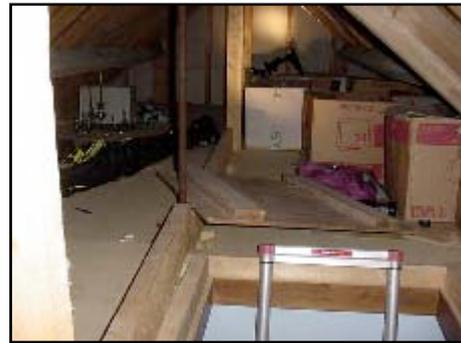
General view into the roof.

The roof had various stored items in it.

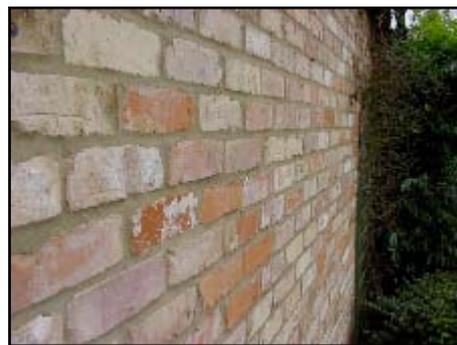
General view of the new brickwork, which is in a cavity bond. The older brickwork being in a Flemish bond.

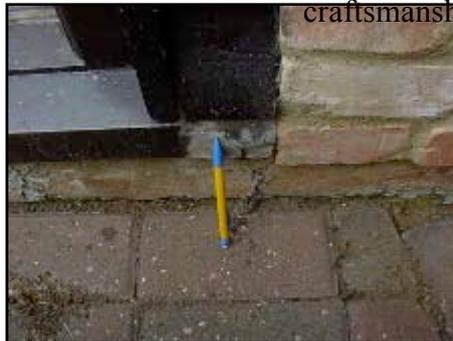
There are however some nice details to the external joinery, such as the flashing at the base of the door entrance, marked here by the pencil.

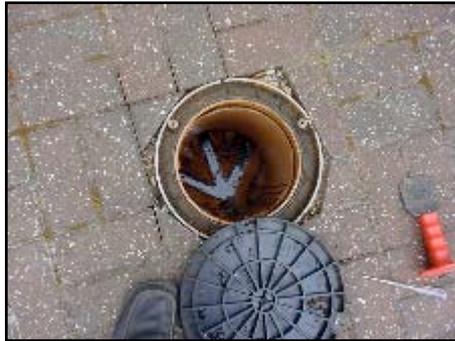
Inspection Chamber One (in front of the front door)

This revealed a plastic chamber, which looked free of any debris at the time of our inspection.

This is directly outside the main property.

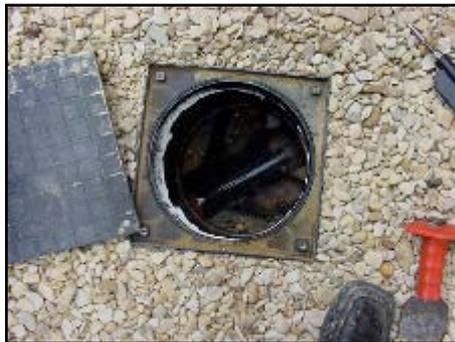
Inspection Chamber Two (located to the far left hand corner of the property)

Again when we unscrewed this one it was plastic and there was no debris found.

Between the main property and the annex.
