JOB REF: J1050/RBS/02

RESIDENTIAL BUILDING SURVEY
OF
Marlborough Road

FOR
Mrs J Little

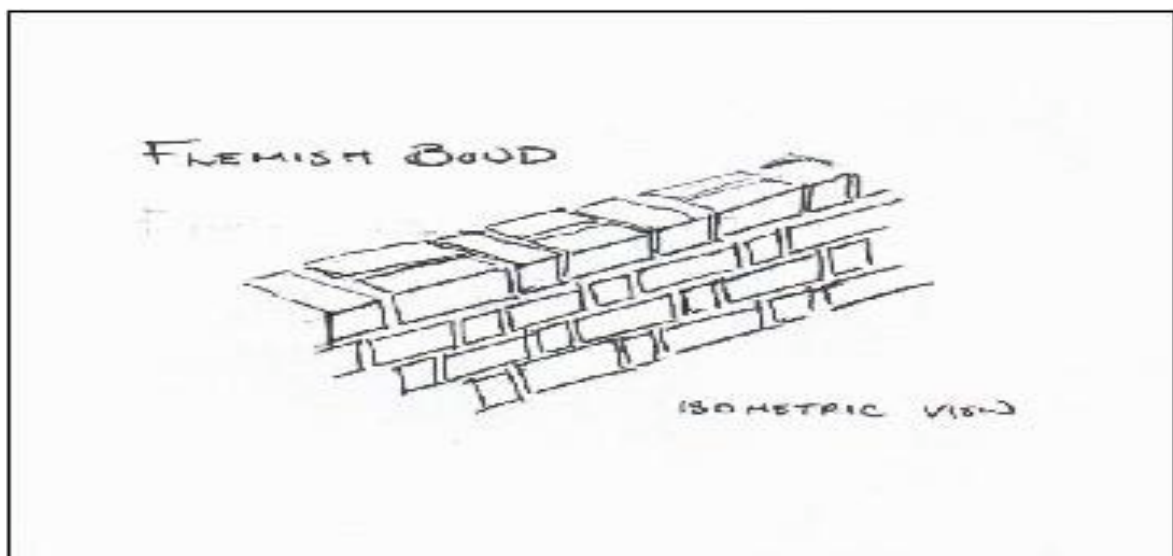
Lime Every Time

Unfortunately the re-pointing, whilst well meaning, is not appropriate for this type of construction. A cement mortar has been used rather than a lime based mortar. We recommend you use lime mortar in any future repairs regardless of what the builders say! Using lime mortar will limit further damage to the brickwork, which is almost impossible to repair successfully.

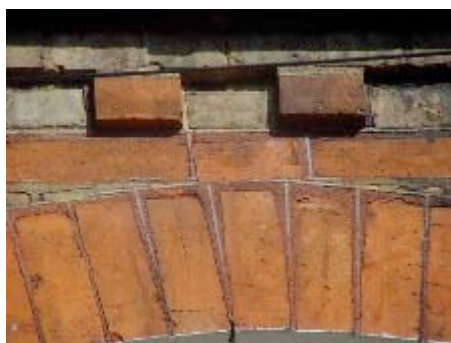
There is a hairline crack to the window. The brickwork is of Flemish bond construction. The decorative brickwork at eaves level is also shown. You may be interested to note new pointing to the soldier course of brickwork above the window, known as pinch pointing, which involves striking the centre of the mortar and pointing in white. At one time the entirety of the building would have had this look.

Close up of the pinch pointing.
