SPECIFIC DEFECTS REPORT

Relating to Damp Walls

1920s Property in Devon

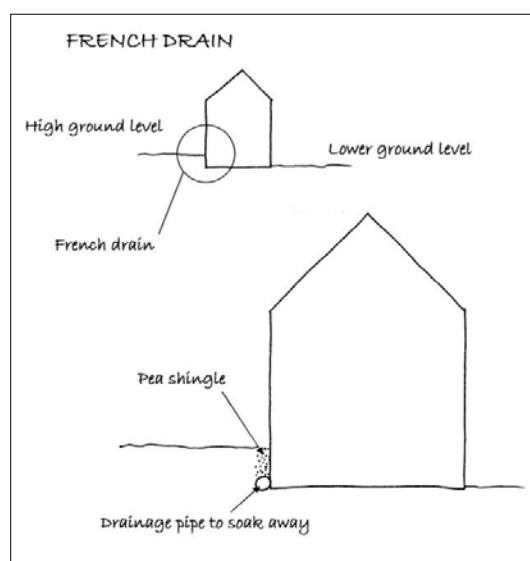
French Drains must be on a slope

The pipe that is at the base of a French drain should be perforated or as we did years ago for land drains, there should be gaps between each pipe which should be set onto a bed of firm ground and the pipes should be on a fall to the drain. Whilst you should be able to ensure that there is enough fall by sight, we always like the idea of rolling a marble from one end to the other! You will then need to place the pipes down and fill the trench with 0.5” (7.5mm) to 1” (15mm) sized gravel. You can leave it at that, or in addition you can cover this with sand and then turf over it. This is how a basic French drain is carried out.
