# **SPECIFIC DEFECTS REPORT**

**Relating to Dampness (as specified on page 3)**

**Victorian Terraced Property with Dampness in Fulham**

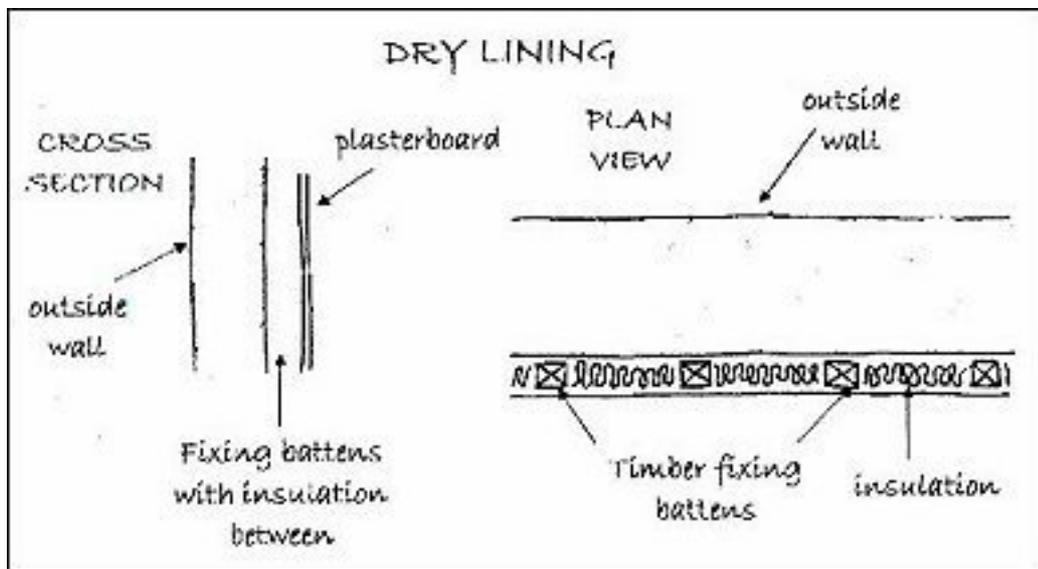
One option is to hide the effect of the dampness, which can be carried out in several ways. A technique often used in basements is to have a false wall in front of the present wall with a plastic sheet (usually patented) which allows any dampness that does surface to travel down the wall; this then would have a drain which moves the water to the outside. Depending upon the amount of water that you have seen in this area (remembering that we have not seen this section when it has been raining) it may be possible and sufficient to carry this work out without a drain, but you do need to discuss this with the manufacturer. This, as we discussed, will mean that the kitchen units will need to be amended to have a gap of typically between 75mm and 150mm.

An alternative solution is to simply hide the dampness and offer no option on how the dampness gets out by cladding the wall. As we discussed some type of Perspex sheet of approximately 5mm thickness could be used behind the kitchen units with some type of cladding above it.

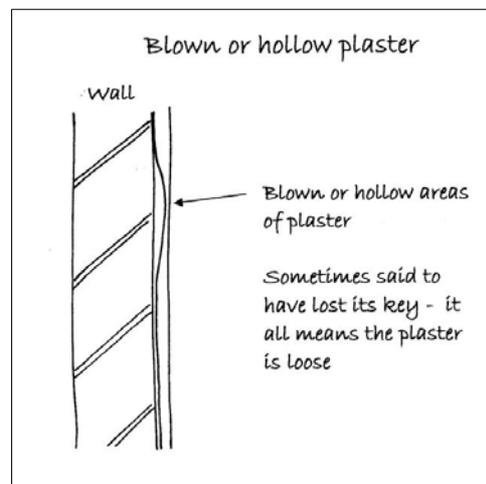
We noted some minor blown plaster, probably typical for this age of plaster.
