COMMERCIAL BUILDING SURVEY

An Modern Office

GEM Associates Limited

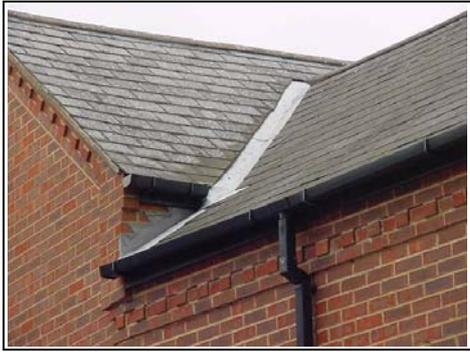
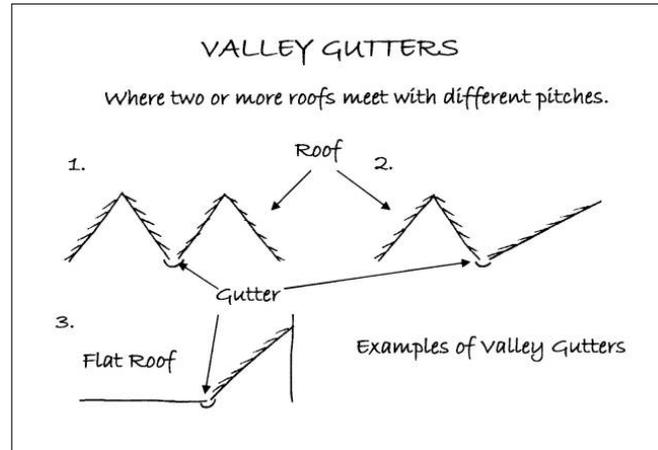
Valley Gutters

Valley gutters occur where two roofs join and these are generally considered weak areas. In this instance we would comment that they look to be metal, possibly lead, although often replacements are used in newer buildings such as this. We look to check that they are not blocked or that there aren't any cement fillets (the bits at the side of the valley gutter) coming loose. From what we could see they all looked to be in average condition.

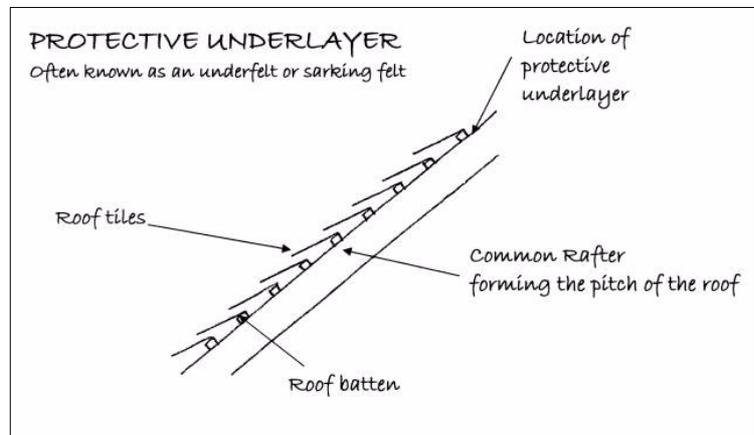
Protective Underlayer (Often known as the sarking felt or underfelt)

When we inspected the loft space we found a Hessian base Bitumen membrane. This type of membrane has been used since the 1960s. We generally found it to be in average condition, although it is damaged in a few places but this is not unusual considering its age.

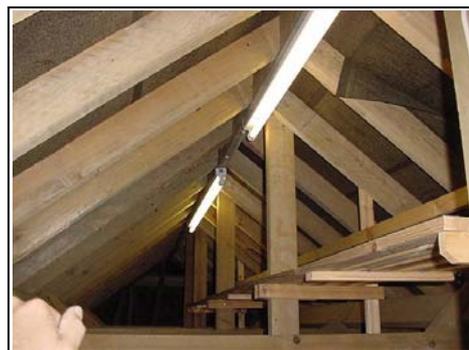
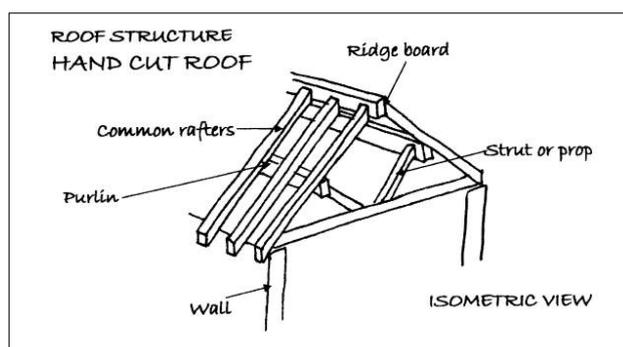
Roof Timbers

We found the roof timbers generally in reasonable condition, with the exception of a few twisted joists, which we believe relates to the defective flooring, which we have mentioned in the Executive Summary, which has been transferred through the structure. As you can see in the adjoining photo one of the common rafters has split. Ideally this should be replaced, but in this instance we would leave it as to replace it would be very difficult. When you have rectified the cause of the problem it should not be a further issue.

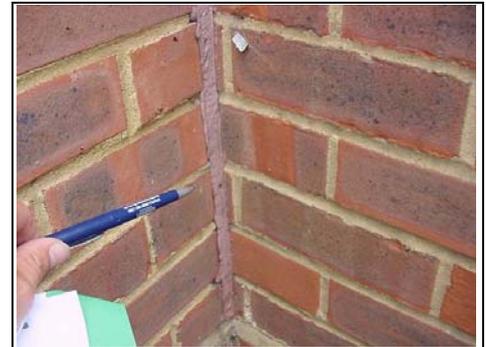
In the adjoining photo we have identified a movement joint (providing it is there), which is the correct practice for a modern wall.

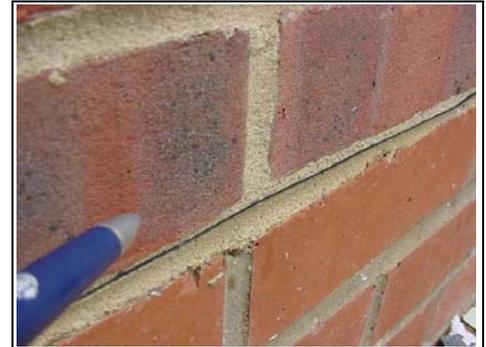
All modern properties should incorporate a damp proof course (DPC) and good building practice dictates that a differential of 150mm (6 inches) should be maintained between the damp proof course and ground levels. In this case, as the property is relatively new (last 30 years in this case) we would expect to find a plastic damp proof course, often known by its trade name of Hyload, as can be seen in the adjoining photo.

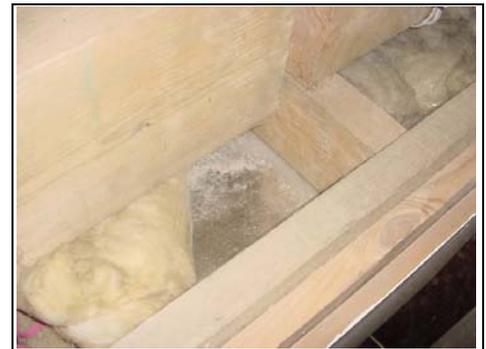
Ceilings

We noted in the loft space that a foil-backed plasterboard has been used. These are generally used to try and reduce condensation occurring into the loft space and are a relatively modern idea that has not as yet undergone the test of time.

With this type of construction hairline cracking is possible, which is not uncommon in plasterboard. This will need filling in due course and we suggest you use a filler that allows for movement, although we would add that where plasterboard sheets join, cracks may open up again.

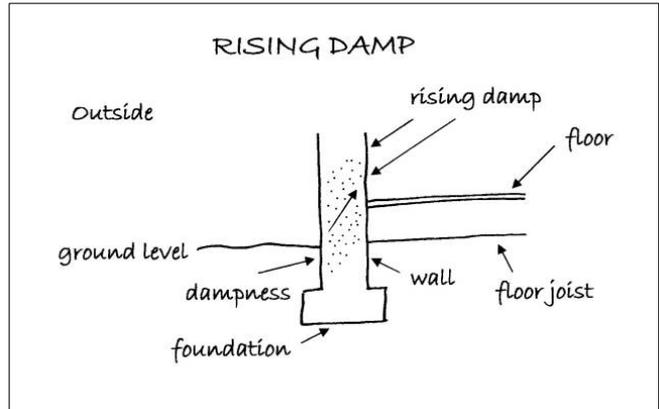
Rising Damp

We carried out random tests with an electronic damp meter and no evidence of any significant rising dampness was detected in the random areas checked.

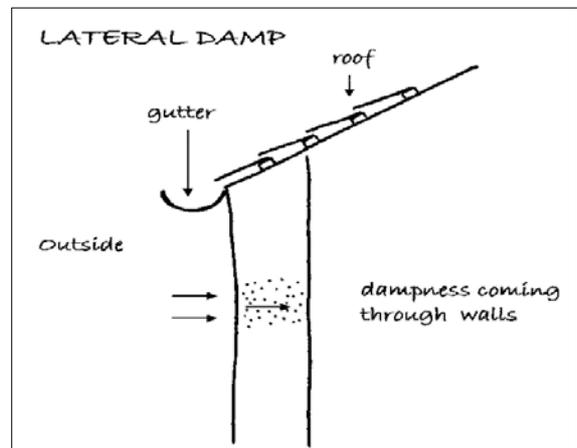
Lateral or Penetrating Dampness

Tests were taken with a moisture meter at random points to internal walls, floors and other surfaces. No evidence of any significant penetrating/lateral dampness was detected.

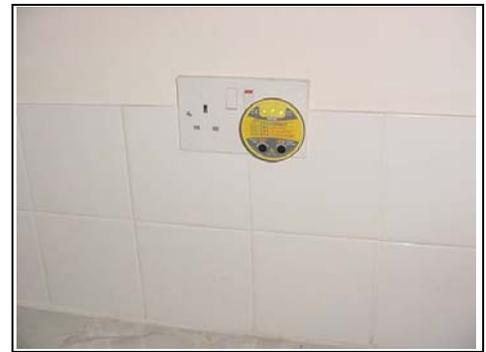
We carried out an earth test in the kitchen area to the socket point that is normally used for the kettle and this proved satisfactory.

ACTION REQUIRED: If there is no record of an electrical test having been undertaken within the last five years, it is recommended that the installation be tested by a competent electrician (NICEIC registered) and all recommendations implemented. Thereafter, the installation should be re-tested every five years.

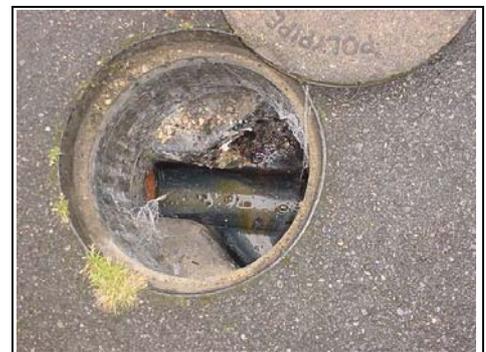
Inspection Chamber – Front Right Hand Side

We duly lifted the cover and found it to be free flowing at the time of our inspection.
