COMMERCIAL BUILDING SURVEY OF A Nursing Home

FOR
Mr A Client

GEM Associates Limited

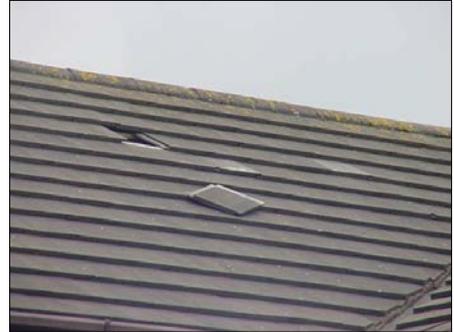
There are the occasional displaced tiles.

ACTION REQUIRED: Generally check the cement mortar to the ridges and sides of the valley gutters and repair appropriately. At the same time check the flashings and replace missing/damaged concrete tiles.

ANTICIPATED COST: As we feel scaffolding access may be required (although it may be possible to do the work from a cherry picker crane) we would expect costs in the region of £5,000 - £10,000. Quotations should be obtained although work will be substantially cheaper if scaffolding is not required.

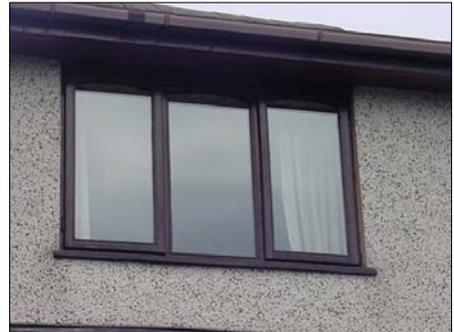
Whilst the majority of the windows are in reasonable condition and are certainly what we would term as 'saveable' we would estimate that approximately 30% would benefit from redecoration. This photo shows a typical window to the property.

ACTION REQUIRED: It would be prudent to redecorate all external joinery, including the windows and fascia and soffit boards, together with some minor repair.

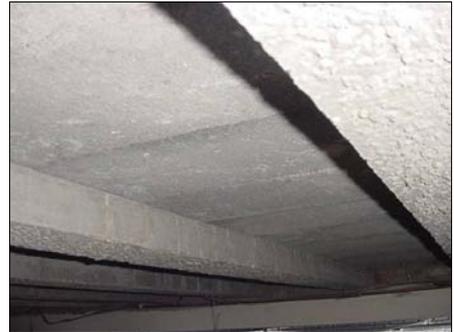
To the Yellow / Laundry Room / Eucalyptus Tree side of the property dampness can be seen in the beam and block floor.

This photo shows a general view of the beam and block floor.

We believe this dampness is due to either a leak from the pipework or condensation from the pipework. We have opened up the ceiling but could not see any specific reason for the dampness.

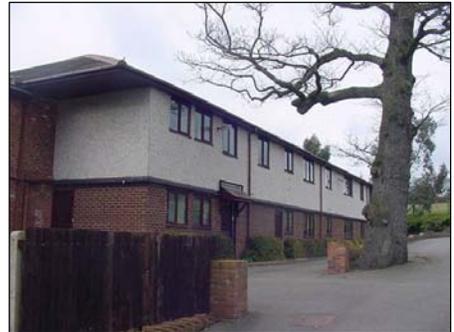
This photo shows one of the surrounding trees.

ACTION REQUIRED: We would recommend that an arboriculturist (not a tree surgeon) is asked to comment upon the trees and that any recommendations are carried out.

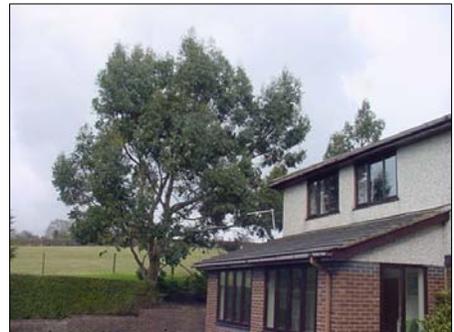
This is the rear of the property with the Eucalyptus trees to the background.

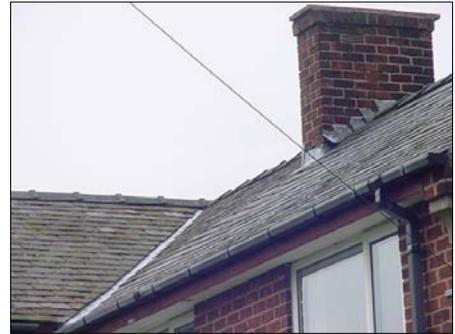
A general check of the roof is required.

ACTION REQUIRED: There is no obvious reason for dampness getting into the roof. It may be wind driven rain or it may be that the property has been empty. A general overhaul of the roof is required. This will require replacement of slipped, broken and missing tiles together with general clearing of the valley gutters, checking of base materials and flashings and checking of gutters and downpipes.

ANTICIPATED COST: In the region of £500 - £2,500 to carry out investigation work and repairs as necessary.

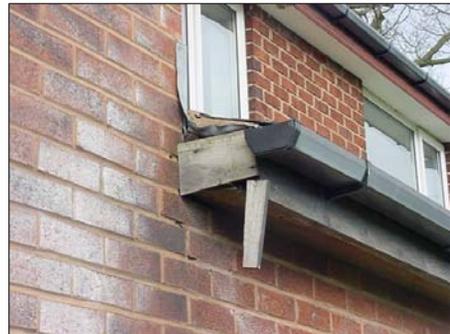
The external joinery is in need of redecoration in some areas. This photo shows bare timber to the fascias and soffits.

ACTION REQUIRED: Paint/re-stain external joinery and repair as necessary.

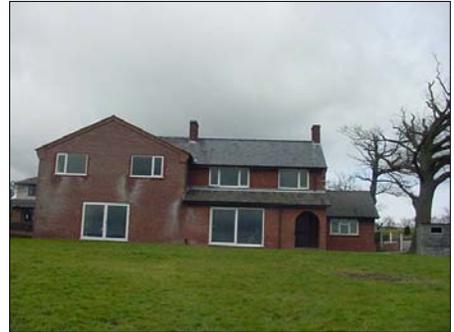
We noted considerable efflorescence.

ACTION REQUIRED: Re-point in a like-for-like mortar – this looks to be in a lime-based mortar. You may wish to use a brick cleaning product to remove the efflorescence, once the source of the problem has been established.

ANTICIPATED COST: In the region of £2,500 - £7,500. Quotations should be obtained.

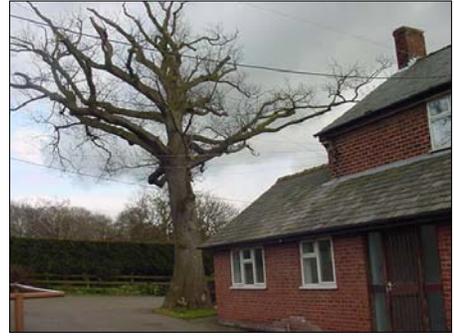
We would refer you to the above sections for both the Nursing Home and the adjoining house itself.

ACTION REQUIRED: Specialist advice is required from an arboriculturist.

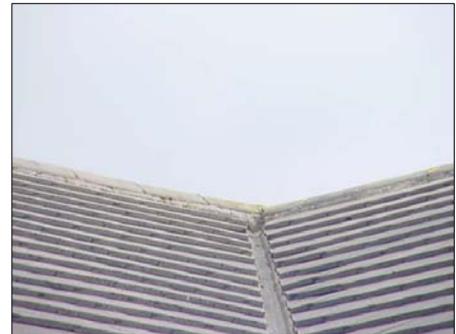
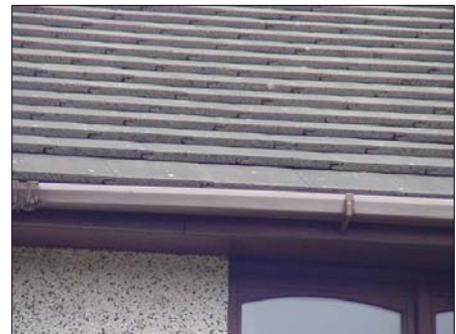
This photo shows a general view of the roof.

As a general comment on the roofs as a whole, as viewed from ground level, the roof coverings showed nothing out of character for their age and type. Weak areas to this type of roof are the ridges, the valley gutters and the perimeter; all of which show signs of deterioration.

Please see our comments in the Executive Summary.

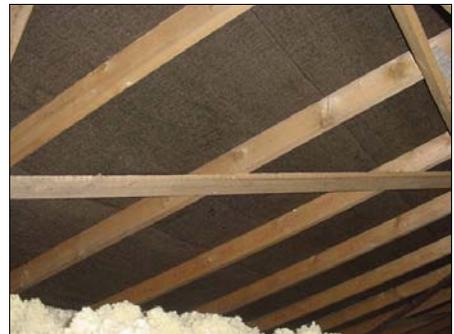
When we inspected the loft space we found a Hessian base Bitumen membrane. This type of membrane has been used since the 1960s. We generally found it to be in average condition, it is damaged in a few places but this is not unusual considering its age.

This photo shows the common rafters (the ones that form the pitch of the roof) and the dark area between is the underlayer.

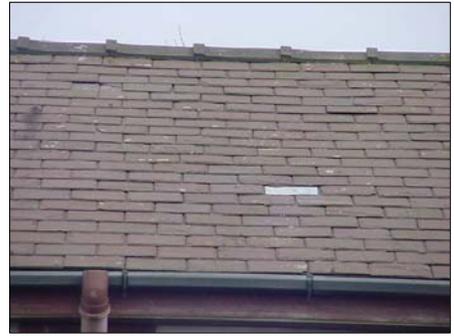
The roof to the adjacent house is pitched and clad with slates. As a general comment on the roofs as a whole, we did not see any particular issues externally, however, internally we noticed that water is getting into the roof. This is usually due to dampness coming in at the junctions, such as the junction of the chimney and the main roof and the valley gutters and the flashings.

ACTION REQUIRED: Please see our comments in the Executive Summary.

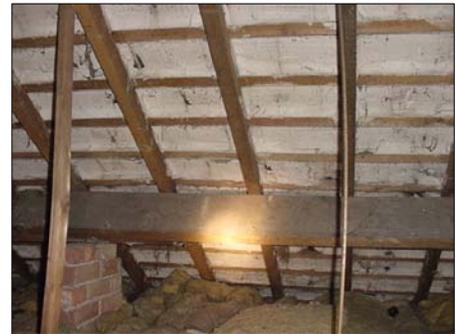
The newer part of the property also had a Hessian based underlayer; the older part of the property has what is known as 'blinding'. This is where the slates are sat onto a mortar bed. It is therefore possible that during periods of heavy and prolonged driving rain some water penetration could take place through the roof coverings.

This photo is within the right hand side of the roof. You can see the blinding that has been used to bed the slates.

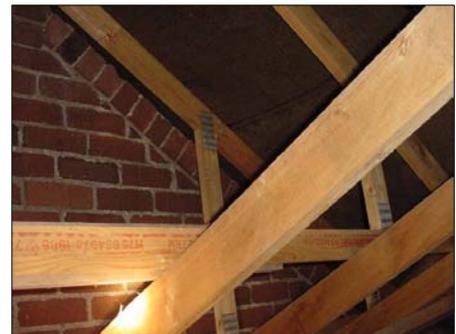
This is the left hand side of the roof where you can see a modern prefabricated roof construction. In the darker area you can see the Hessian based felt.

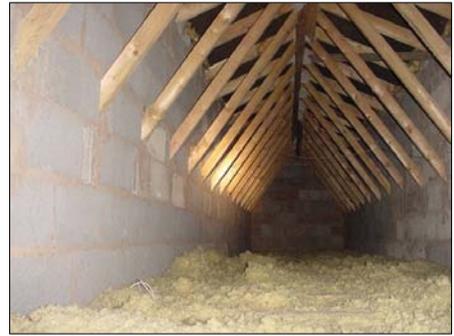
A general view of the outer side of the roof.

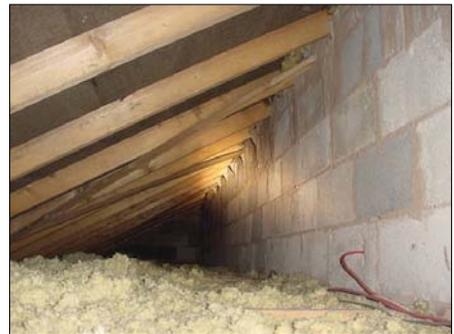
A general view of the apex of the roof.

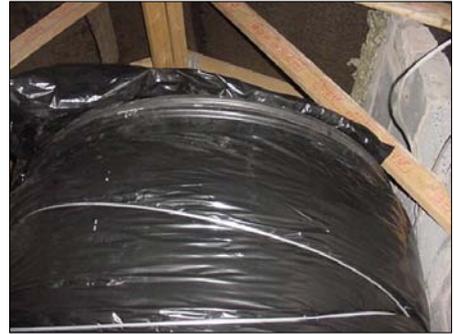
We noted a water tank located in the Blue roof section, which is adjacent to the dwelling house.

We would always recommend that water tanks be drained down and cleared of any debris etc. (we have seen dead birds and other unmentionable things in these tanks). As people may be cleaning their teeth with this water it is best that it is as clean as possible!

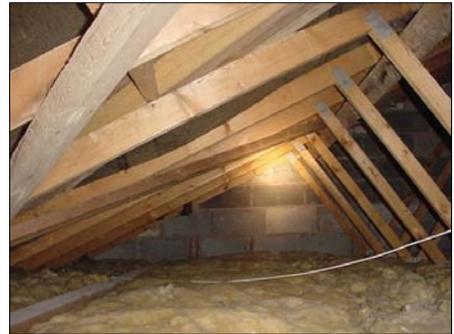
The newer section of the roof is pre-fabricated and the timbers, we assume, have been treated and generally looked in reasonable condition. This photo shows a general view of the roof looking towards the new gable end with the blockwork visible.

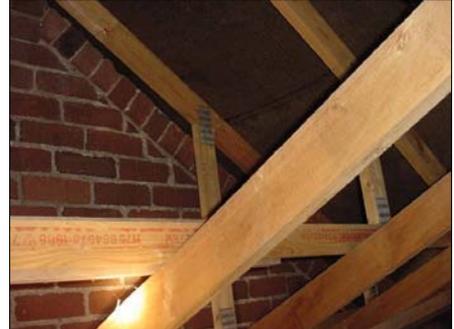
This is a general view of the roof looking towards the brickwork.

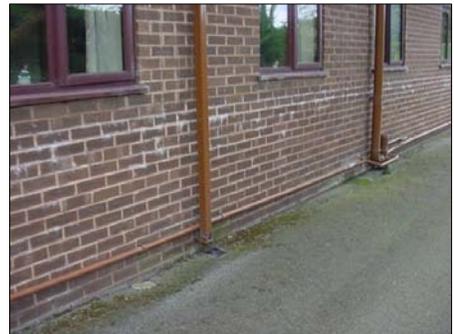
There is efflorescence both to the Nursing Home and to the Adjacent House indicating that dampness is being retained in the brickwork. To the Nursing Home we believe this is where it is sheltered by the Eucalyptus trees to the rear and therefore does not see much sunlight (see photo on right).

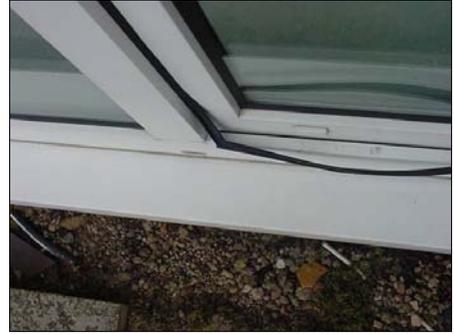
There are a mixture of double glazed plastic windows and timber windows. The timber windows are in need of redecoration in some areas. The plastic windows are generally in reasonable condition with one or two exceptions, for example, in this photo, the seal is missing around the window.

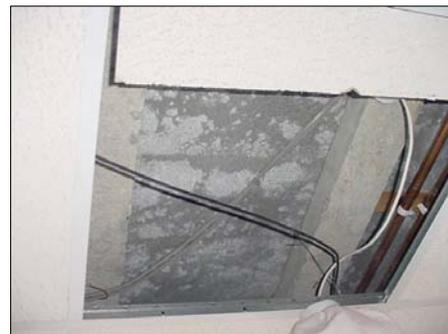
We have opened up a random selection of the ceiling tiles to expose the construction. Above we found a beam and block construction and, as mentioned elsewhere in this report, we noted signs of dampness coming through in some areas.

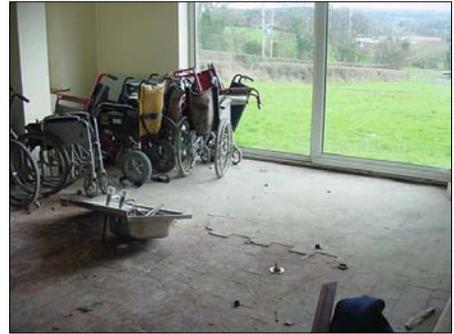
We found cracking to part of the floor.

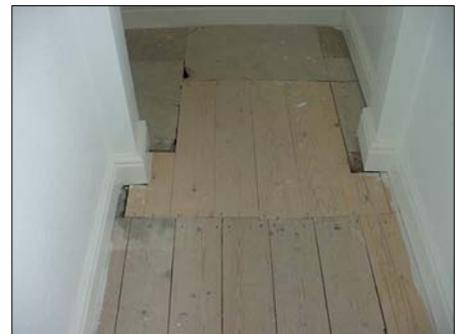
This photo shows an example of the floorboards.

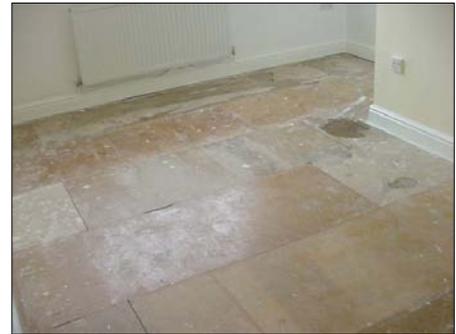
This photo shows an example of the floorboarding.

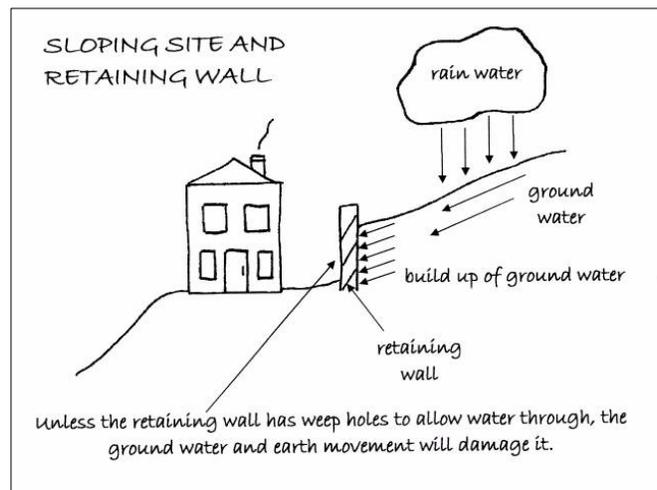
As the property is sitting on a sloping site there are boundary walls around it. We note that some of them do not have weep holes, particularly to the side that faces the adjacent house.
