**RESIDENTIAL BUILDING SURVEY**  
**OF**  
**The Square, London**

**FOR**  
**MR T**

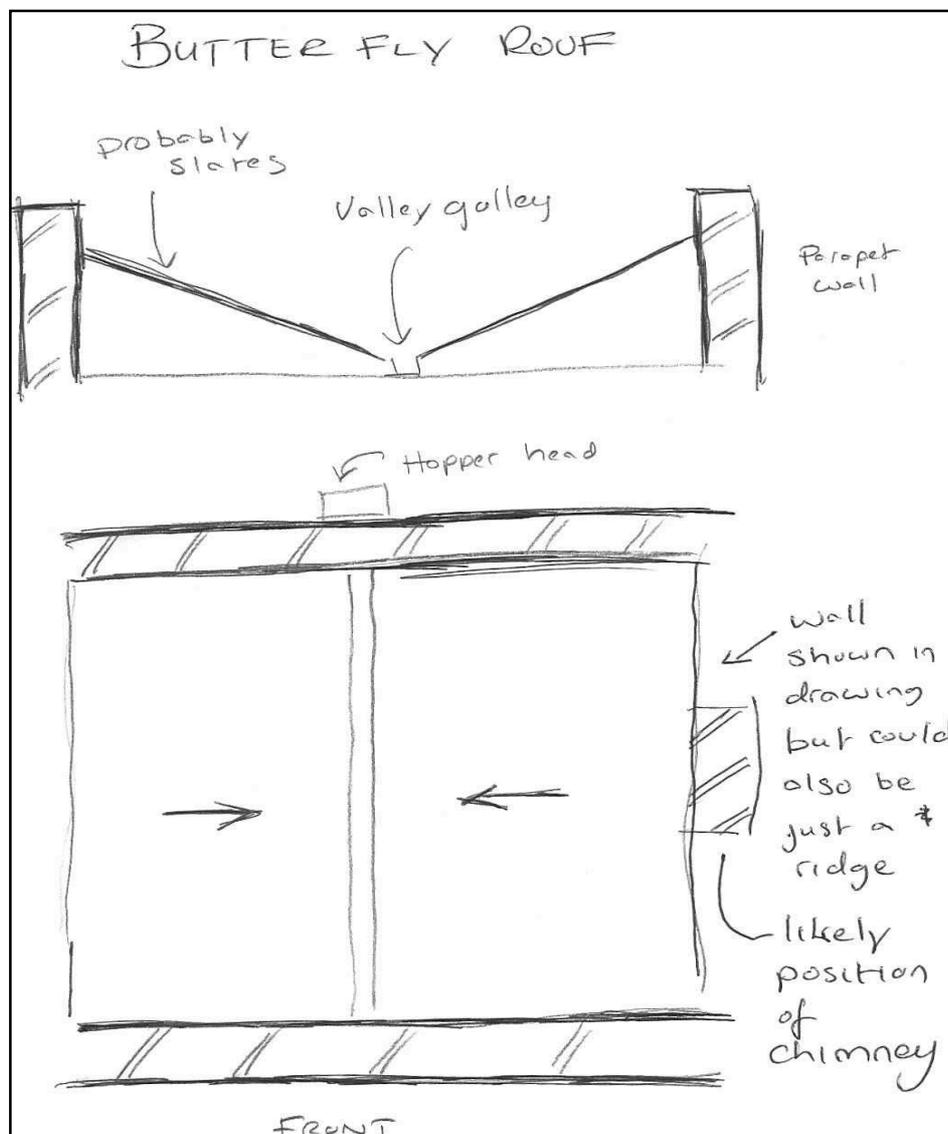
We have come to this conclusion due to the position of the rainwater goods to the rear of the property, which are positioned centrally and is common for this type of roof.

Unfortunately as we have not seen this roof we cannot comment upon its condition other than to say that a slate roof typically has a life of 100 years and this roof is coming to the end of its economical life unless it has been replaced or repaired during that time.

A very common problem with this type of roof is the central valley gutter which more often than not leaks. We are concerned that this is a liability that you will have to take on as well.

**ACTION REQUIRED:** We would very strongly recommend that the landlords are contacted by your solicitor to confirm what recent work has been carried out to the roofs and when they anticipate they will need replacement as this will be a very costly exercise.

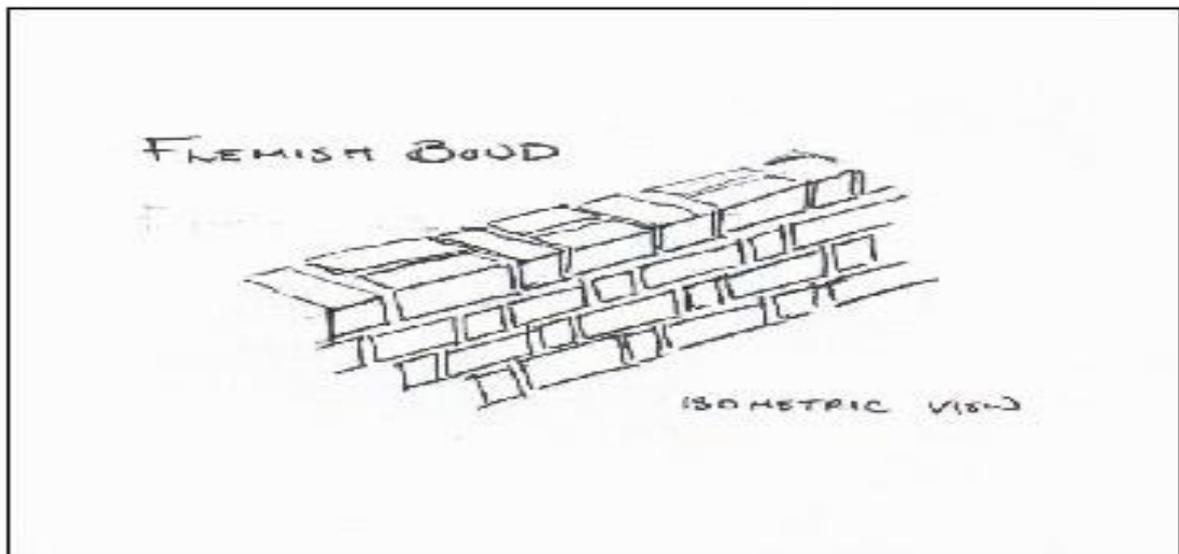
### **Lime Every Time**

Unfortunately the re-pointing, whilst well meaning, is not appropriate for this type of construction. A cement mortar has been used rather than a lime based mortar. We recommend that you use a lime-based mortar in any future repairs regardless of what the builders say! They will often not recommend the use of lime mortar because they are not skilled enough to actually utilise this particular material. Using lime mortar, however, will limit damage to the brickwork which is almost impossible to repair successfully.

**ACTION REQUIRED:** Future repairs to be carried out in a lime mortar.
