RESIDENTIAL BUILDING SURVEY

OF
1940s Detached Chalet Bungalow

Mr H

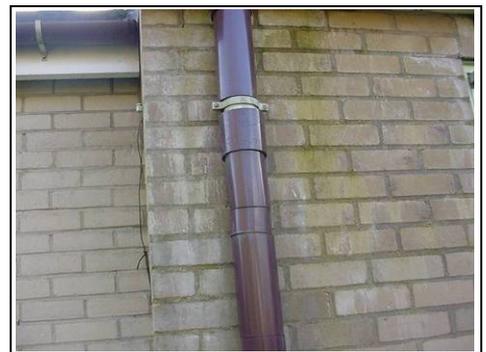
Downpipes covered in plastic

ACTION REQUIRED: Some of this we would class as DIY type work. However, for replacing the downpipes we would recommend it is carried out professionally.

ANTICIPATED COST: £3,000 to £4,000. If the downpipes are found to be asbestos, which it looks like they may be, then this cost is likely to go up towards £10,000, as asbestos removal can be very expensive.

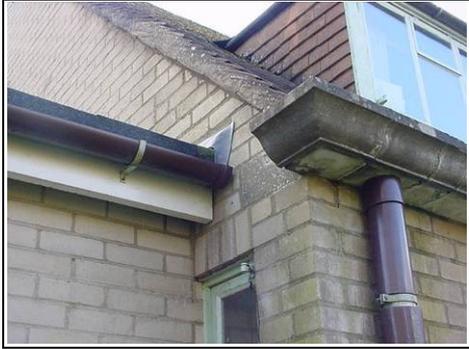
Finlock gutters

- a. The Finlock concrete gutters, which can be difficult to make watertight. These are presently allowing water into the property walls in what is known as lateral dampness (through the walls).

ACTION REQUIRED: The gutter needs to be made watertight. Typically, this is with a bitumen paint, which could be a DIY type job, particularly as great care needs to be taken over it to ensure that it is done properly. The bitumen coating will need regular repair to ensure it stays watertight. An alternative may be to line the gutters with lead, providing sufficient fall can still be obtained on them.

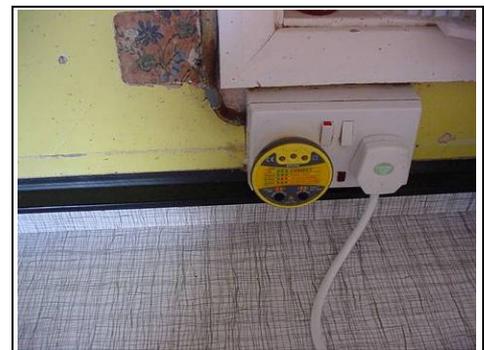
Earth test

We carried out an earth test in the kitchen area to the socket point that is normally used for the kettle and this tripped the circuit.

ACTION REQUIRED: Please see our comments in the main body of the report.

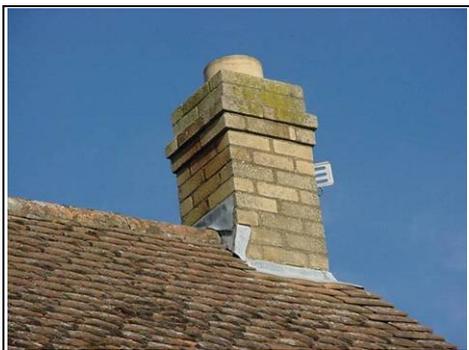
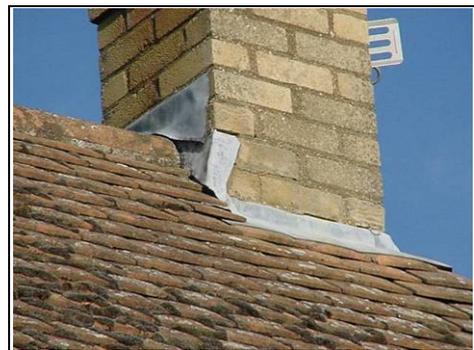
Chimney

The chimney is brick finished with a lead flashing, with one chimney pot. Unfortunately we were unable to see the very top of the chimney known as the flaunching, we therefore cannot comment upon it. It does, however, look to have been rebuilt. Chimneys, due to their exposed locations can suffer and this may be why it has been rebuilt.

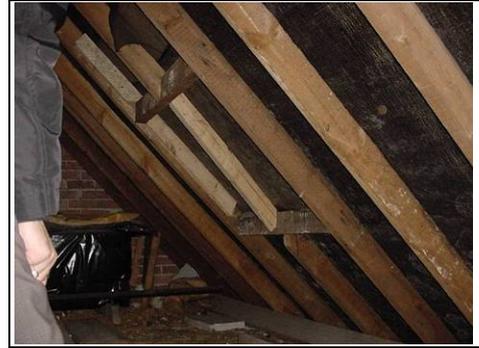
We spoke about this chimney being removed. It could be reinstated if you employ the right trades people.

The section of the roof where the chimney has been removed, in the centre of the photo with the multi-coloured timbers

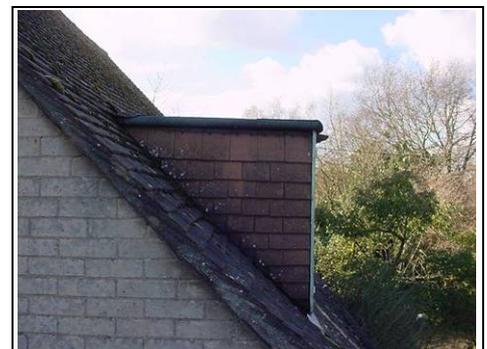
There are two dormer windows, one large and one small, to this property. They have been inspected from ground level and the adjoining flat roof. The sides are tiled with a flat roof, which unfortunately, we could not see. It looks to be felt from the edge detailing, which looks in average condition.

ACTION REQUIRED: We recommend that you check the flat roofs when you are carrying out the work to the guttering.

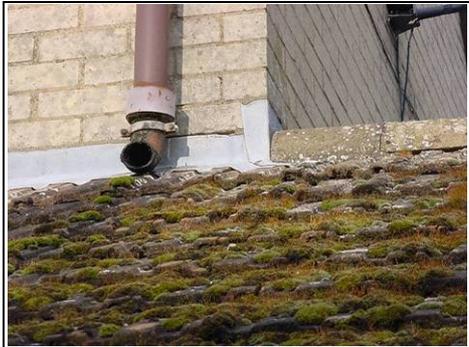
This is heavily covered in moss.

The rear pitched roof and the moss

ACTION REQUIRED: We would reiterate our earlier comments.

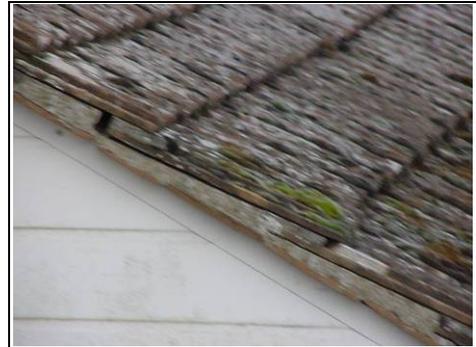
Some work is required to the repointing of the perimeter of the roof

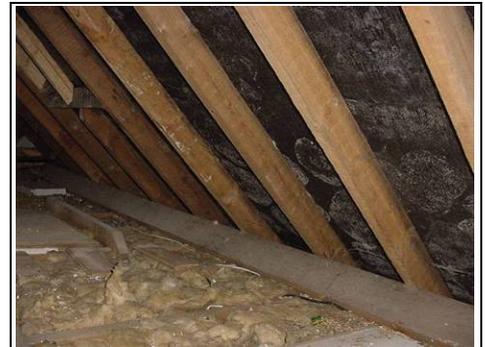
When we inspected the loft space we found a Hessian base Bitumen membrane. This type of membrane has been used since the 1960s. We generally found it to be in average condition, its damaged in a few more places than we normally find.

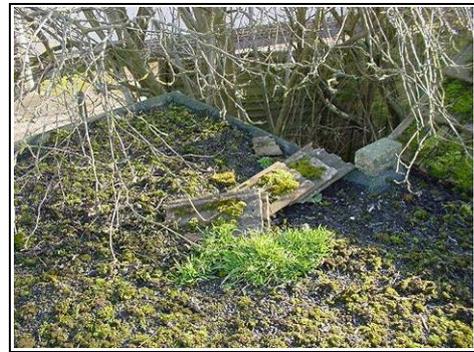
You have two large flat roofs, one to the left hand side, one to the right hand side. The left hand side is in the poorest condition. It has suffered badly from being flat and therefore no water can drain off it. You should have a fall of approximately 12 to 15 degrees. As you are aware, having been on the roof, it is covered with moss and grass is literally growing from it, all of which we squelched around on!

Grass growing through on left hand flat roof

ACTION REQUIRED: We recommend complete replacement of the roof, and to ensure that there is a fall on it we would recommend adding cellular insulation, cut to falls, with a high performance felt on top.

Finally, we would recommend that the tree is cut back to allow some sunlight onto the roof, which should reduce the moss.

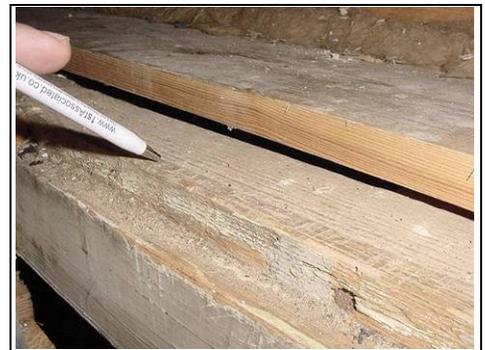
We did find minor woodworm around the entrance to loft hatch. Please see our comments in the Woodworm Section of this Report.

Minor woodworm

ACTION REQUIRED: The only way to be 100 per cent certain is to have the roof cleared and checked.

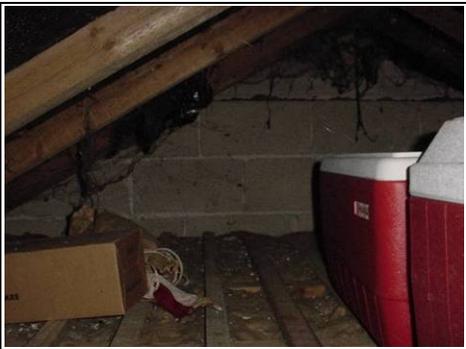
Ground floor roof void

From our limited view we would comment that generally this roof is in average condition. Where the pitched roof meets the flat roof we feel there may be some problems with dampness getting in. More than likely, this problem has been caused by the condition and the very wet flat roof (the left hand side flat roof).

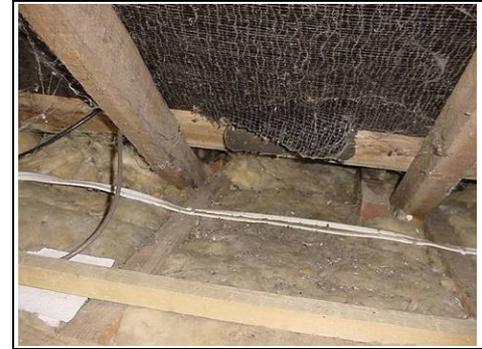
Looking at where the pitch joins the flat roof

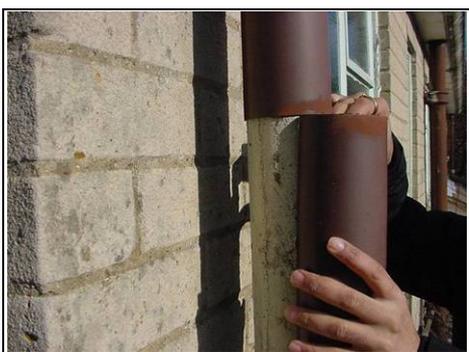
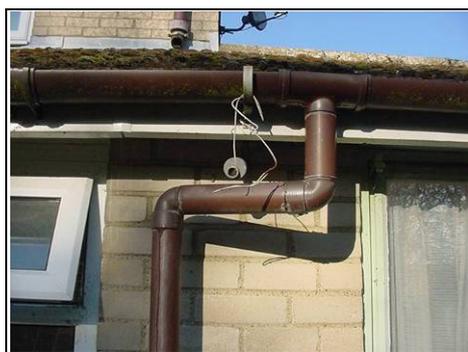
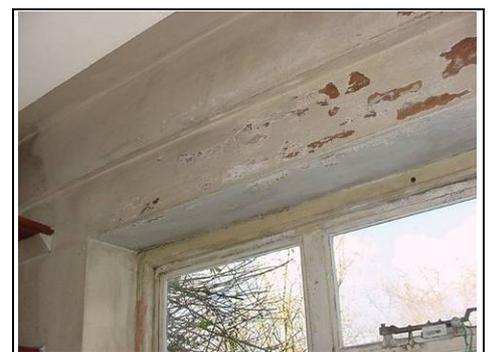
Some of the awkward/awful downpipe details

This swan neck should not be level

This damage has been caused by leaking gutter

The property has a mixture of the concrete Finlock gutters and plastic gutters. It is probably best to say that all the guttering needs looking at and considering whether to repair or replace.

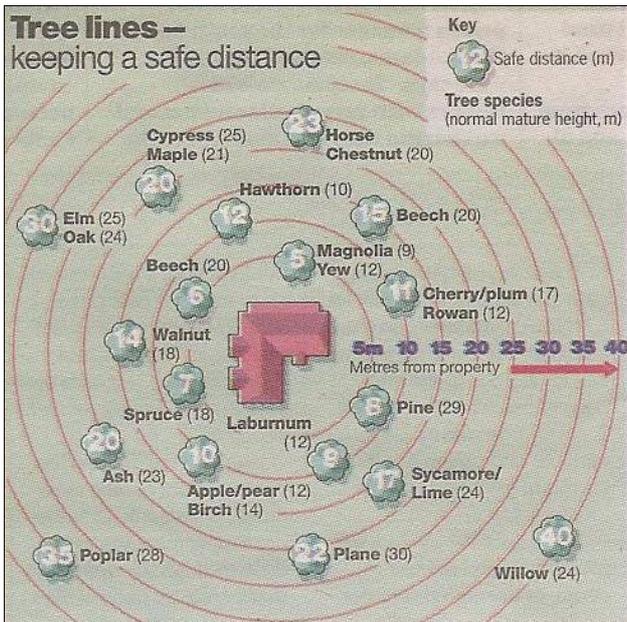
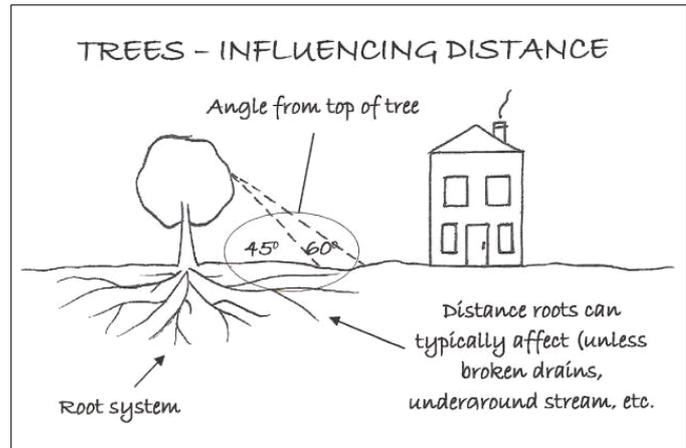
Damage to foundations and underground services can be caused by trees and shrubs. There are a number of these in the vicinity of the building, what we term within influencing distance, particularly the willow tree, and we believe that these trees may be affecting the property.

The willow tree is relatively close to the property and you need to get advice specifically on this tree. Interestingly, it is generally considered that, where there is a willow tree there is usually water.

Influencing Distance Defined

This is the distance in which a tree may be able to cause damage to the subject property. It is not quite as simple as our sketch; it depends on the tree, its maturity, the soil type etc., etc.

ACTION REQUIRED: You need to obtain advice from an arboriculturist (not a tree surgeon). Please see our comments within the executive summary.

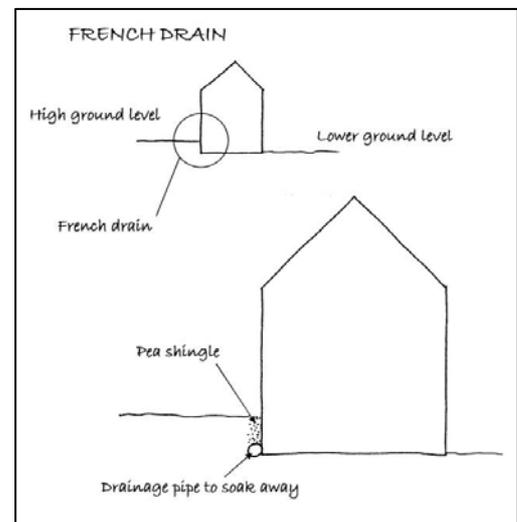
Unfortunately, the ground level is high in some areas and you will need to lower this. This may be sufficient, however we have recommended adding a French drain, as a belt and braces measure.

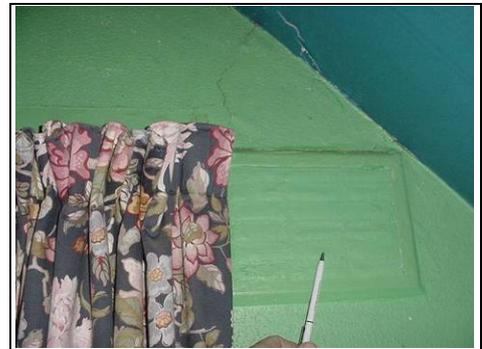
High level airbricks

We noted high level airbricks and these were used to help reduce condensation and were, we believe, a building regulation requirement of the time. These were typically added in the 1960's to help reduce the condensation being caused by the metal windows.

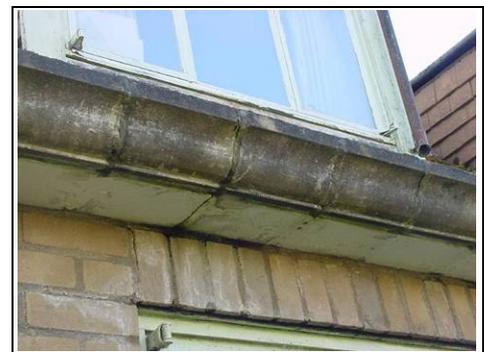
The guttering effectively acts as a fascia and soffits.

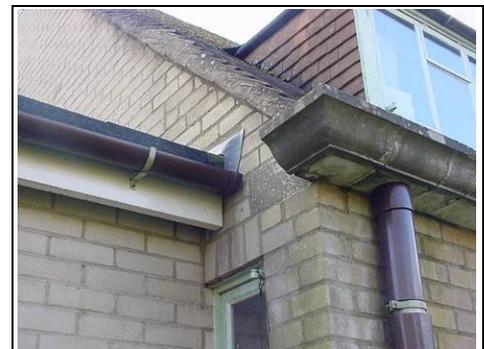
In some areas there is a traditional fascia board, this looked in reasonable condition, as can be seen in the adjoining photo.

ACTION REQUIRED: Please see our comments in the Executive Summary.

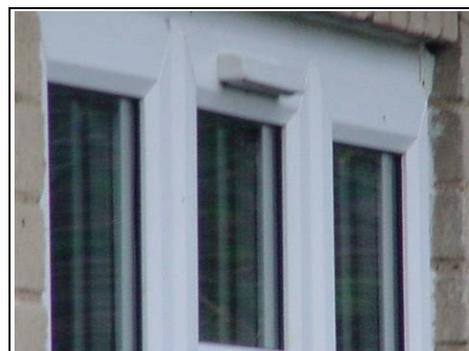
Some areas have been re-glazed in plastic double glazing. They generally look to be of a reasonable quality, but probably to the lower end of the market. We were pleased to see trickle vents in the windows.

Plastic windows with trickle vents

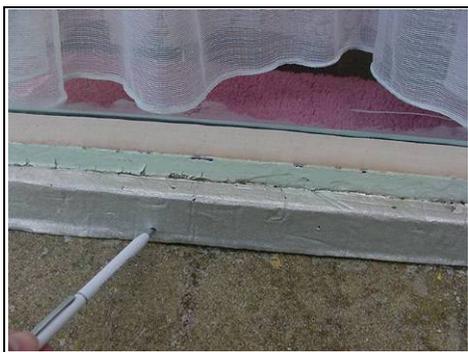
A foil was noted to the base of most windows. We can understand the rationale behind this on the metal windows, as this is a timber frame, which could rot and this could protect it, but not on the plastic windows.

Metal window with foil at the bottom

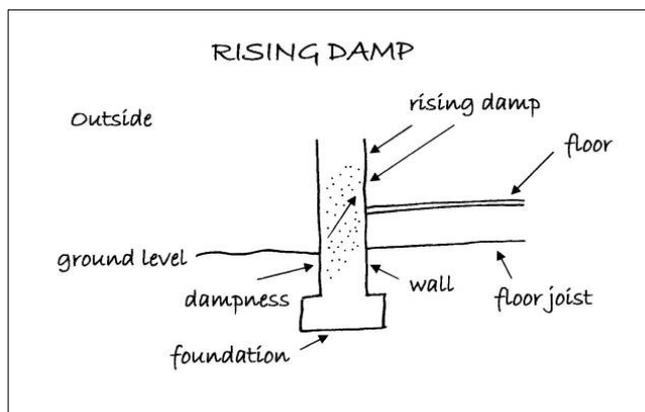
The ground floor of the property is below the outside ground level this leads to dampness.

ACTION REQUIRED: Lower the ground level and add a French gully. Please see our comments in the Executive Summary.

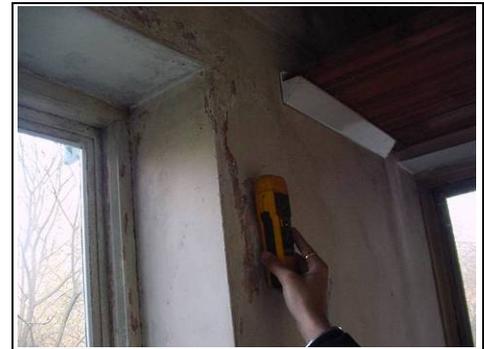
Tests were taken with a moisture meter at random points to internal walls, floors and other surfaces. We get high readings, in some areas.

Please see our comments in the executive summary.

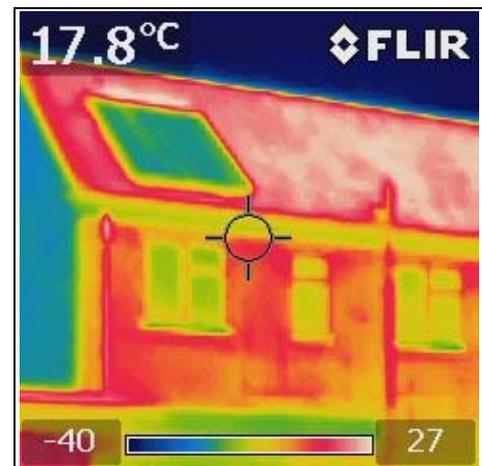
Roof Insulation

Some roof insulation was present, although not to current Building Regulation requirements of 270mm. We would not be overly concerned about this as we typically find in roofs between 100mm – 150mm of insulation. In this instance you have approximately 100mm.

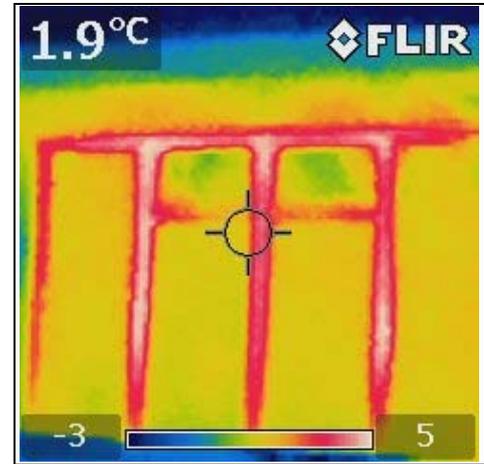
Windows

A mix of double glazed windows, which will have reasonable thermal properties and single glazed windows, which will have poor thermal properties, particularly as these are metal windows.

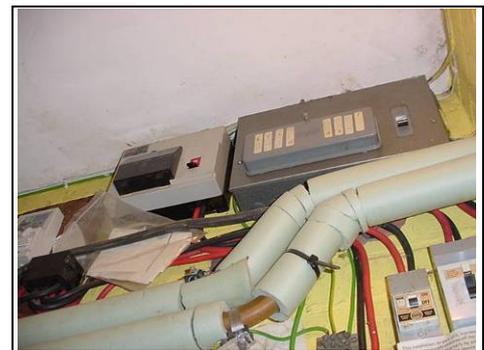
Fuse Board

The electric fuses and consumer units were located in the utilities room. We would date the fuseboard as being from the 1960s and, whilst not the best now available, it is reasonable.

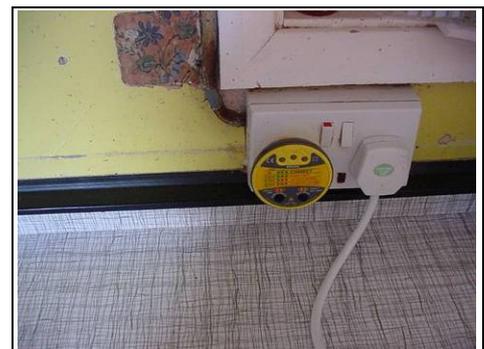
We carried out an earth test in the kitchen area to the socket point that is normally used for the kettle and this proved satisfactory.

ACTION REQUIRED: If there is no record of an electrical test having been undertaken within the last five years, it is recommended that the installation be tested by a competent electrician (NICEIC registered) and all recommendations implemented. Thereafter, the installation should be re-tested every five years.

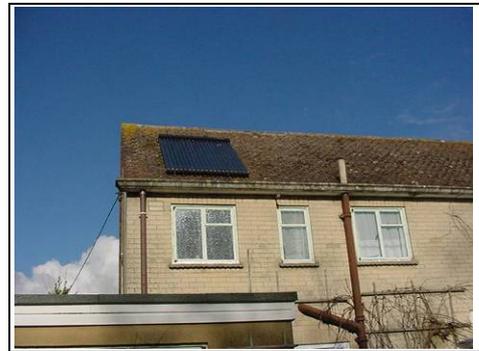
Solar panel

We have no idea whether the solar panel works or not as the property was unoccupied when we carried out the survey and we did not have the chance to carry out our normal questionnaire during a question and answer session with the occupier/owner.

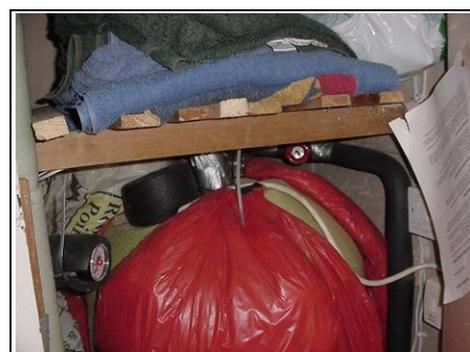
Hot Water Cylinder

The property has two hot water cylinders, one located in the airing cupboard and one in the cupboard within the left hand bedroom (all directions given as you face the property). We assume that one of these is for the solar panels.

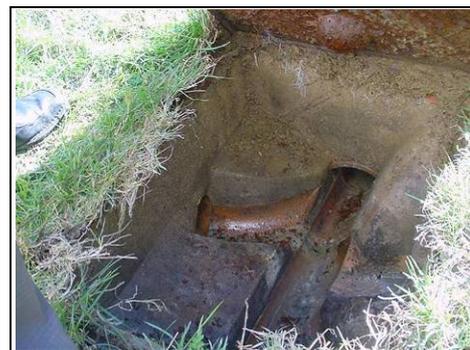
We duly lifted the cover and found it to be free flowing at the time of our inspection.

From what we could see it is finished in concrete.
