***Building Surveying***

***Follow the Trail***

# Building Surveyors must follow the trail of suspicion

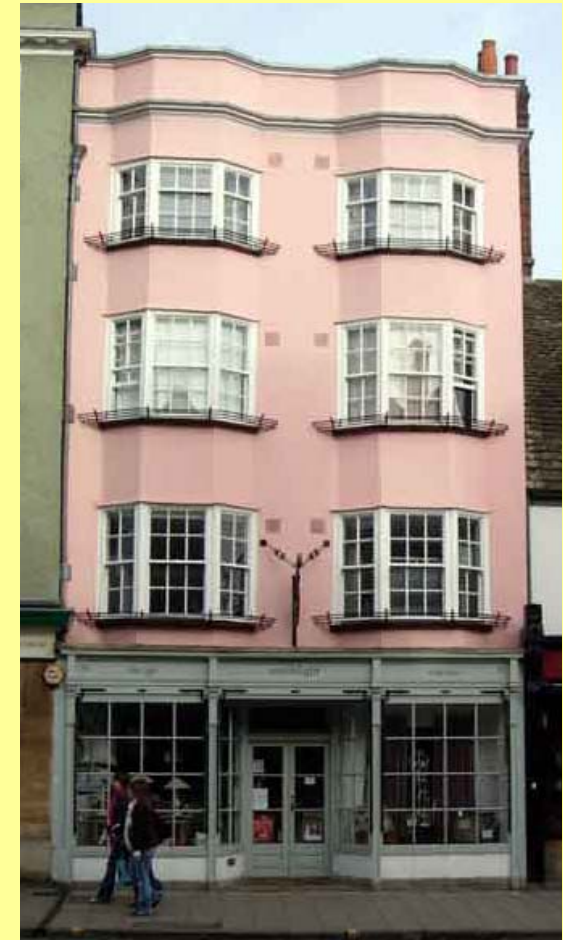
- Grade II listed commercial property, timber frame construction comprising of a shop with office above
- Surveyor identified and commented he had concern at the condition of the timber frame to the gable

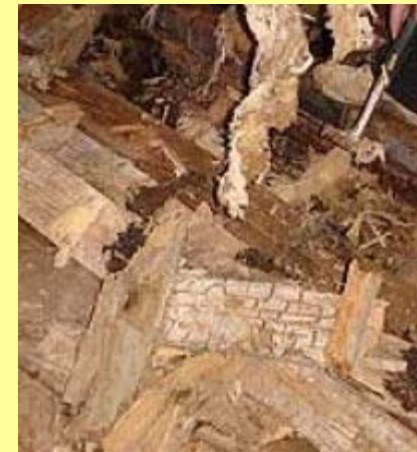
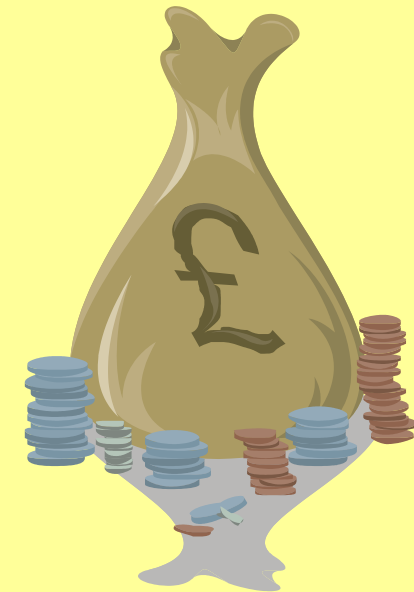
- A second surveyor was instructed and found deep seated rot in many timbers, including some structural timbers
- And extensive poor quality cement patching, which was loose in many areas
- Costing far more than the original surveyors estimate

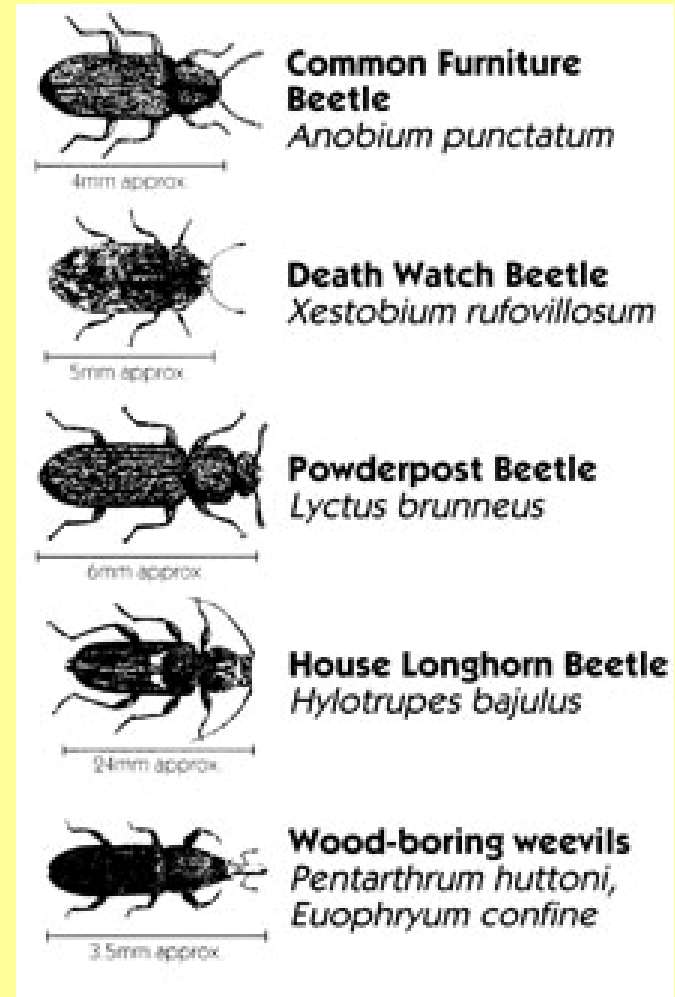
The building surveyor made reference to woodworm infestation but did not make a clear distinction between death watch beetle and common furniture beetle – death watch beetle being much more likely to cause structural damage.
