SCHEDULE OF CONDITION

Address: XXXXXXX

Prospective Tenant: Mr X

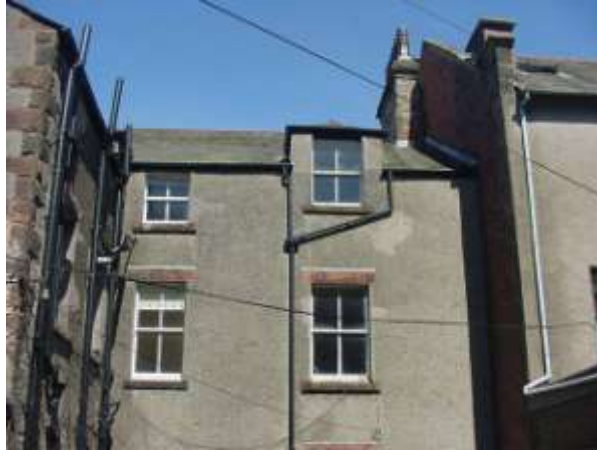
REAR ELEVATION

DESCRIPTION	CONDITION	ACTION REQUIRED
<p>Chimney:</p> <p>See front elevation</p>		
<p>Roofs:</p> <p>Pitched slate roof Dormer roof not visible</p>	Average	
<p>Gutters and Downpipes:</p> <p>Cast iron with some plastic</p>

Damaged downpipe	<p>Clear vegetation. Ensure all gutters are watertight and falling towards the downpipe. Repair and secure as necessary, ensure downpipes are clear.</p>
<p>Soil and vent Pipe:</p> <p>Not visible assumed within toilet area</p>	Signs of leaks	<p>A close circuit TV camera report is recommended of the drains.</p>

<p>Walls:</p> <p>Roughcast render with hairline cracks visible</p>

<p>Hairline cracking to render</p>

<p>Lower render area starting to deteriorate</p>	<p>General repairs to render to make watertight.</p>
<p>Joinery/Detailing:</p> <p>Windows: Sliding sash single glazed</p>	<p>Dirty and some windows painted shut</p>	<p>Repair, prepare, ease and adjust, redecorate and clean.</p>

<p>Repairs to hairline cracking that has taken place on render</p>

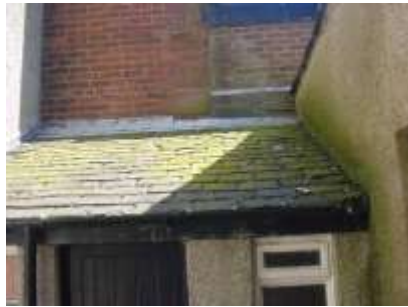
Left hand side outbuilding

DESCRIPTION	CONDITION	ACTION REQUIRED
<p>Left hand side outbuilding - external:</p> <p>Single pitched slate roof</p>

<p>Lead tingles were noted to the roof indicating that the fixings could be deteriorating.</p>	<p>Check whether fixings are deteriorating and replace roof if they are.</p>

<p>Left hand side outbuilding - internal:</p> <p>Toilets</p>	<p>Dampness found to the floor and the walls</p>    	<p>Solve dampness problem. The ceiling needs to be opened up to check the condition of the timbers.</p> <p>Upgrade to modern standards.</p>
<p>Rear outbuilding – External:</p> <p>Single pitched slate roof</p>	<p>We noted that there was slight undulation in the roof; we also noted to the left hand side (all directions given as you face the front of the property) there was a poor parapet and wall detailing which may be allowing water in.</p>   <p>View from the back</p>	
<p>Rear outbuilding - Internal:</p>	<p>Dampness noted.</p>  	<p>The ceiling needs to be opened up to check the condition of the timbers.</p>

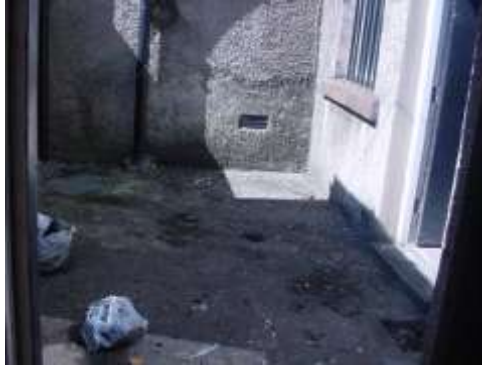
Rear yard

<p>Overgrown and algae/lichens/moss build up</p>	<p>Power clean, clear and weed killer</p>
<p>Rear yard:</p>	<p>Rubbish has been thrown and placed in the area, this needs to be cleared. Overgrown and algae/lichens/moss build up.</p>

<p>Just outside the rear yard there was a walkway where the drain was duly lifted and found to be free flowing nevertheless we would recommend a close circuit TV camera report.</p>	<p>Power clean, clear and weed killer. In addition clear gulleys to the rear and rubbish from area. It may be necessary to add a French Drain around the outside of the property to lower the ground level to allow the insertion of airbricks to the rear of the property to allow a through flow of air underneath the property. It also may be necessary to put a gully into the yard area to direct the water.</p>

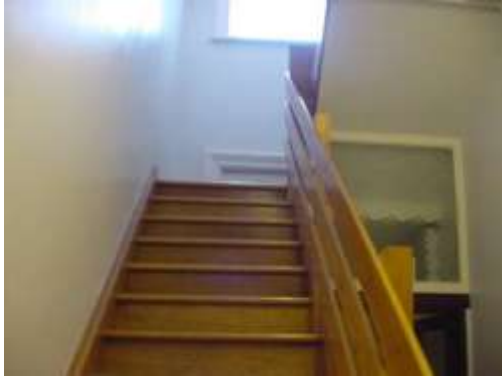
Stairway

DESCRIPTION	CONDITION	ACTION REQUIRED
Ceilings: Painted	Dirty and dated.	Repair, prepare and redecorate.
Walls: Painted

Damage particularly to the rear of the hallway caused by damp proof course being inserted. Inappropriate damp proof course added, the walls are still damp (damp meter readings were obtained on internal walls)	Eliminate dampness and repair, prepare and redecorate.
Floors: Carpets		Clear and clean

<p>Joinery/Detailing:</p> <p>Stairs: Timber</p> <p>Door:</p>		<p>Ensure meets Fire Regulations; additional lining to the back of the stairs likely to be required.</p> <p>Redecorate door area and associated skirtings and architraves.</p>
<p>Services: See Services section</p> <p>Fuse board/Electrics:</p> <p>Heating:</p> <p>Lighting:</p> <p>Fire alarm system:</p>	<p>Not to modern standards</p> <p>None</p>	<p>Box in electric supply with a half hour fire resistant unit. A check is required and re-wire.</p> <p>We would recommend new heating is added.</p> <p>Replace</p> <p>Add</p>

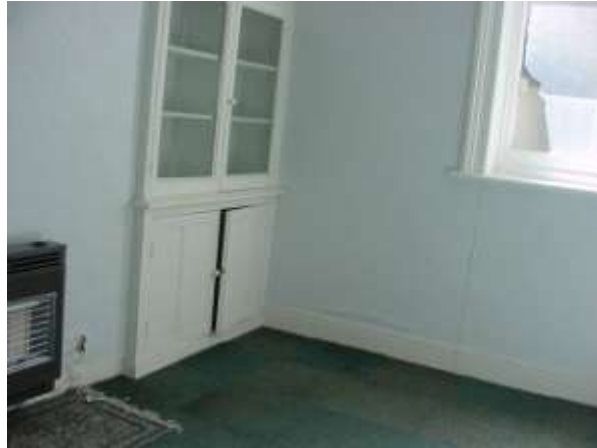
Rear office – proposed kitchen and toilet facilities

DESCRIPTION	CONDITION	ACTION REQUIRED
Ceilings: Ceiling tiles

Replace ceiling tile system including lighting.
Walls: Painted	Dampness found	Eliminate damp, repair, prepare and redecorate.
Floors: Carpets tiles	Dated	Clean and/or replace
Joinery/Detailing: Windows Doors		Ease and adjust, repair, prepare and redecorate. Repair, prepare and redecorate.

Services:		
Lighting	Lights not to modern standards	Replace
Electrics		Re-wire
Heating		We would recommend new heating is added.
Fire alarm system	None.	Add.

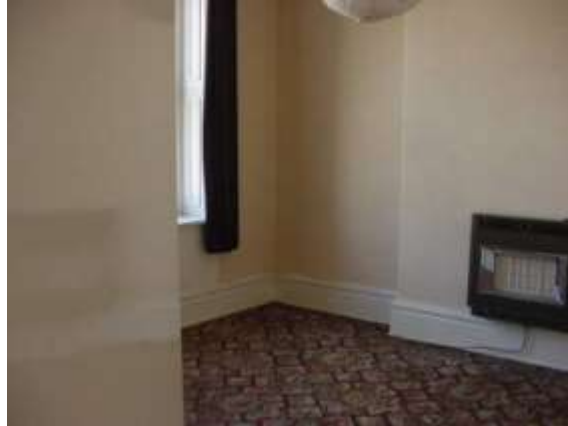
Front office

DESCRIPTION	CONDITION	ACTION REQUIRED
Ceilings: Painted	Dirty and dated	Repair, prepare and redecorate.
Walls: Painted	Marked and signs of lateral dampness coming through	Stop dampness, repair, prepare and redecorate.
Floors: Carpets	Excessive deflection in floor indicating that there is rot to the joist ends or the floor joists or both	Open up floors; add appropriate structural support/replace timbers.
Joinery/Detailing: Windows Doors		Ease and adjust, repair, prepare and redecorate. Ensure that doors are half hour fire resistance ideally one hour or as stated by the Fire Officer
Services: See Services section Electrics: Re-wire Heating: We would recommend new heating is added. Lighting: Lights not to modern standards - replace Fire alarm system: Add

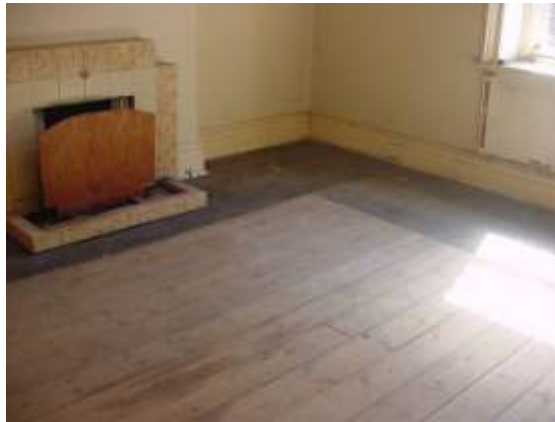
Rear office

DESCRIPTION	CONDITION	ACTION REQUIRED
Ceilings: Painted	Dirty and dated	Repair, prepare and redecorate.
Walls: Painted	Marked and signs of lateral dampness coming through	Stop dampness, repair, prepare and redecorate.
Floors: Bare timber	Excessive deflection in floor indicating that there is rot to the joist ends or the floor joists or both	Open up floors; add appropriate structural support/replace timbers.
Joinery/Detailing: Windows Doors	Dated	Ease and adjust, repair, prepare and redecorate. Ensure that doors are half hour fire resistance ideally one hour or as stated by the Fire Officer
Services: See Services section Electrics: Re-wire Heating: We would recommend new heating is added. Lighting: Lights not to modern standards - replace Fire alarm system: Add

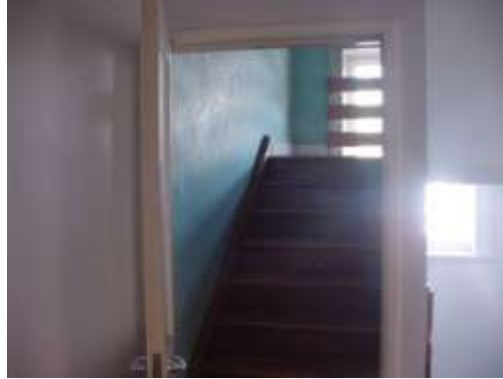
Landing Area

DESCRIPTION	CONDITION	ACTION REQUIRED
Ceilings: Painted	Redecorate	Repair, prepare and redecorate.
Walls: Painted	Redecorate	Repair, prepare and redecorate.
Floors: Timber floorboards that run from front to the back, i.e. joists run side to side		Check condition of floor by opening up
Joinery/Detailing: Doors		Repair, prepare and redecorate.
Services: Lighting Electrics Heating Fire alarm system	Lights not to modern standards None.	Replace Re-wire We would recommend new heating is added. Add.

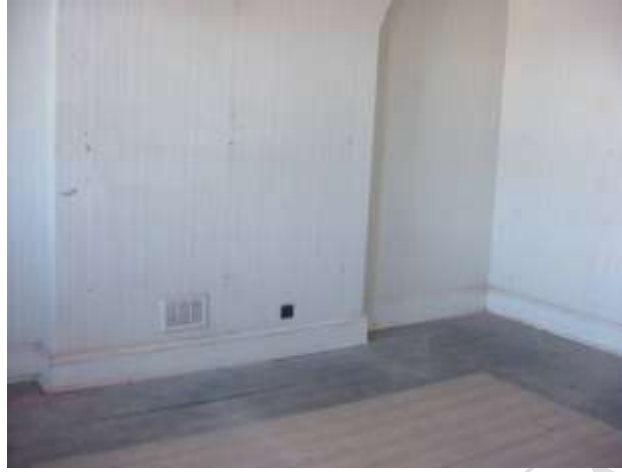
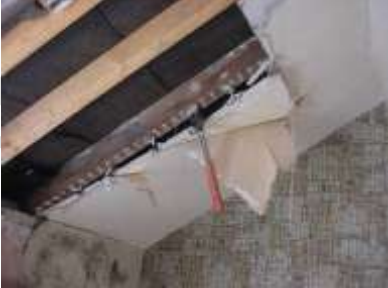
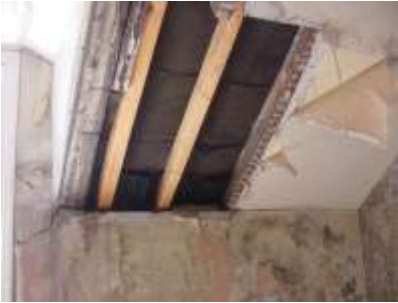
Rear office

DESCRIPTION	CONDITION	ACTION REQUIRED
<p>Ceilings: Painted</p>	<p>Water damaged. The roof has been letting in water.</p>

<p>Underside of roof</p>	<p>Ensure watertight, repair, prepare and redecorate.</p>

<p>Walls:</p> <p>Painted and papered</p>	<div style="text-align: center;">

<p>Crack to wall</p> </div> <p>Marked and signs of lateral dampness coming through</p> <p>Rear right hand corner there has been a repair with dampness coming in,</p>	<p>Make an insurance claim with regards to the crack to the rear wall; investigate via the adjoining property</p> <p>Stop dampness, repair, prepare and redecorate.</p> <p>The plaster needs to be made good, re-skim and redecorate.</p>
<p>Floors:</p> <p>Timber floorboards that run from front to the back, ie. joists run side to side</p>	<p>Excessive deflection in floor indicating that there is rot to the joist ends or the floor joists or both</p>	<p>Add appropriate structural support.</p>
<p>Joinery/Detailing:</p> <p>Windows</p> <p>Doors</p>		<p>Ease and adjust, repair, prepare and redecorate.</p> <p>Ensure that doors are half hour fire resistance ideally one hour or as stated by the Fire Officer</p>

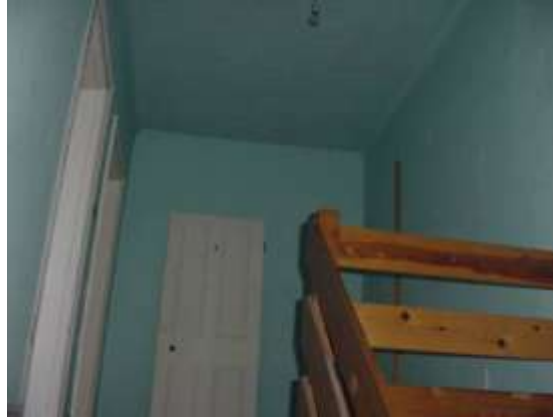
Landing Area

DESCRIPTION	CONDITION	ACTION REQUIRED
Ceilings: Painted	Redecorate	Repair, prepare and redecorate.
Walls: Painted	Redecorate	Repair, prepare and redecorate.
Floors: Timber floorboards that run from front to the back, i.e. joists run side to side		
Small access hatch:

We were only able to carry out a head and shoulders inspection due to its location and size.	We recommend a large access hatch is formed in a safe area and the roof is re-inspected.
Joinery/Detailing: Doors		Repair, prepare and redecorate.
